## **Aging of Composite Aircraft Structures Beechcraft Starship and B-737 Horizontal Stabilizer**

**John Tomblin, PhD**  
*Executive Director, NIAR*

June 17<sup>th</sup>, 2008

**The Joint Advanced Materials and Structures Center of Excellence**

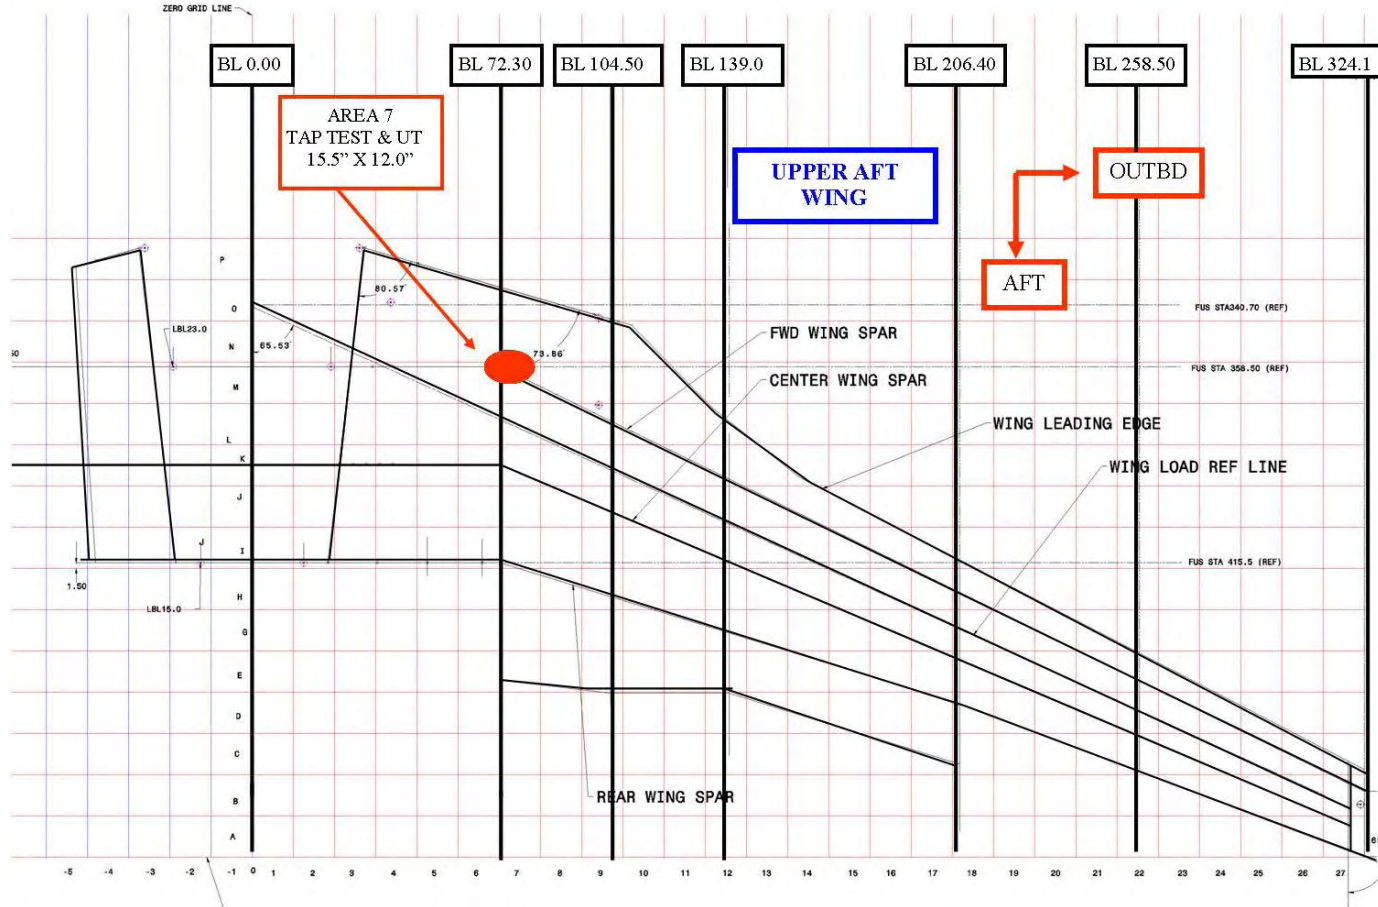
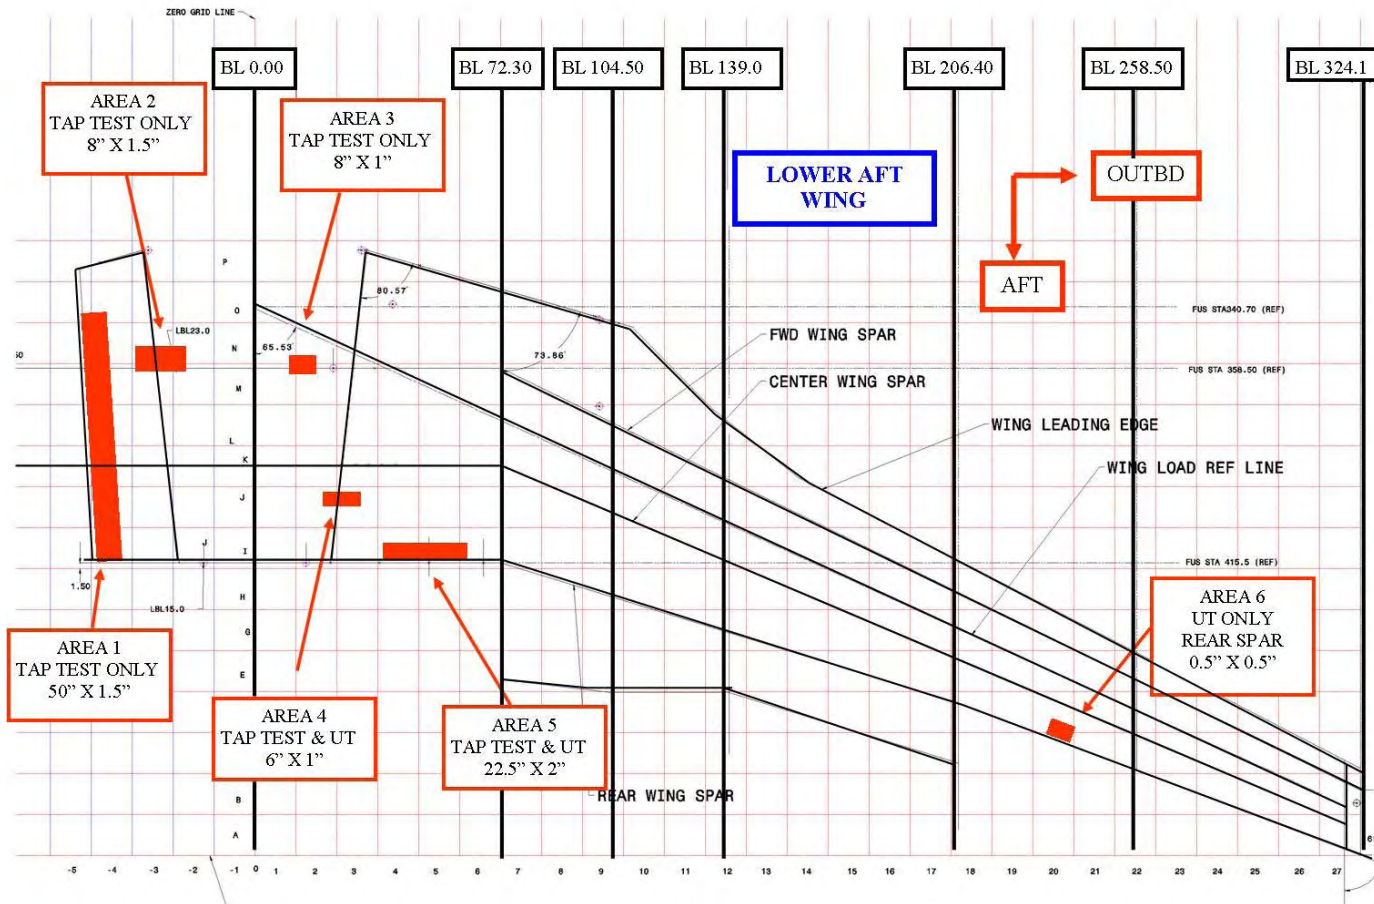
- A baseline Non-Destructive Inspection scan has been generated prior to conducting the full scale test in order to identify possible manufacturing flaws or defects induced during service
- NDI grid has been drawn on the structure for ease of inspection and flaw growth monitoring
- Visual inspection, TTU and tap testing were used for the inspection
- A few areas in both the upper and lower skins have been identified as disbonds by the inspectors

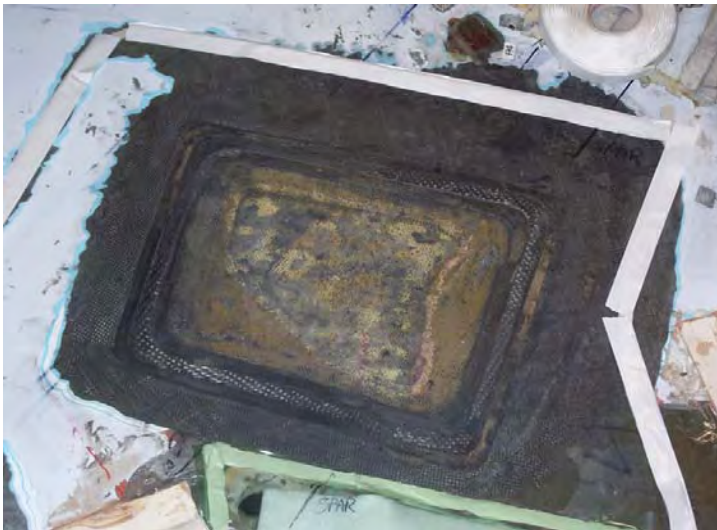
**Scarf repair area**

- Wet lay-up repair per BS 24204 and BS23727 using EA 956 resin
- Repair Analysis conducted by the OEM and demonstrated positive margins for axial loading
- Repair Stacking sequence: PW45/T0/8HS0/T0/8HS90/T0/PW45

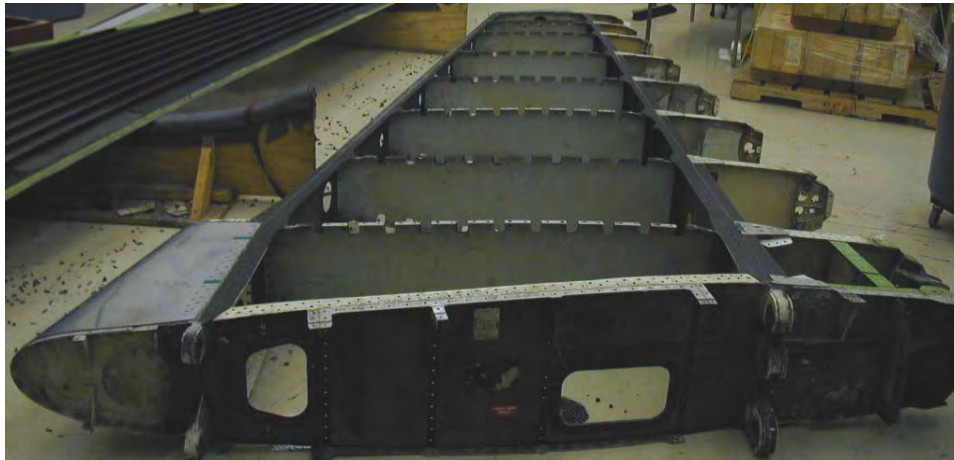
**Center Box (RH)**

- Structure held very well
- No evidence of pitting or corrosion as would be observed in a metal structure
- No residual strains compared to the LH

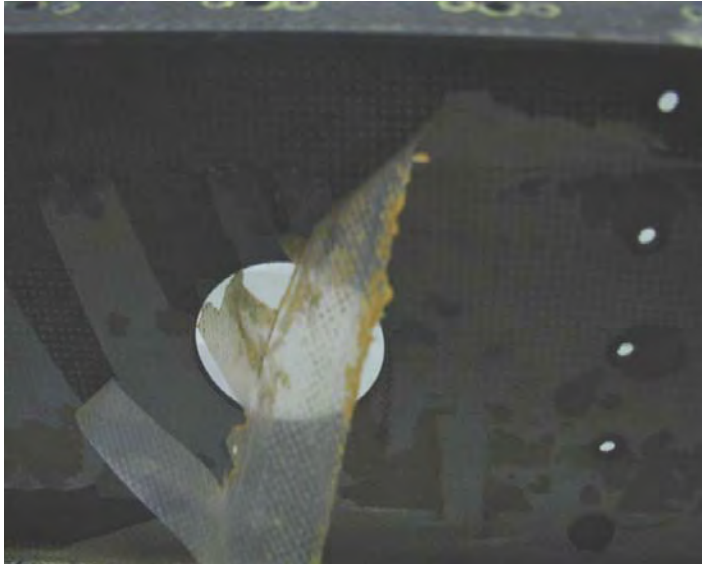
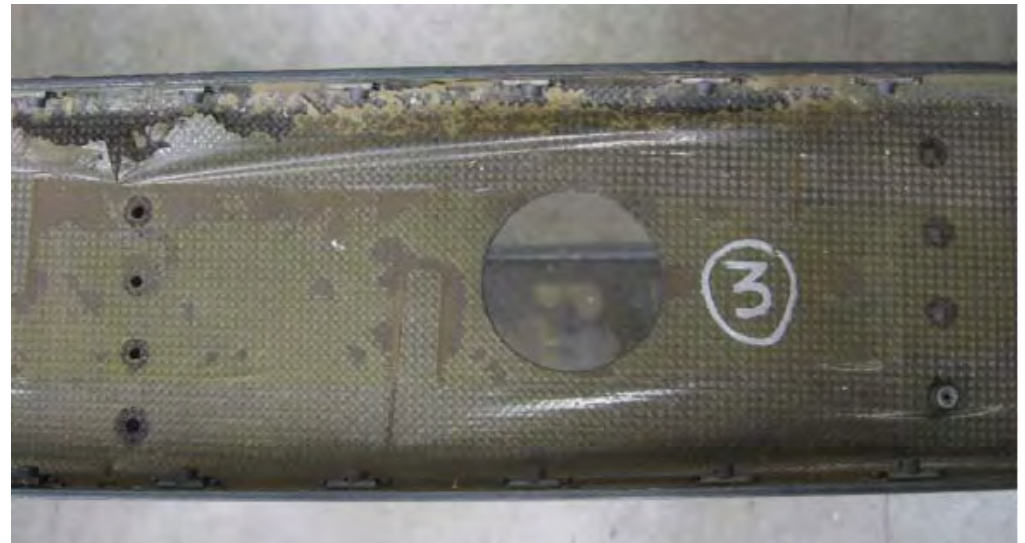
Degradation of Tedlar Moisture Barrier film

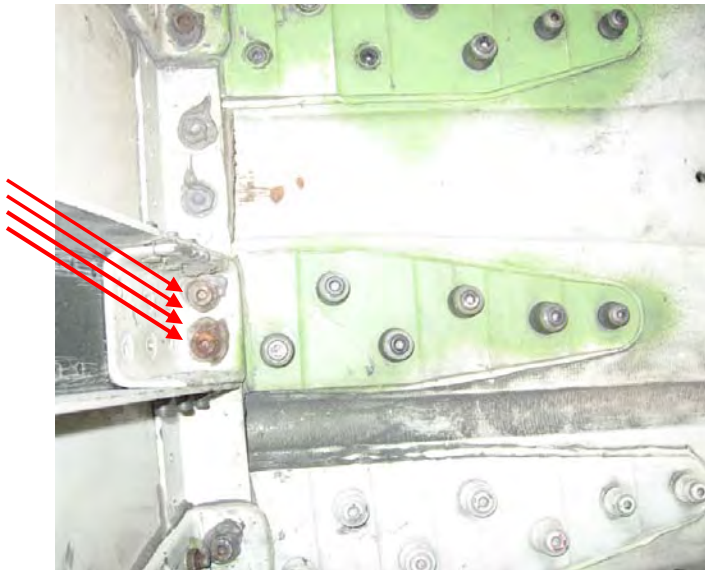
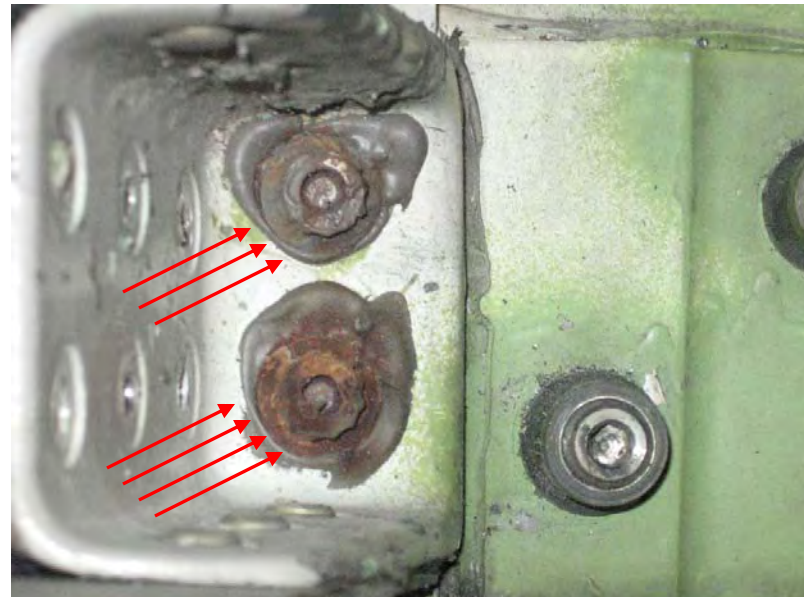
**A few corroded fasteners due to sealant deterioration**

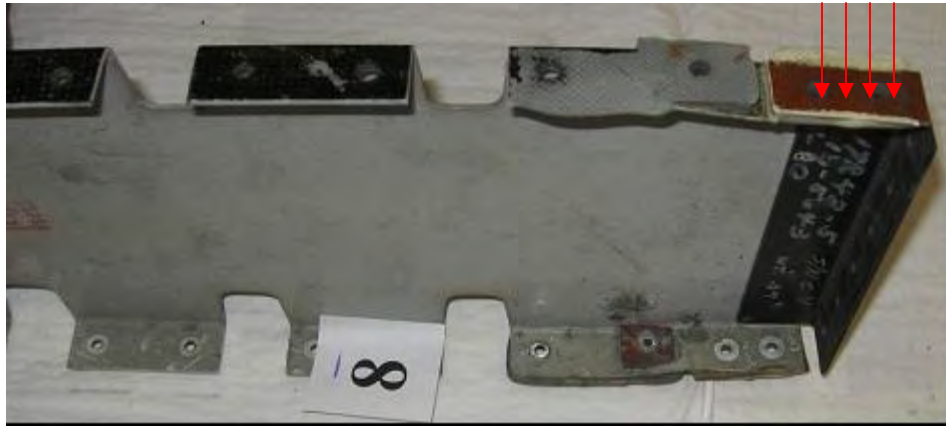
**Phenolic shims used to fill gaps between skin and ribs**

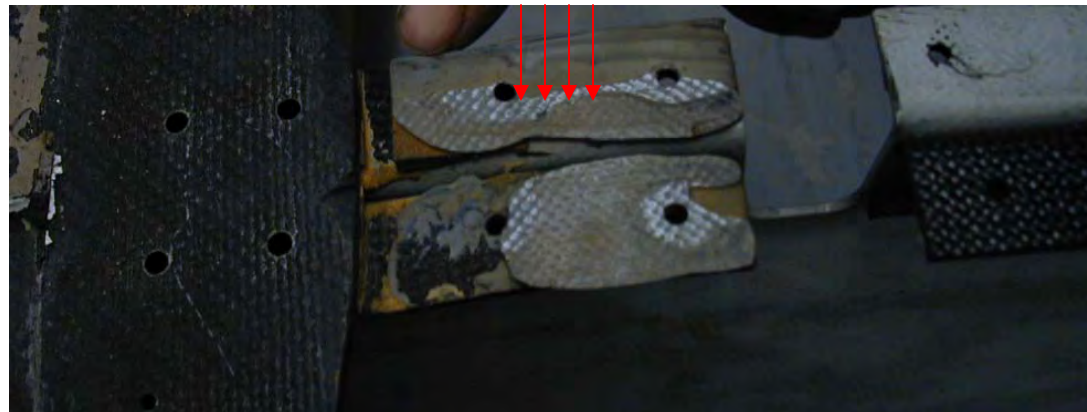
**Liquid Shims used to fill gaps between the upper skin and the stabilizer ribs**

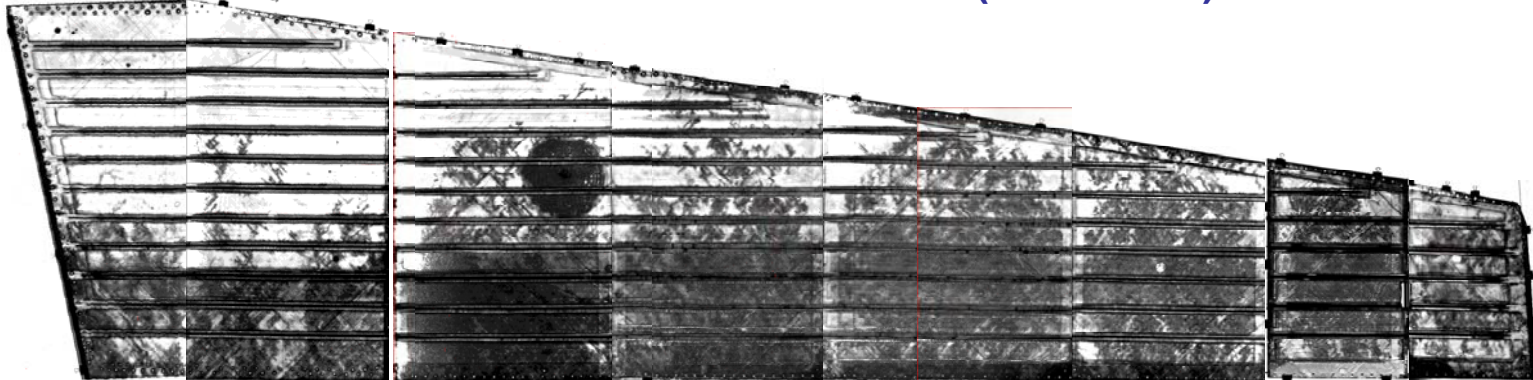
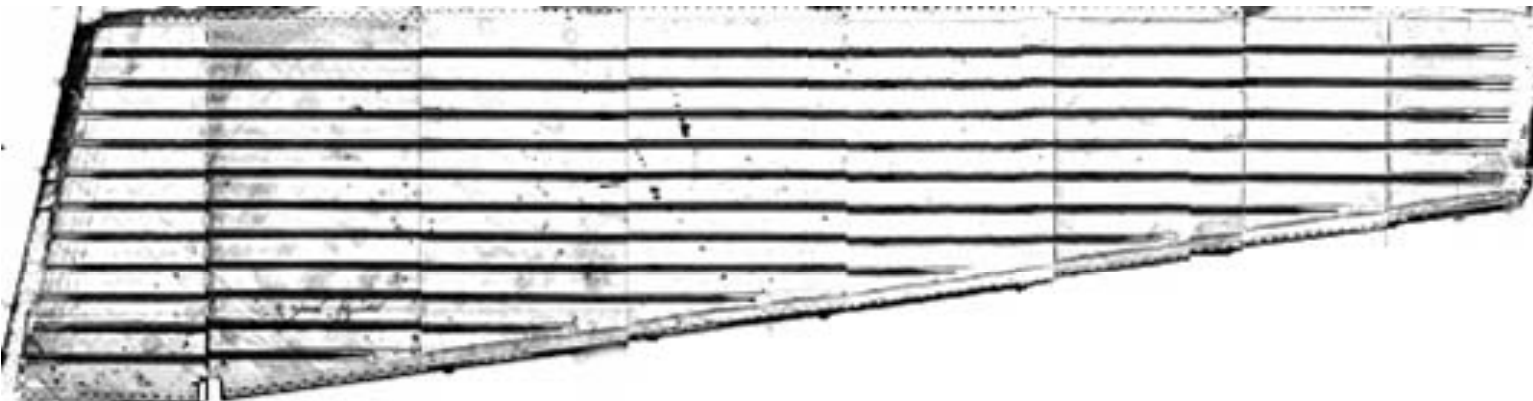
- NDI pulse echo inspection showed significant levels of porosity in the upper skin compared to the lower skin (tooling and process variability)
- Porosity levels have been quantified using image analysis/ physical tests
- Very porous repair between rib stations 2 and 3 (str 5 and 8)

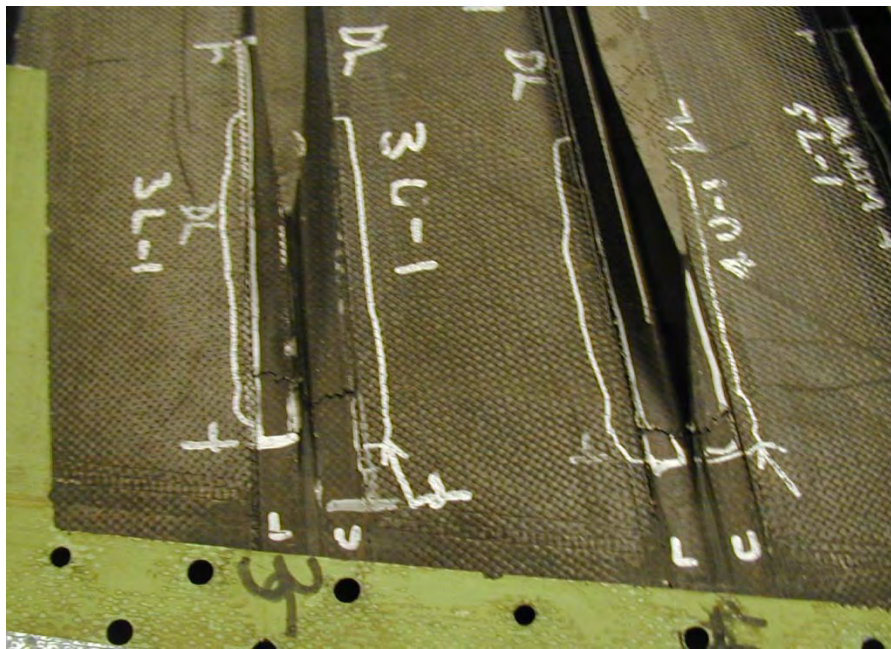
- DSO of 75000 flights
- Upper Skin Inboard delaminations at stringer runouts due to maintenance personnel walking on a no-step zone

Upper skin Inboard delaminations at stringer runouts

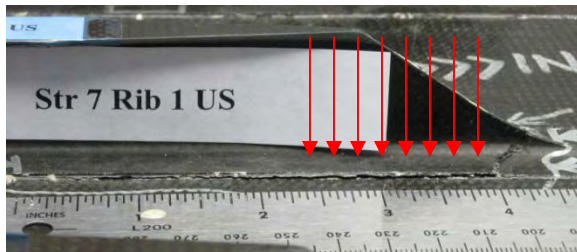
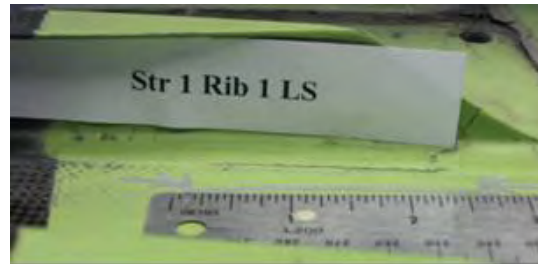
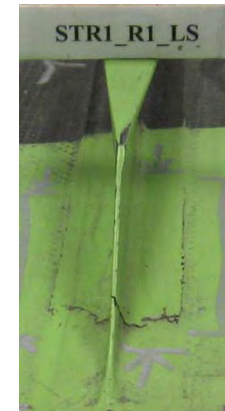
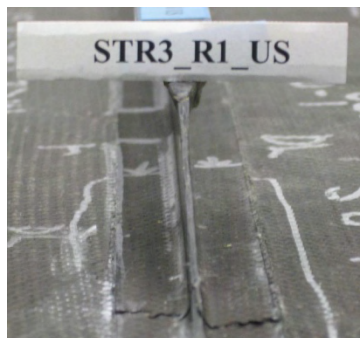
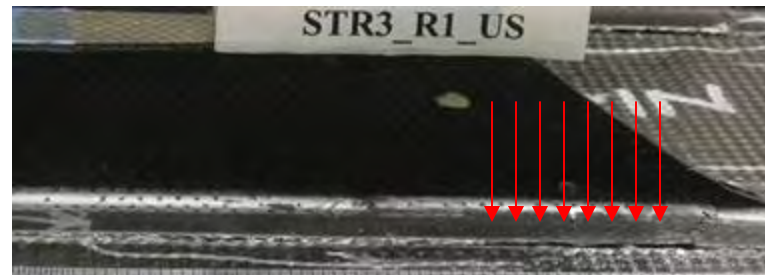
- Destructive evaluation has been conducted on sections of the stabilizer identified as disbonds from the NDI inspection to verify the existence of these delaminations. Destructive evaluation confirmed the results.

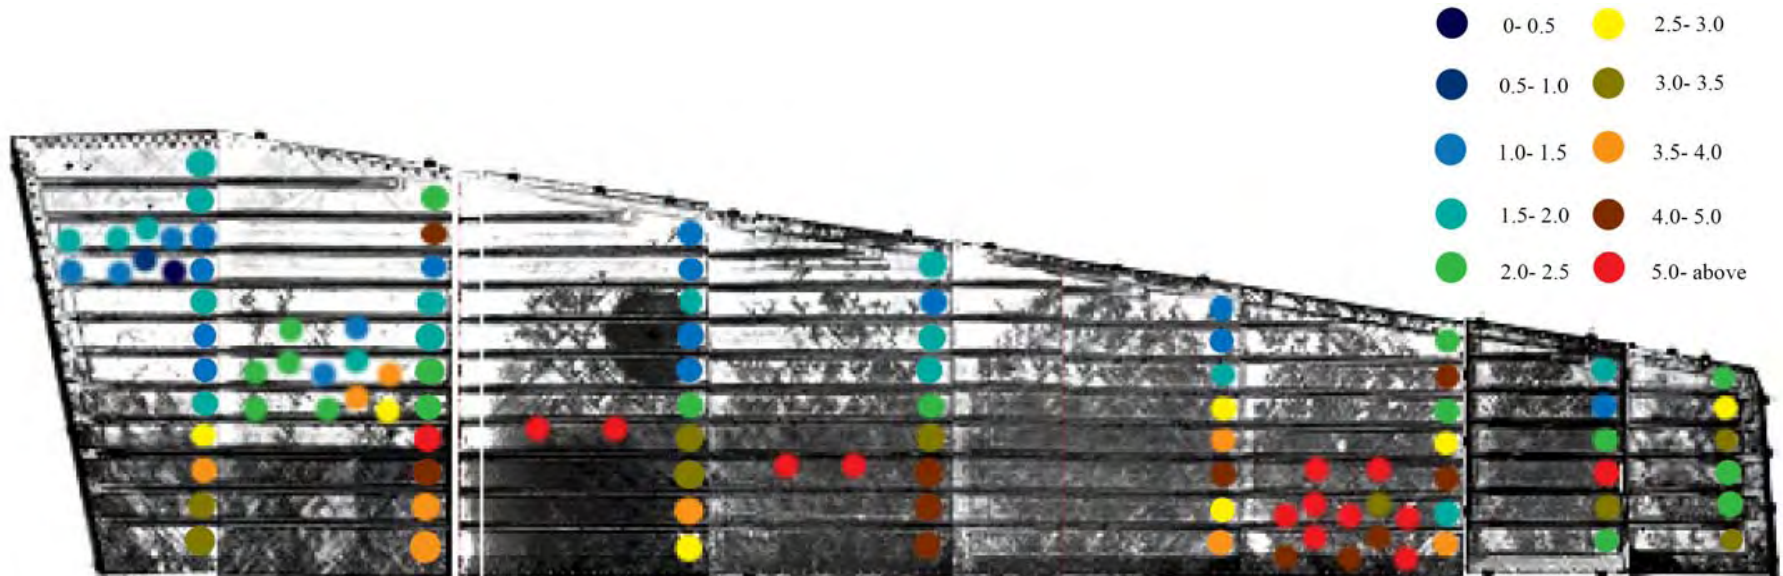
Upper Skin (Max void Content 7.26%)

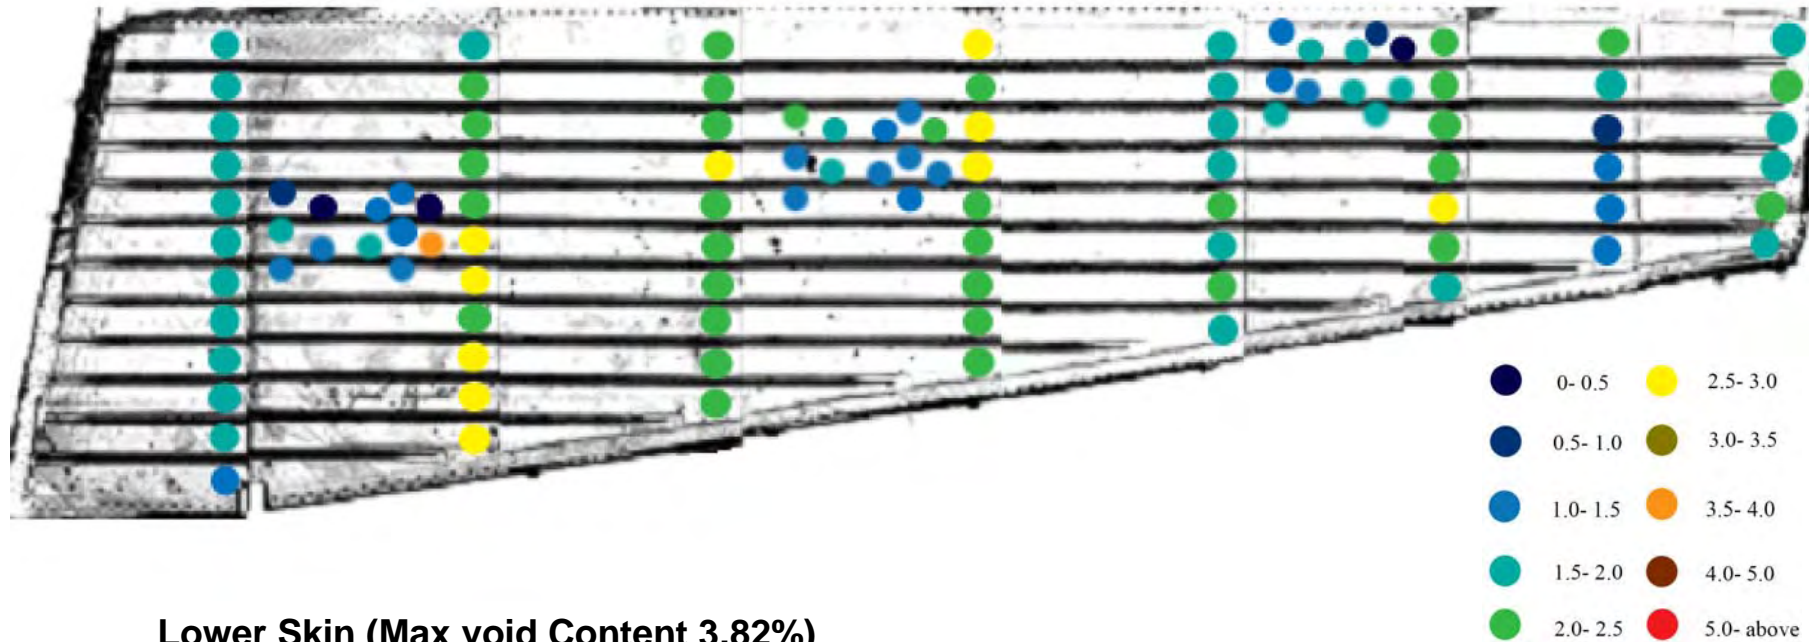
**Lower Skin (Max void Content 3.82%)**

**Front and Rear Spars (Less than 1.14% and 1.67% void content)**

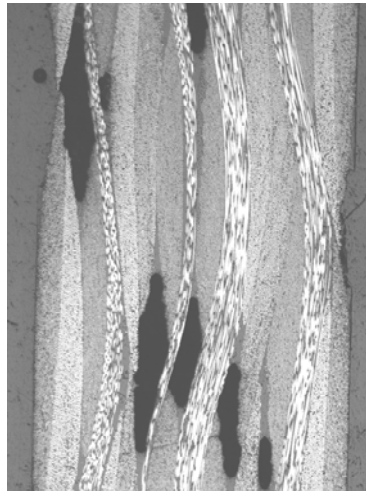
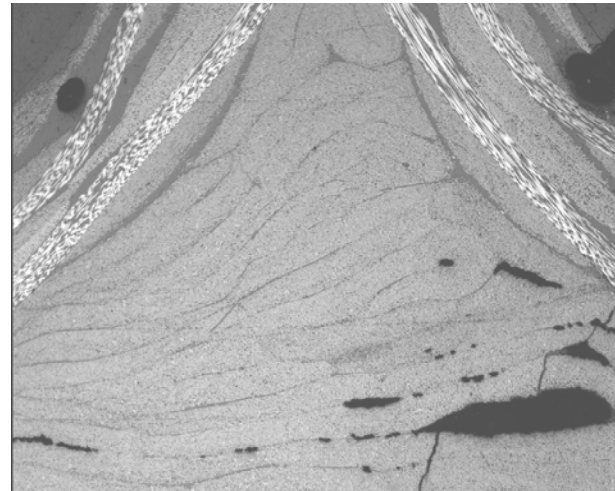
- Image analysis was performed to detect porosity/ micro-cracking and any evidence of aging in the structure.
- Both images show evidence of porosity embedded in the laminate. The flange cross section also shows evidence of microcracking initiating in the void areas.

**X-section of stringer 2, rib station 2 at a magnification of 50x stringer web (left image) and flange (right image).**
