Aging of Composite Aircraft Structures

John Tomblin, PhD
Executive Director, NIAR

May 19th, 2010

Beechcraft Starship Aft Wing Teardown- FAA Sponsored Project Information

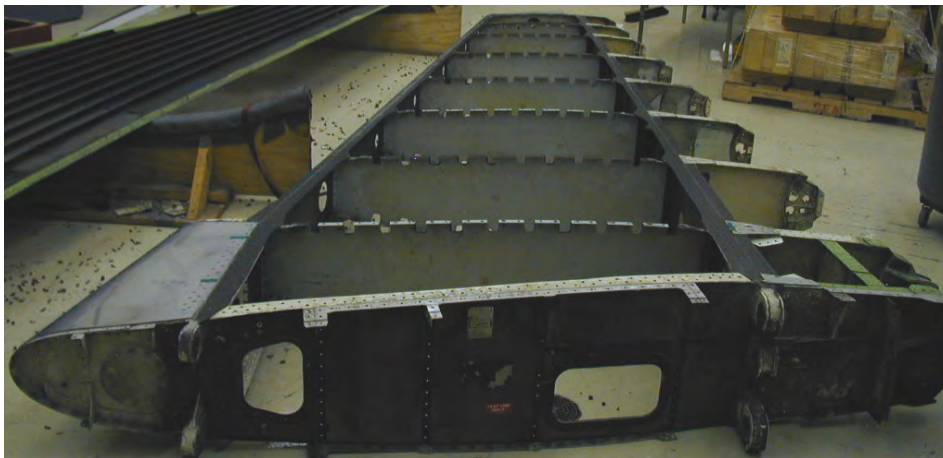
Center Box (RH)

- **Structure held very well**
- **No evidence of pitting or corrosion**
 as would be observed in a metal structure with similar service history

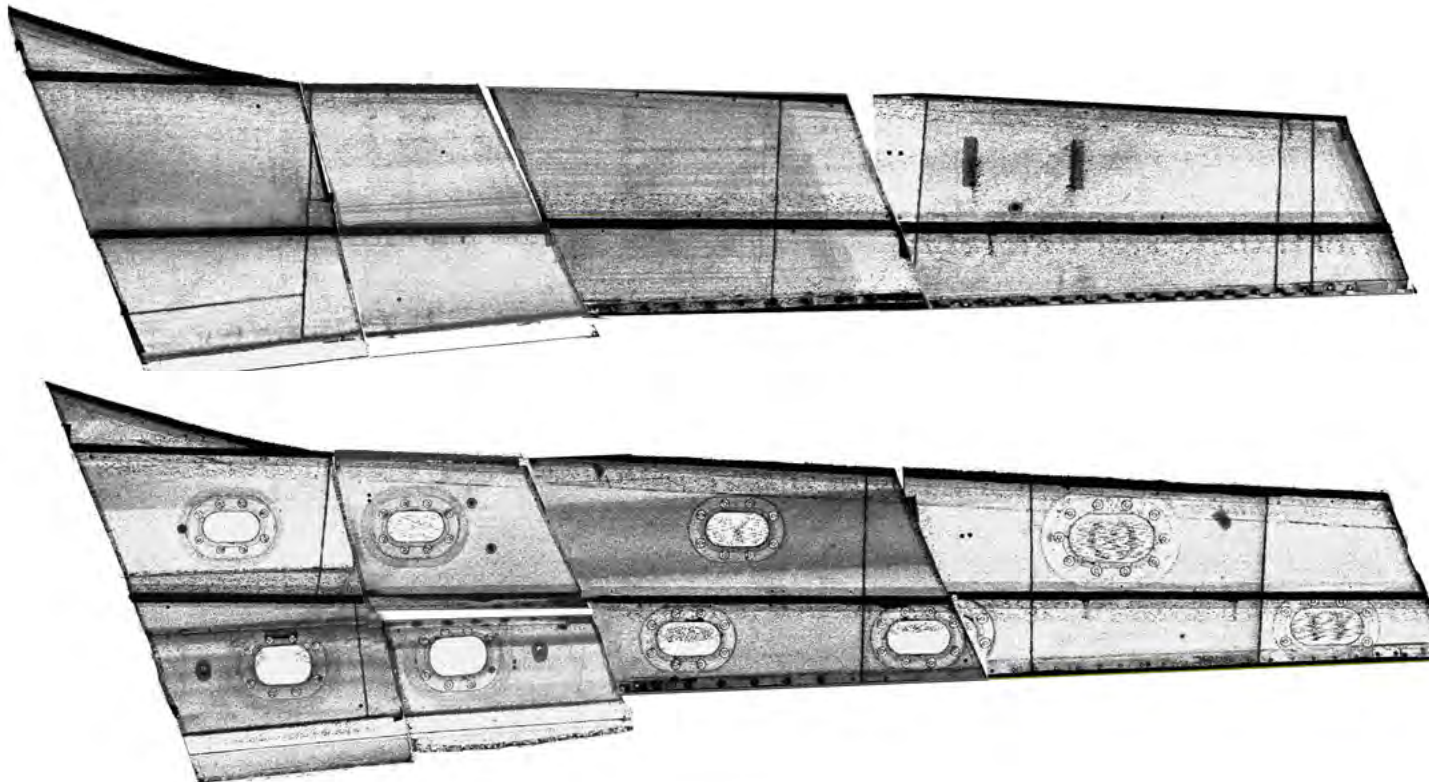
NDI-LH Main Wing (Skins)

TTU Non-Destructive inspection showed no major flaws induced during manufacture or service in the skins. Maximum porosity levels found were less than 2.3%.

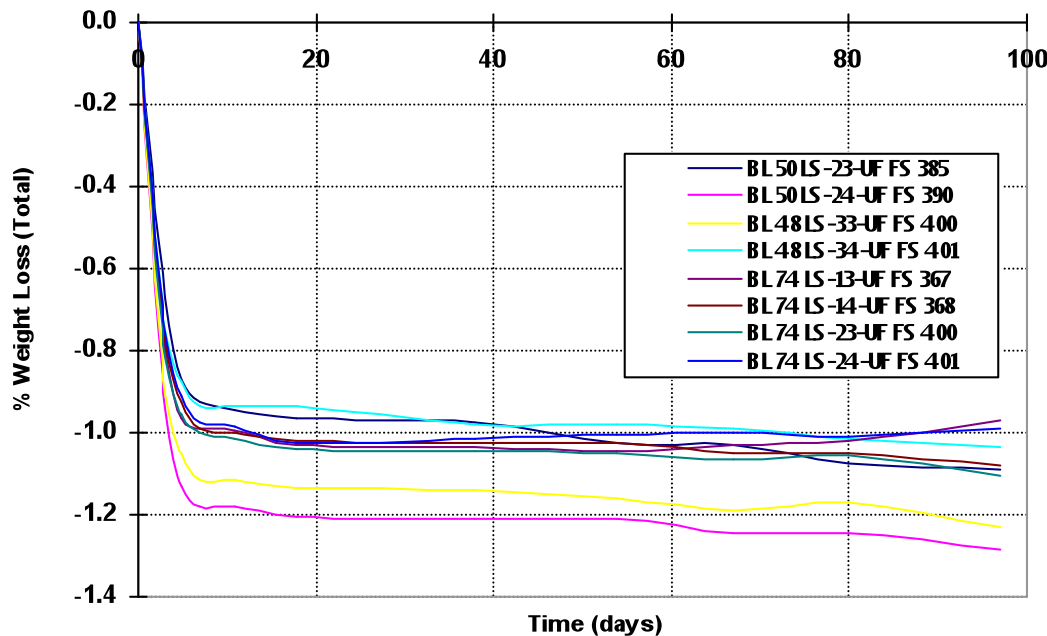
Moisture Content - Lower Skin Upper Facesheet

Maximum Moisture content ~1.065% for US and ~1.286% for LS

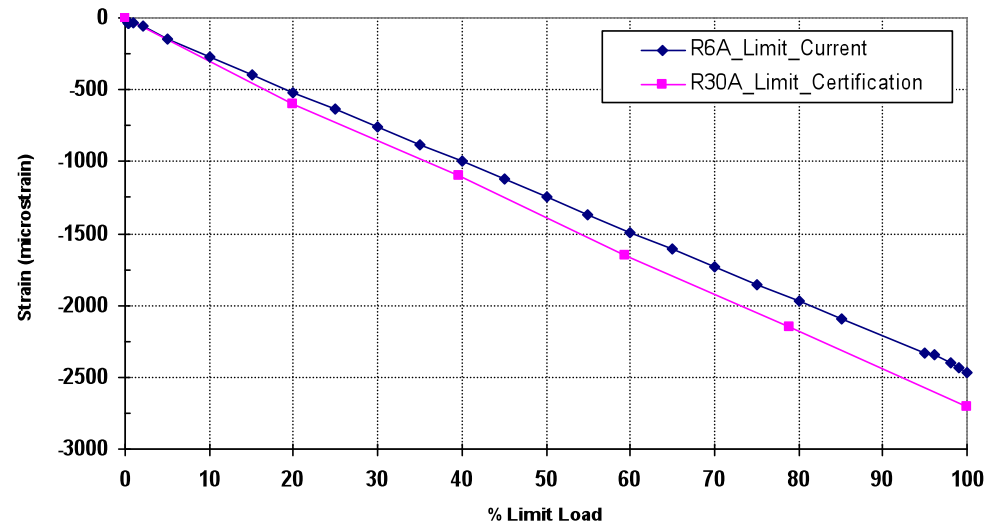
**Strain Gage R6 on test article
Located on Upper Skin
RBL 174 FS 424.5
Same Location as R30
(Certification Test)**

- **Certification test article data correlates very well with aged structure limit load test data (data linear to limit load)**

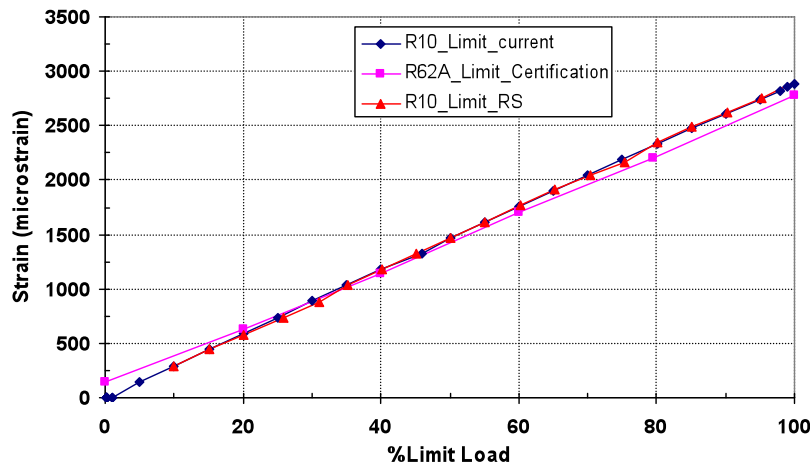
**Strain Gage R10 on test article
Located on Lower Skin Outer Facesheet
RBL 208 FS 439.5
Same Location as R62 (Certification Test)**

- Certification test article data correlates very well with aged structure limit and residual strength (to limit) test data (data linear to limit load)
