# Composite Thermal Damage Measurement with Handheld FT-IR

1. Materials Science and Engineering, University  
of Washington, Seattle WA
2. The Boeing Company, Seattle, WA

- Determine if handheld Fourier transform infrared (FTIR) spectroscopy can detect ITD and guide repair

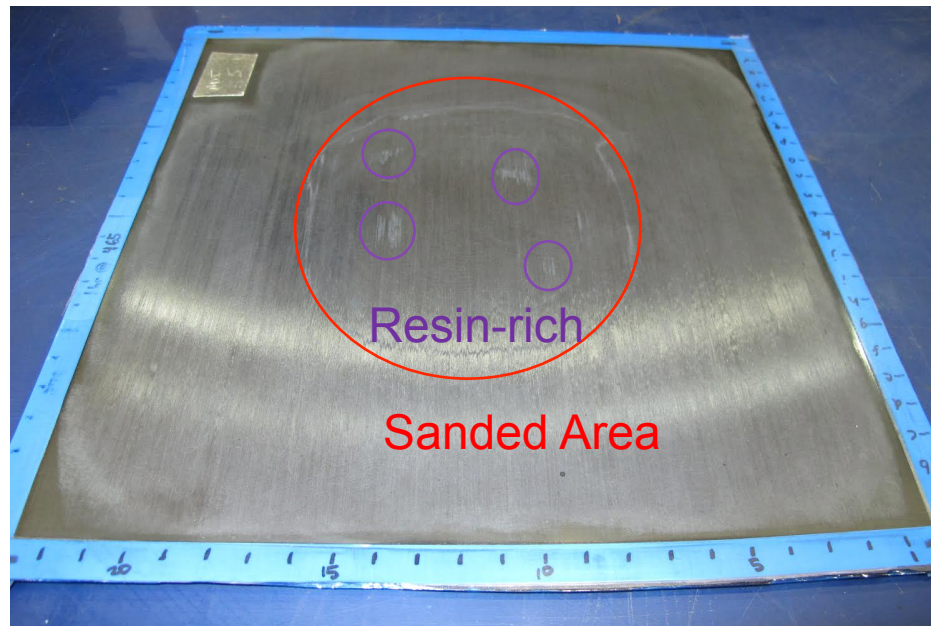
- Located damage based on FTIR inspection and sanded down to next ply
  - Small areas of over-sanding leading to resin rich spots

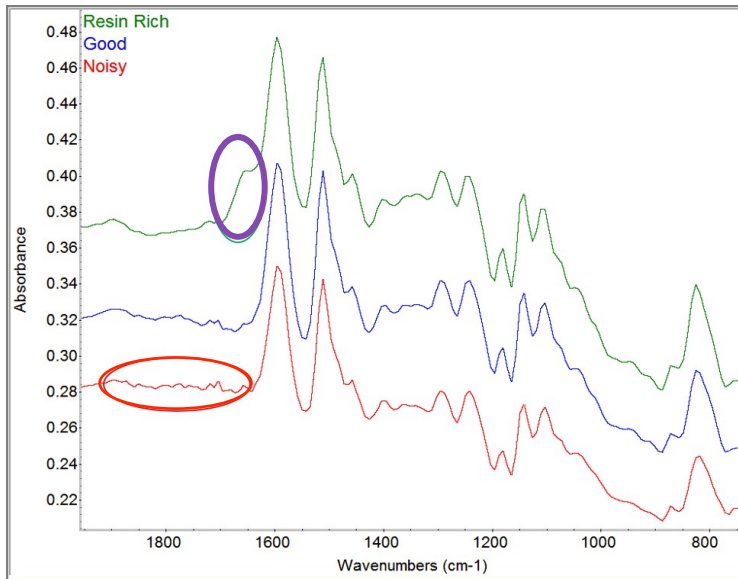
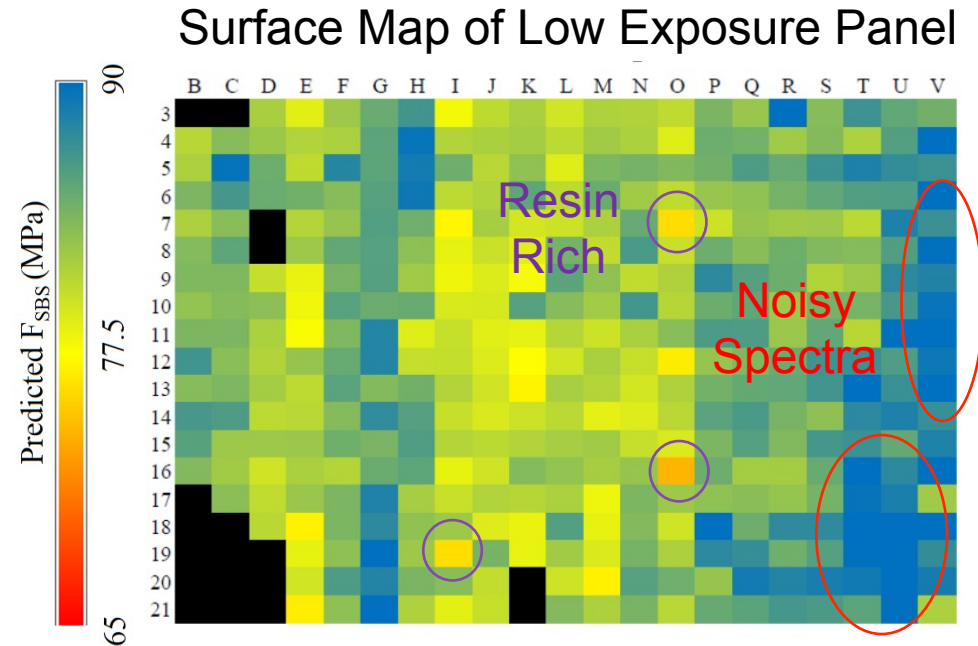
- Resin rich spectra exhibit broad carbonyl peak between 1600-1690  $\text{cm}^{-1}$ 
  - Predicted lower  $F_{\text{SBS}}$  values
- Noisy spectra were observed by an increase in noise in the baseline
  - Predicted higher  $F_{\text{SBS}}$  values
  - Can be mitigated by taking a new background reference

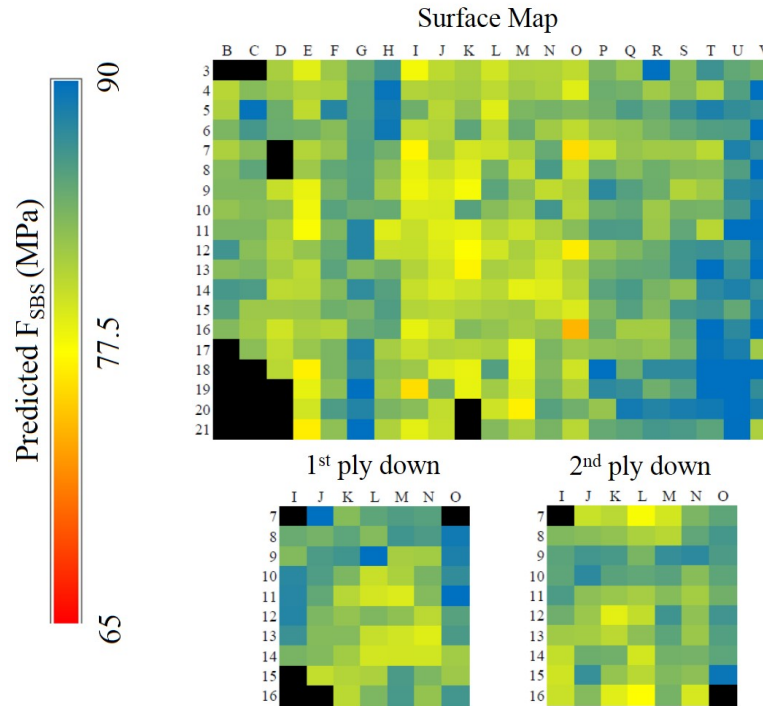
- Low exposure panel used to establish a Go/No Go threshold to damage removal
- Sanded down 2 plies to evaluate prediction variance
  - 79.5 MPa (90% retention of undamaged  $F_{SBS}$ ) chosen as the threshold (Green or blue color on the map)

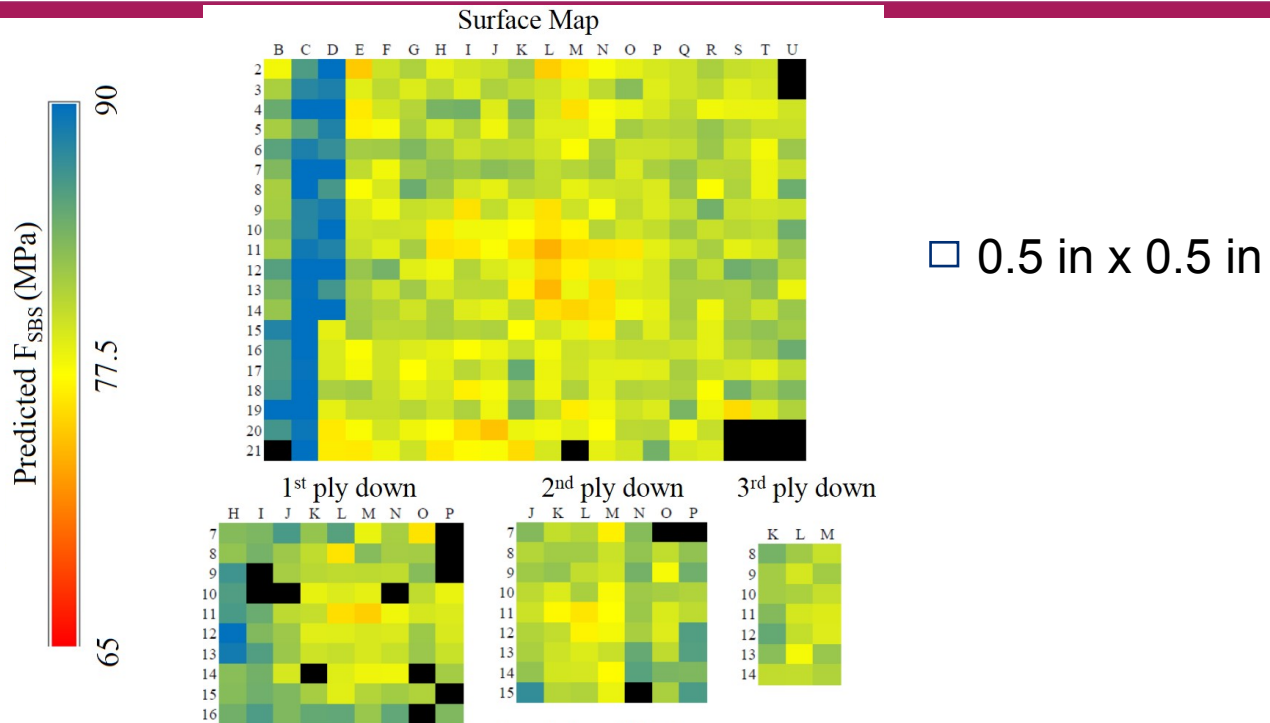
- Medium exposure panel exhibited moderate damage in 3" x 3"
  - Low  $F_{SBS}$  values around 74-75 MPa ( $\sim 82\%$  of undamaged  $F_{SBS}$ )
- Most of the damage was removed after sanding to the first ply down
- Panel passed Go/No Go threshold after sanding 3 plies down

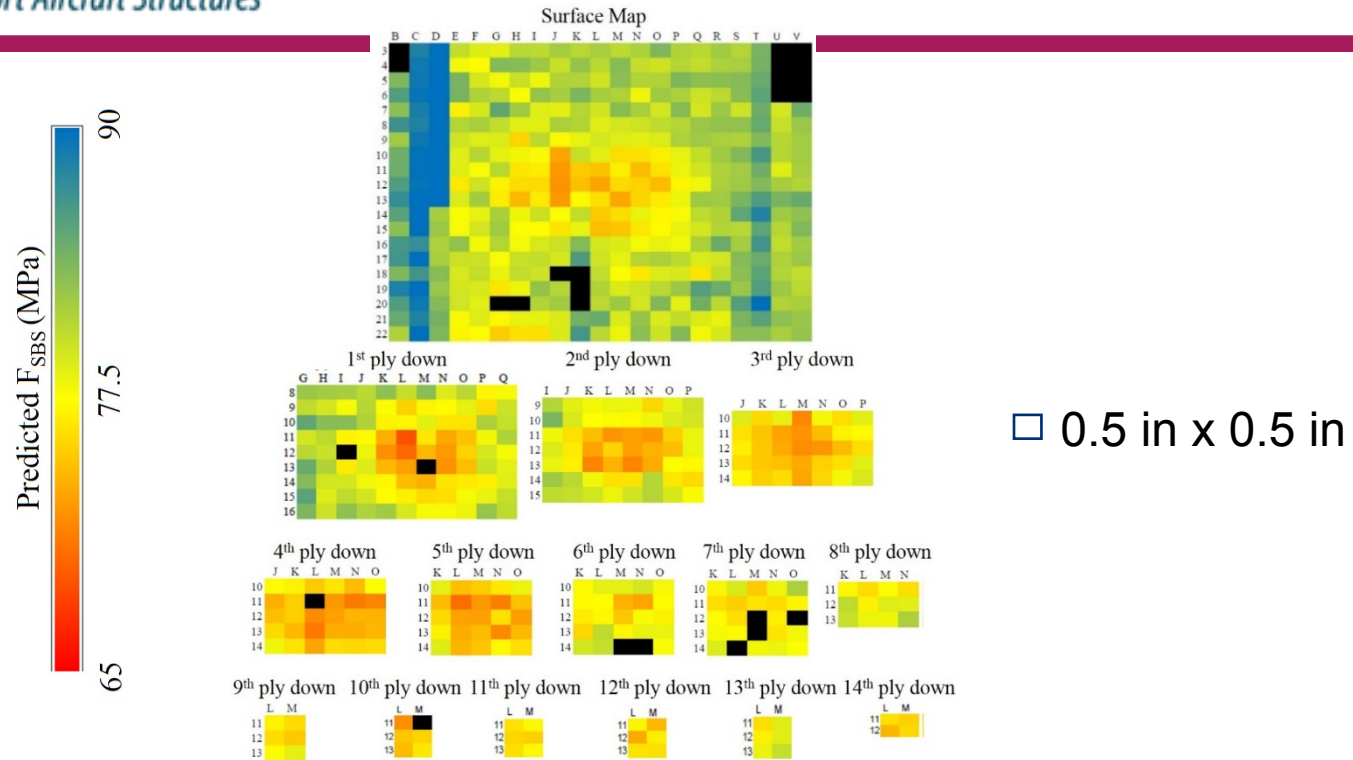
- High exposure panel had large damage region  $\sim 5'' \times 5''$ 
  - Low  $F_{SBS}$  values around 72-73 MPa ( $\sim 80\%$  of undamaged  $F_{SBS}$ )
- Go/No Go threshold not passed in the center of the panel after sanding down 14 plies
- Inspection stopped due to repair size restriction

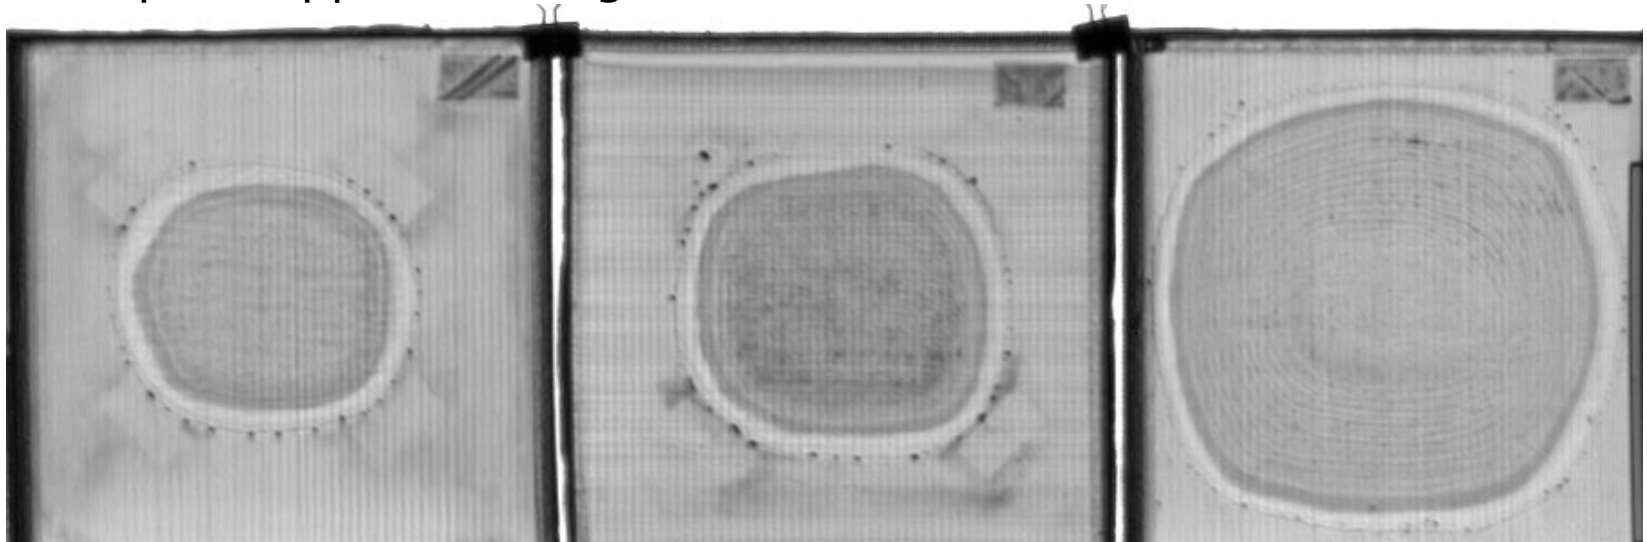
- Repaired panels inspected using ultrasound
  - 5Mhz 2.5" Focused TTU
  - 6" Water Path
  - .04 Resolution
- Repairs appear to be good

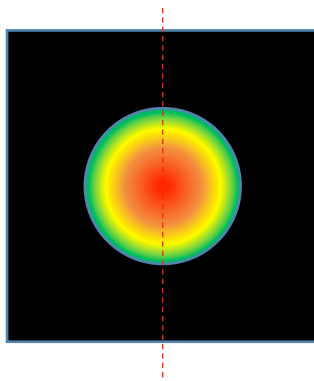
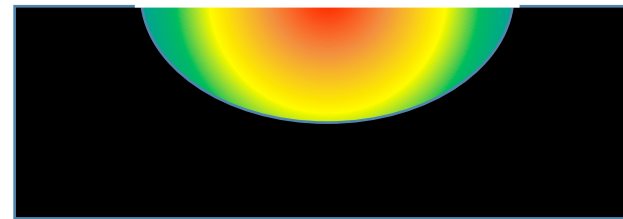
Top View of Damage Panel

Representative cross-section of damage area  
taken along red dashed line

Red = high damage  
Blue/Green = light damage  
Black = no damage
