# Composite Thermal Damage Measurement With Handheld FTIR

Tucker Howie  
Materials Science and Engineering  
University of Washington

JAMS 2014 Technical Review  
March 25-26, 2014

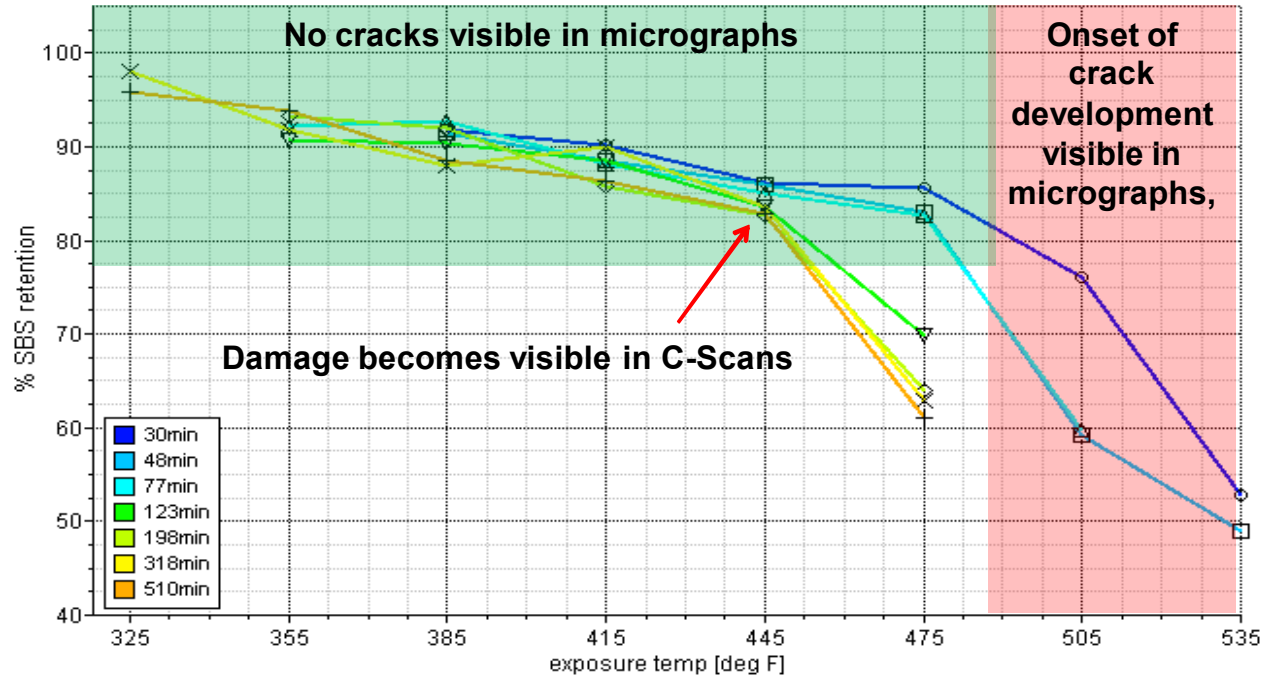
Short Beam Shear Strength Retention vs. Temp./Time – Epoxy 1

- Properties like short beam strength (SBS) degrade before detection possible with ultrasound or visual inspection
  - Damage termed ITD
- Need a method to detect ITD
  - FTIR?

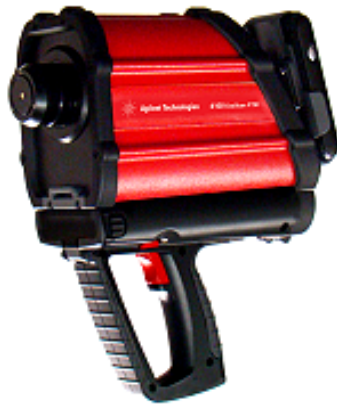
ExoScan FTIR

- Detects chemical changes in the matrix due to thermal degradation
- Mid-IR data region:  $4000\text{ cm}^{-1}$  to  $650\text{ cm}^{-1}$
- Diffuse reflectance sampling interface
- Data collection: 90 coadded scans with  $16\text{ cm}^{-1}$  resolution for background and specimen

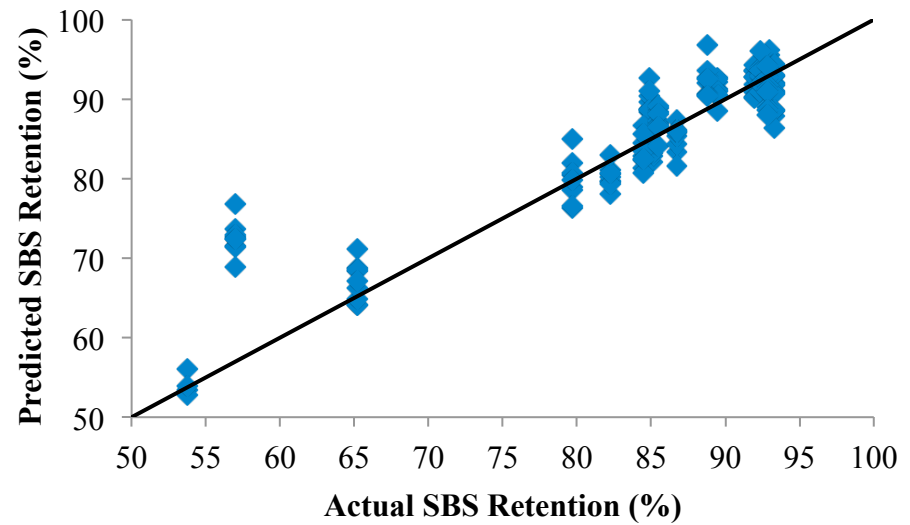
- A PLS model relating the SBS measurements to FTIR spectra was successfully generated for sanded surface
- Model was validated by predicting independent evaluation set
  - Model showed good predictive capabilities of evaluation set (~85% of samples had < 5% error)

Prediction of independent evaluation set

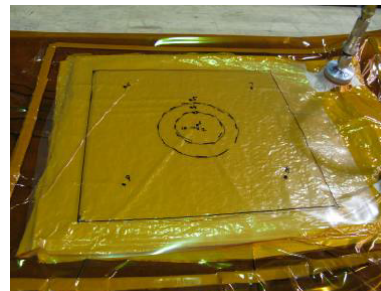
- 12" x 12" panels (24-ply) subjected to localized hotspot
- Local hotspot generated by stacking insulation layers on top of heat blanket in center of panel
- Three peak temperatures (440 °F, 465 °F, 490 °F) exposed for 1 hr

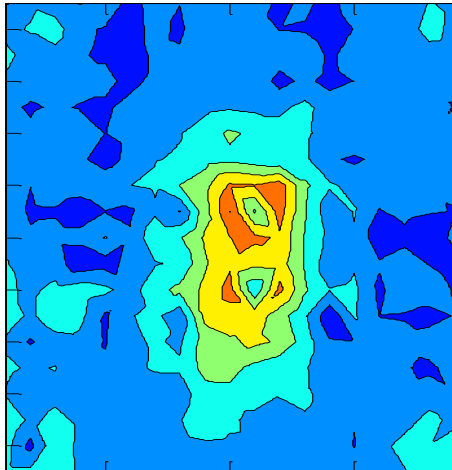
Resin Rich  
Surface  
(1<sup>st</sup> year)

Note: Scaling, panel orientation, and color scheme are different

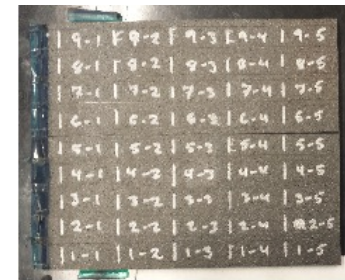
Side view

- 12" x 12" quasi-isotropic panels (24-ply) locally heated using a heat lamp
  - Max exposure ~ 450 °F for 1 hr
- Panel cut up into alternating strips for SBS and dynamic mechanical analysis (DMA) samples
  - Panel too thick for DMA samples → specimens cut from surface exposed to heat

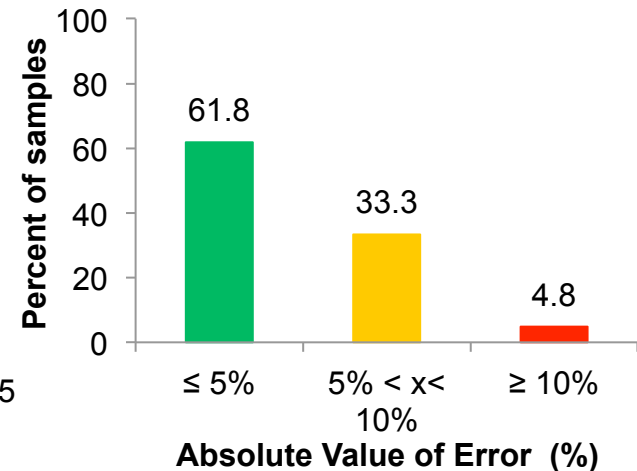
Prediction Error

$$\%Error = \frac{predicted - actual}{actual} * 100\%$$
