# **Composite Thermal Damage Measurement with Handheld FTIR**

October 31, 2012

Brian D. Flinn, Ashley Tracey and Tucker Howie  
University of Washington

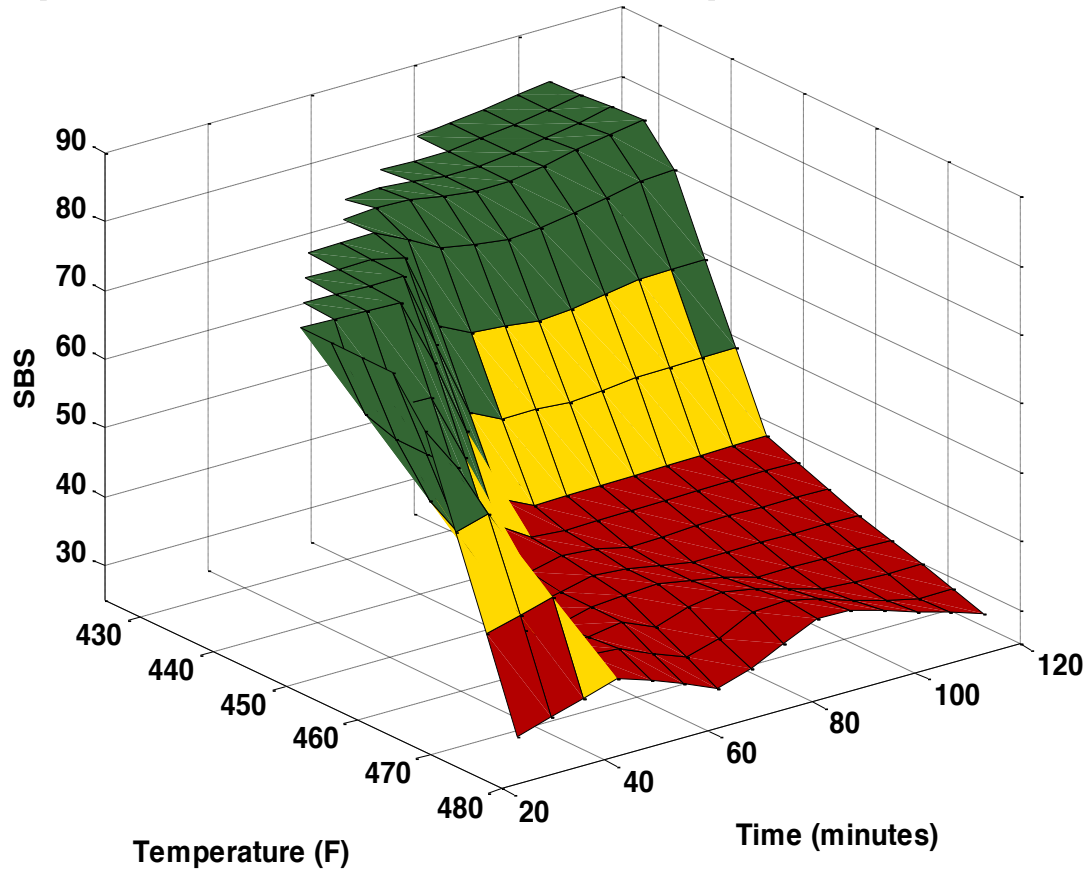
- Coupon level thermal exposure in oven

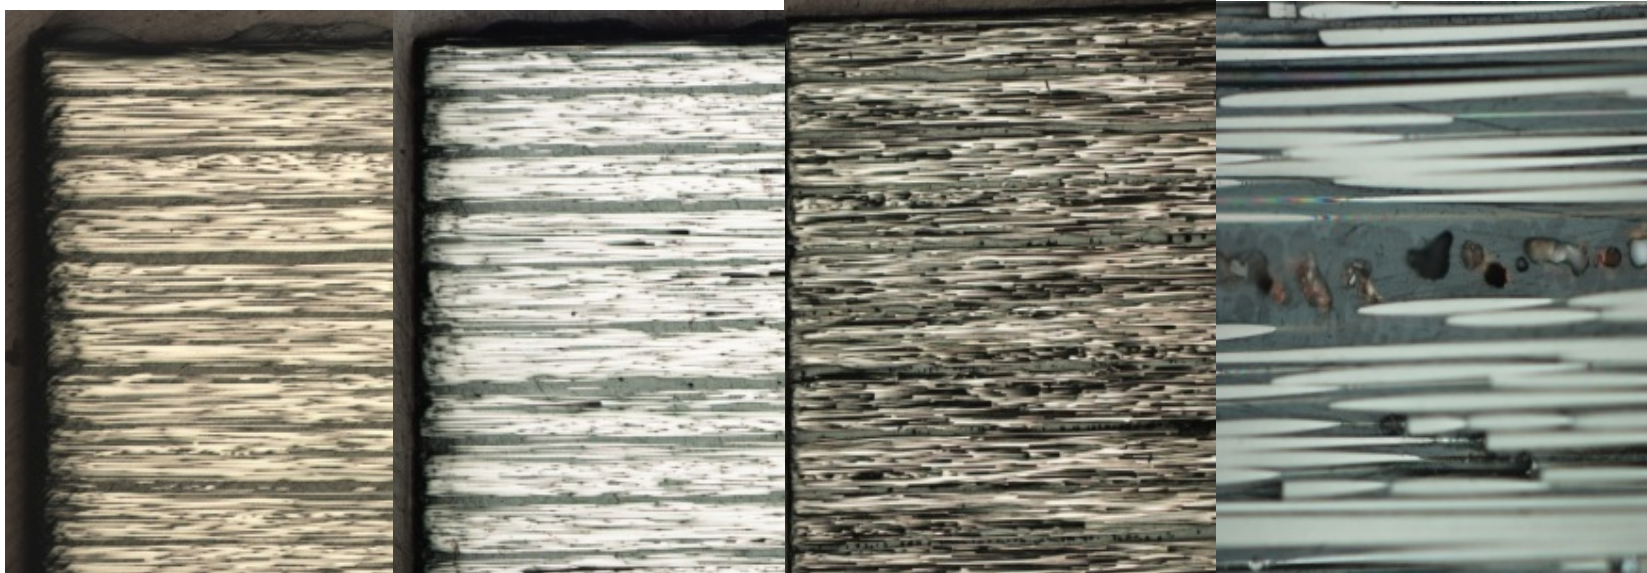
Low Exposure  
415F, 30min  
5X

Medium Exposure 415F,  
200min  
5X

High Exposure  
535F, 30min  
5X

High Exposure  
535F, 30min  
50X

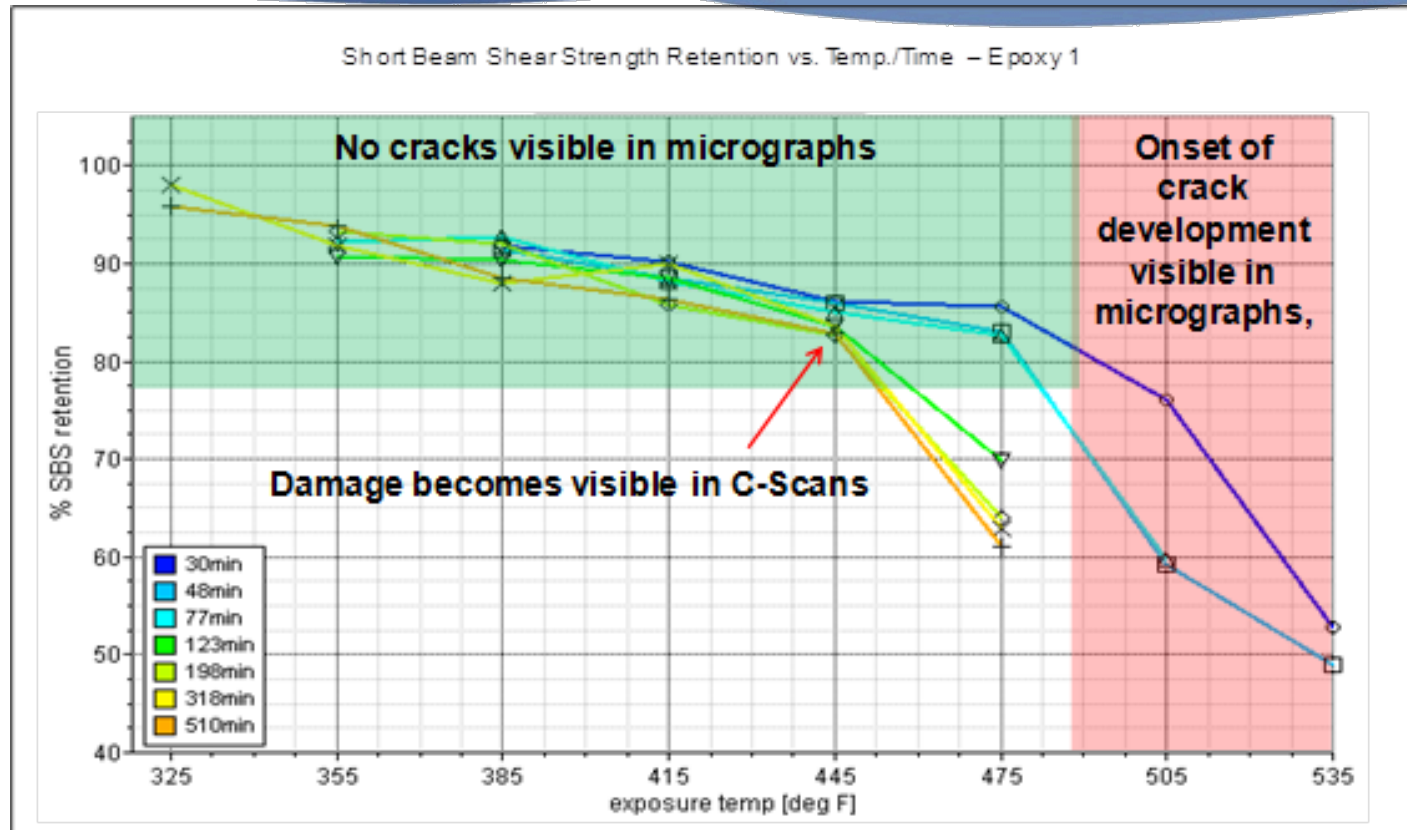
**SBS, ultrasound and microscopic analysis of BMS8-276**

➤ **Properties degrade before detection is possible**

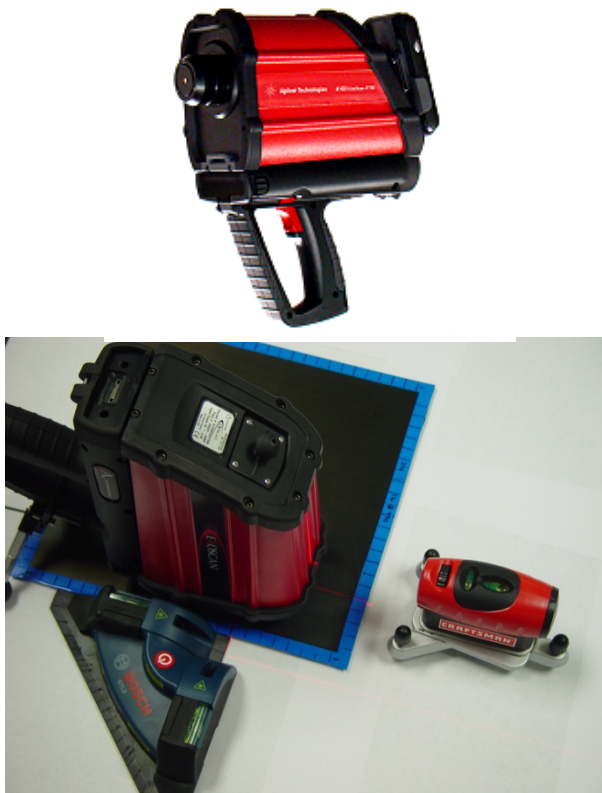
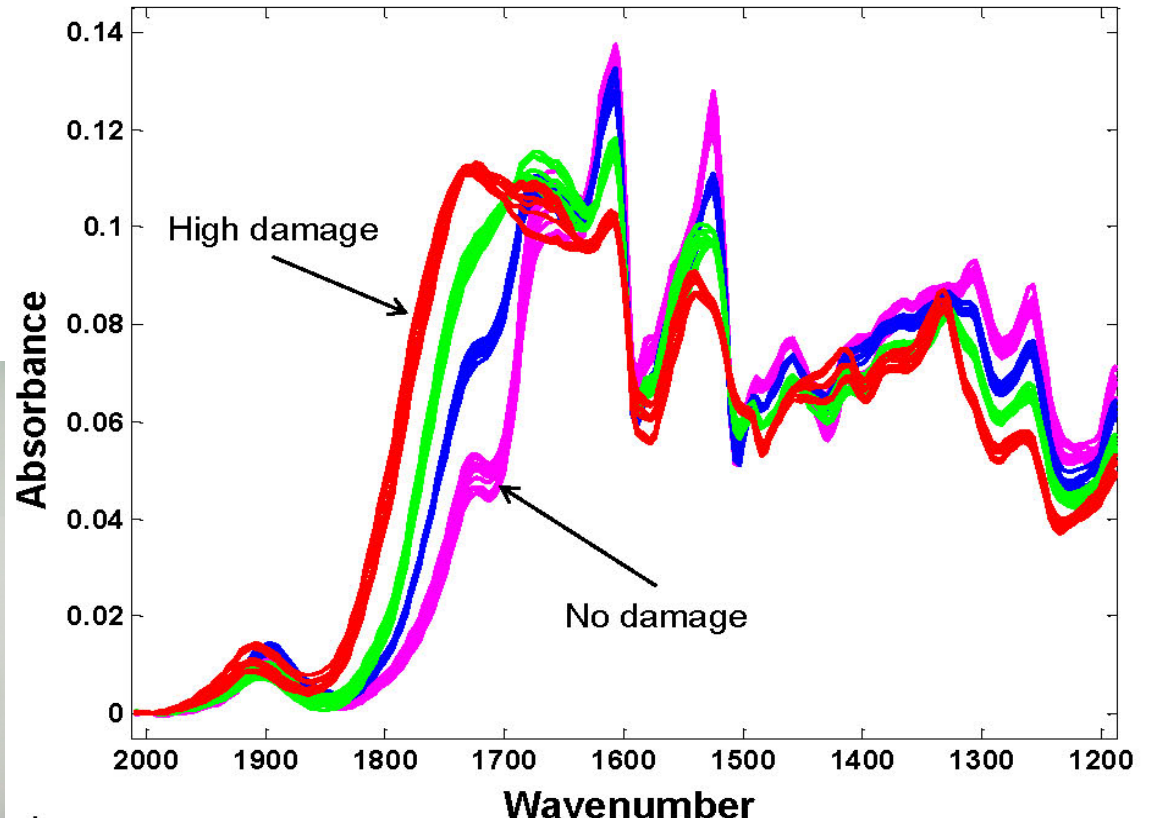
FTIR spectra reflect changes indicative of degradation of the chemical bonds of the resin

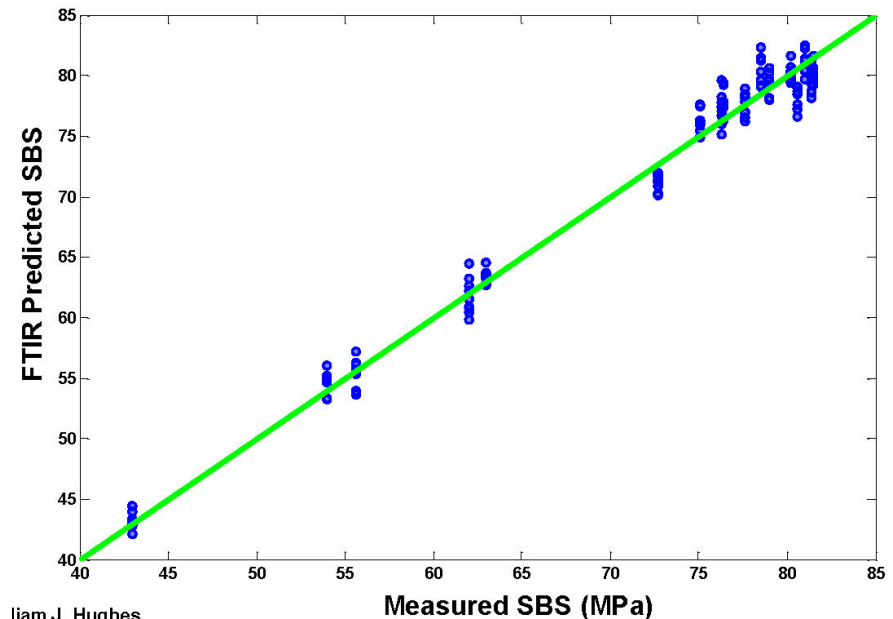
Correlate chemical change (FTIR) with SBS

- Multivariate Analysis
- Neural Net Analysis
- Both approaches > 97% accurate
- Developed calibration curve for FTIR spectra for levels of thermal damage

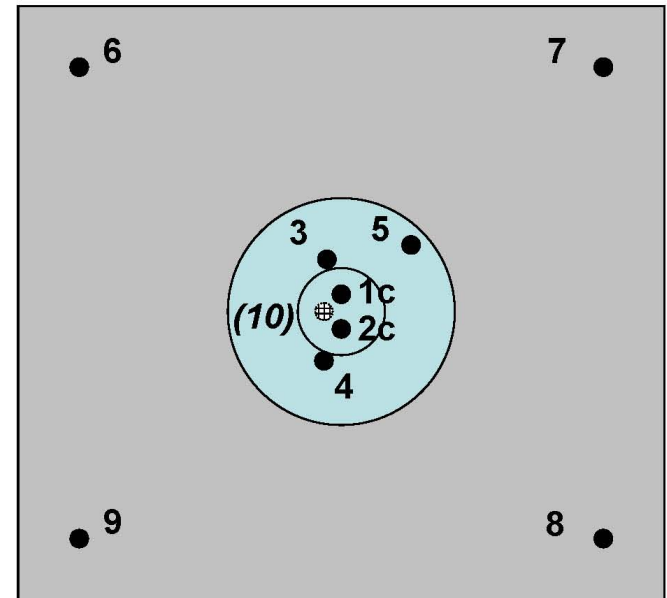
- Hot Spots created
- 3 different levels of damage
- 2 panels each level

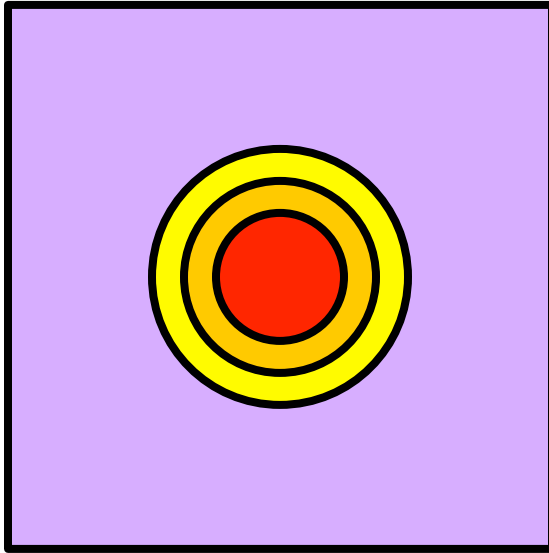
**What are appropriate tests?**  
**What are appropriate specimens?**  
**Guided by NDE results?**

- Matrix dominated properties**
- Minimize damage gradient**
- Small sample size**

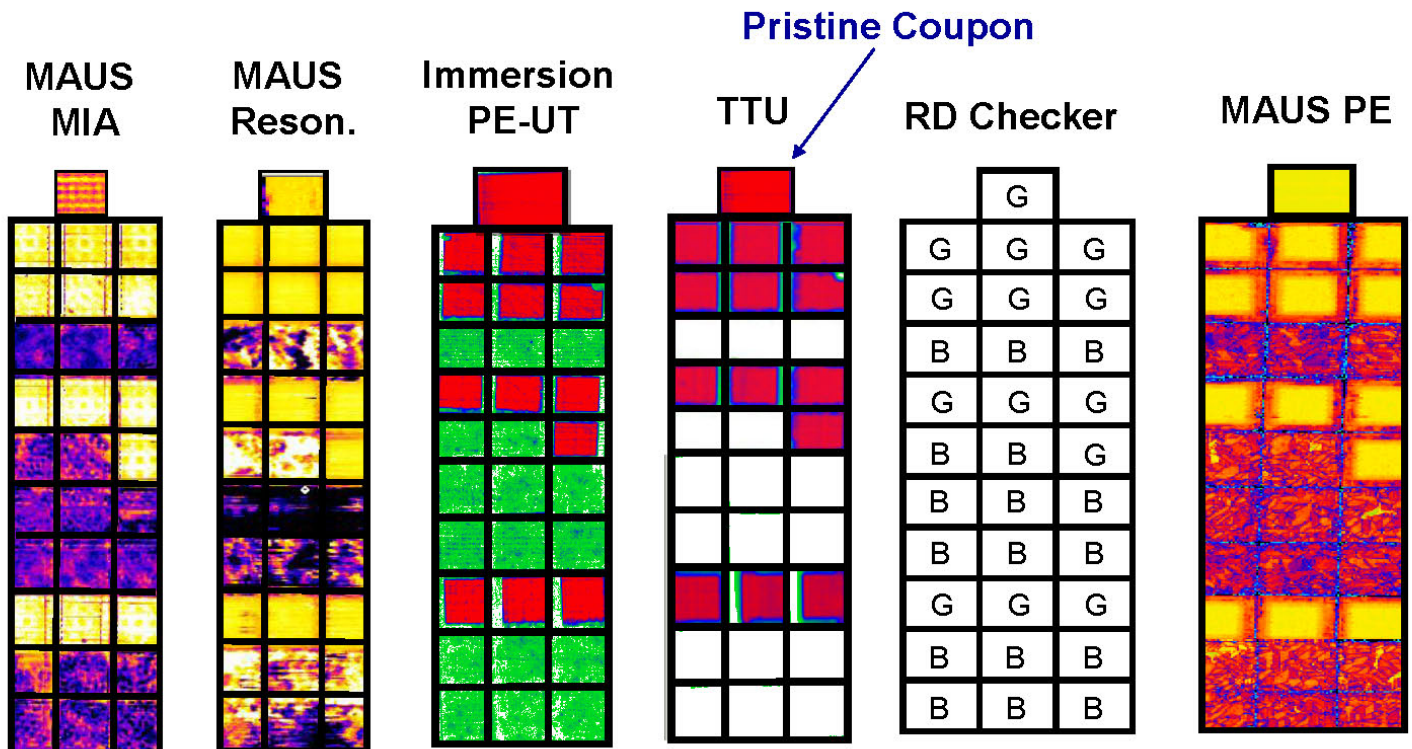
## Composite Heat Damage – Comparison of Several NDI Methods

(BMS8-276 Uniaxial)

Temp. & Time Exposure Varied in All 30 Coupons

Good (G)  
 Bad (B)
