Proposed Research on  
**Aging Degradation in Polymeric Composites**

Kuen Y. Lin

Department of Aeronautics and Astronautics  
University of Washington

October 25, 2007

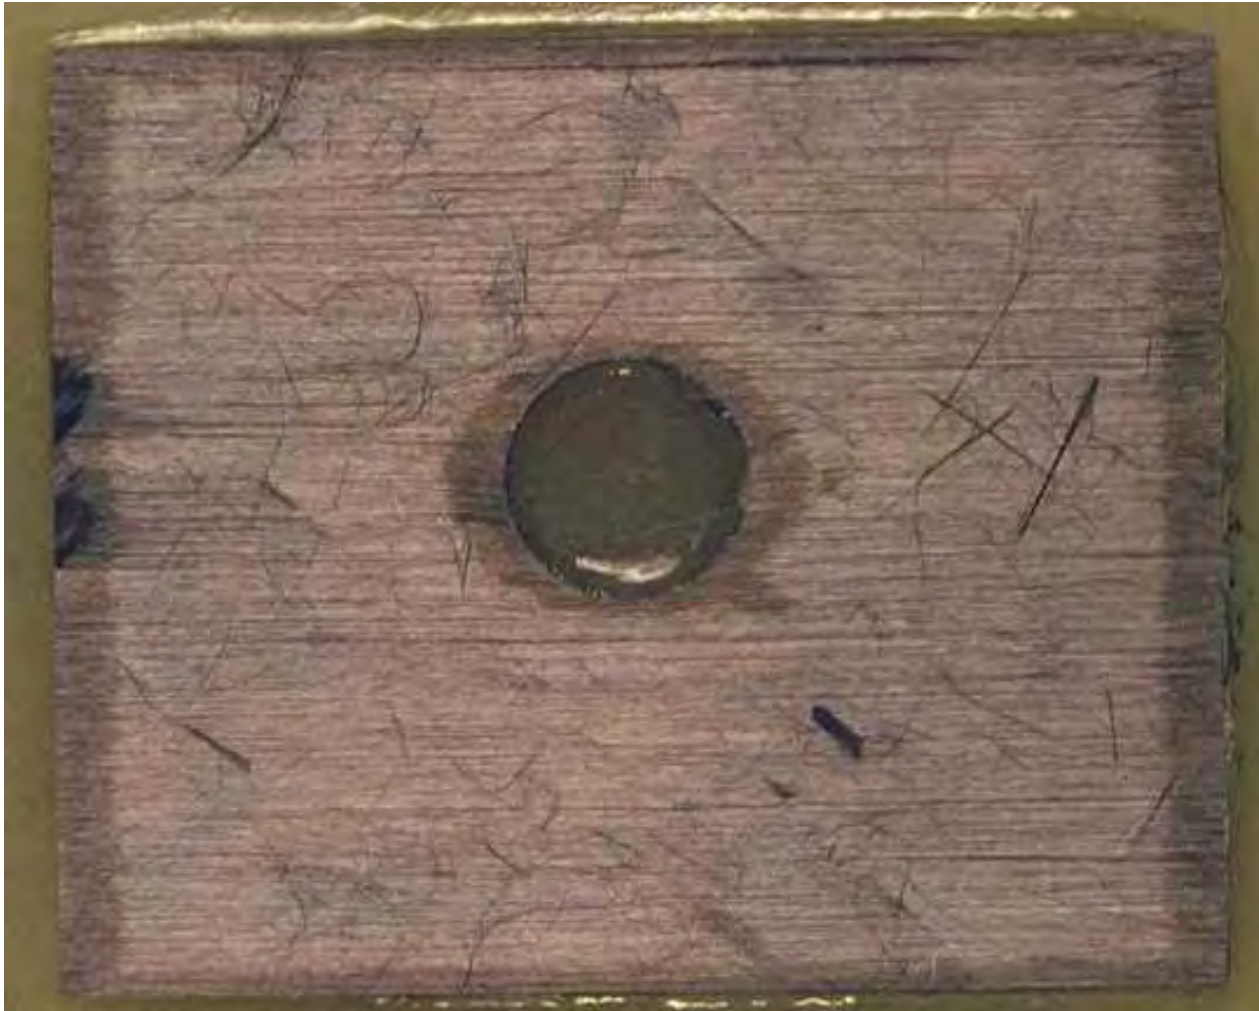
Discolored region in IM7/5260 specimen  
0 ply, 350°F, 13 months

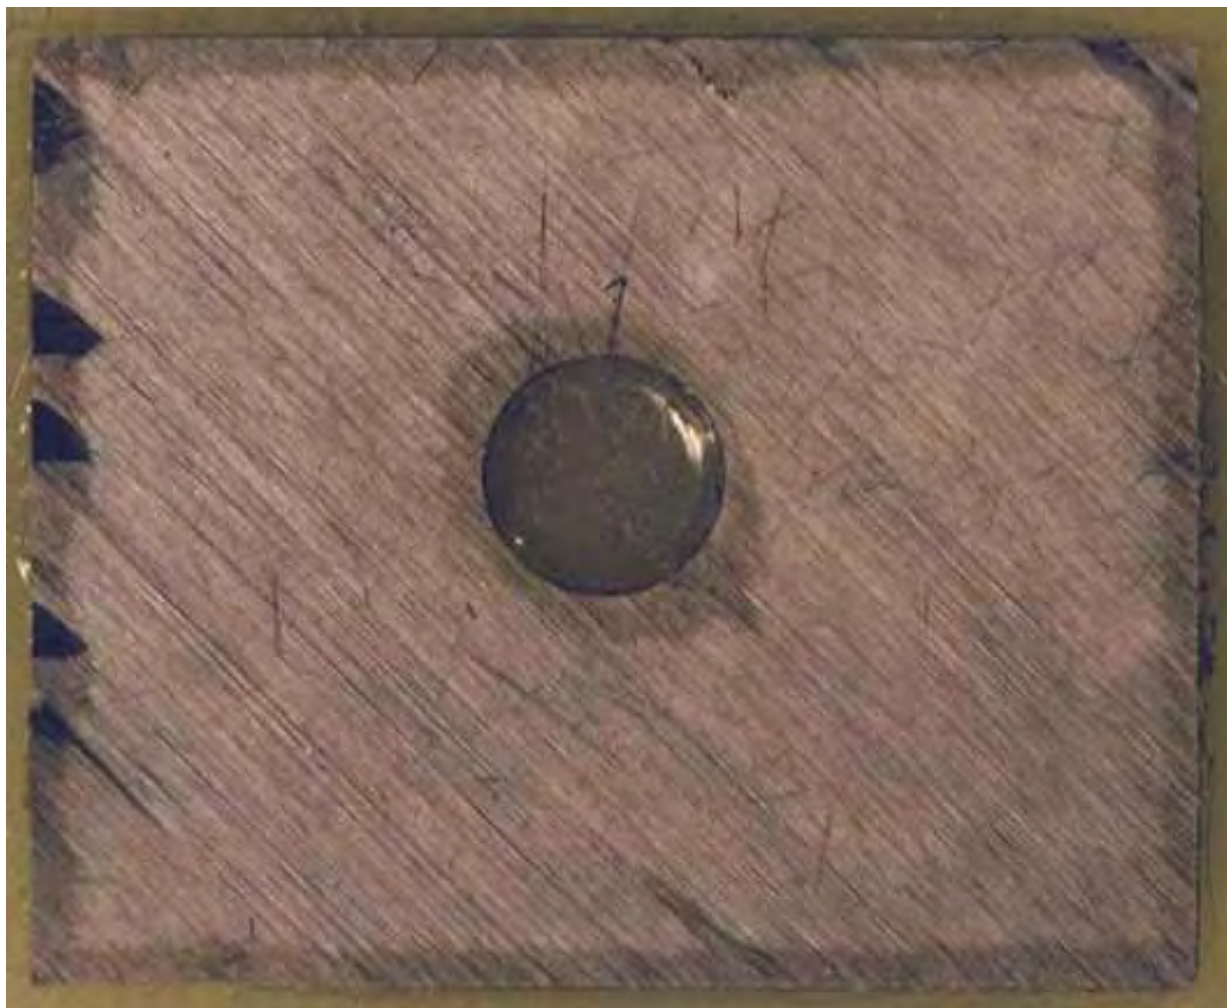
# Discolored Region in IM7/5260 Specimen 45 ply, 350°F, 13 months

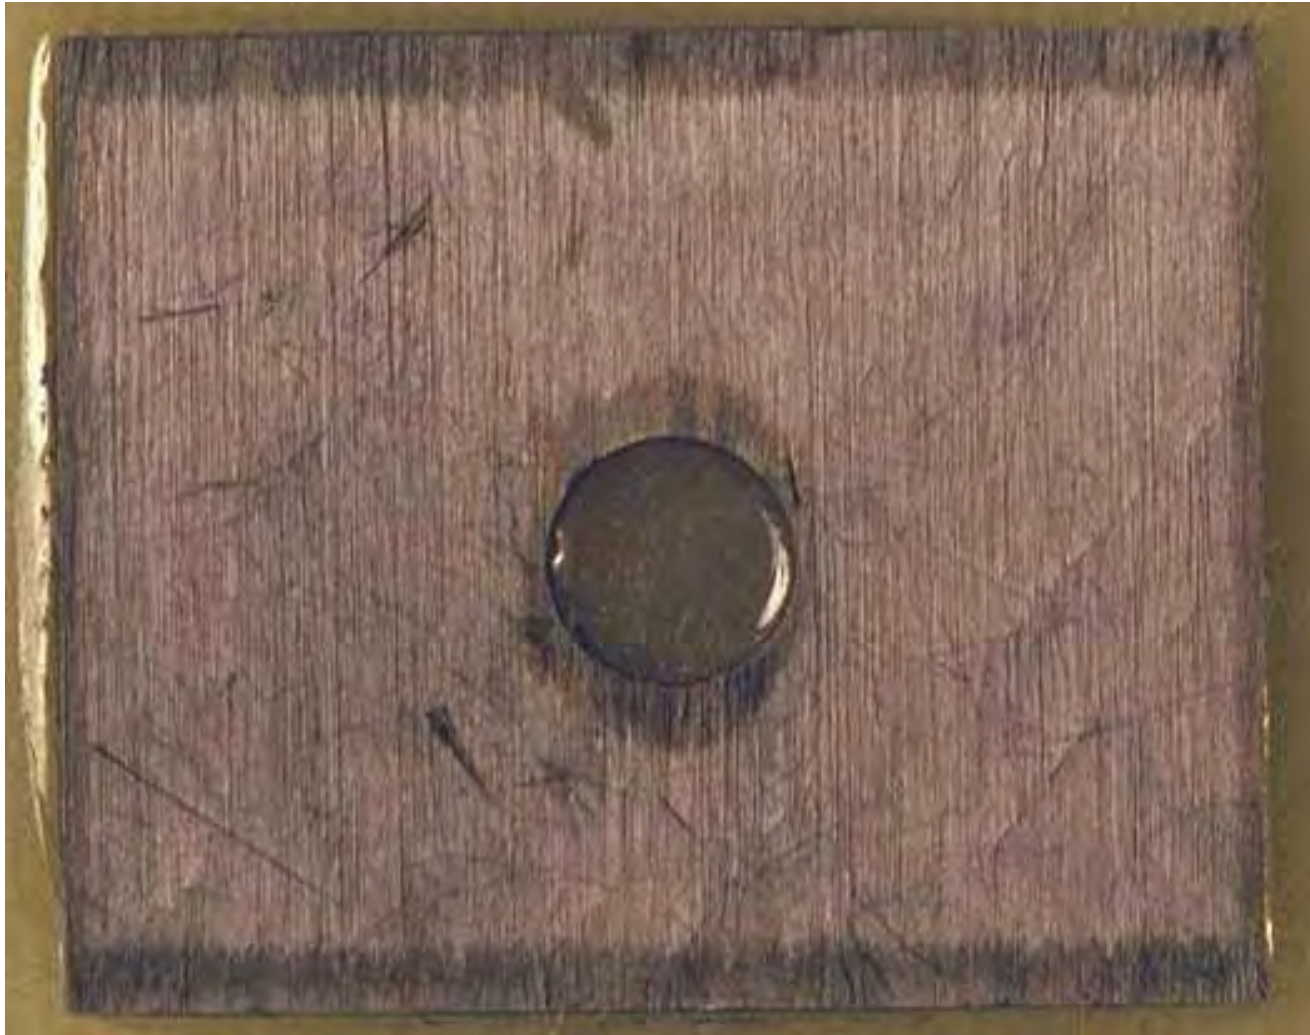
Discolored region in IM7/5260 Specimen  
90 ply, 350°F, 13 months

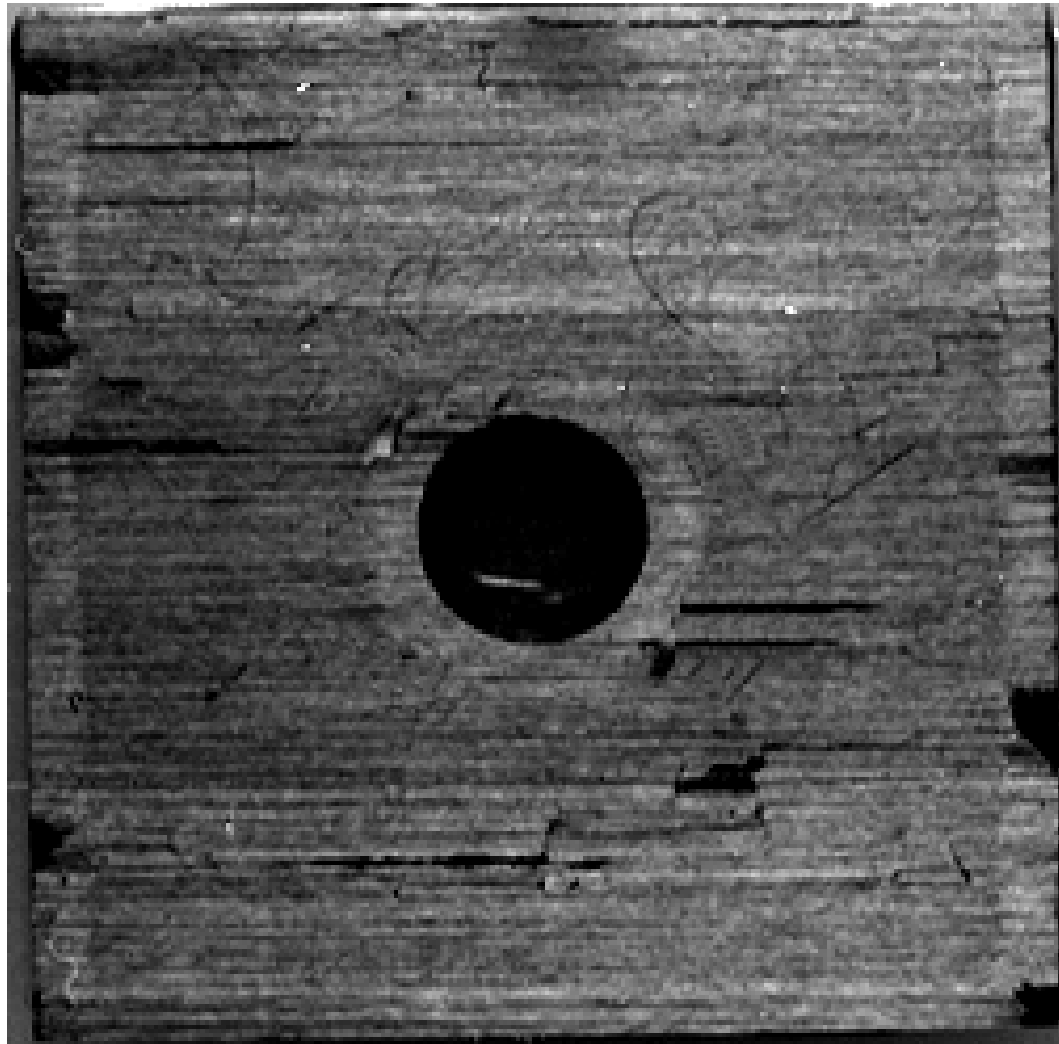
# Discolored Region in IM7/K3B Specimen 0 ply, 350°F, 13 months

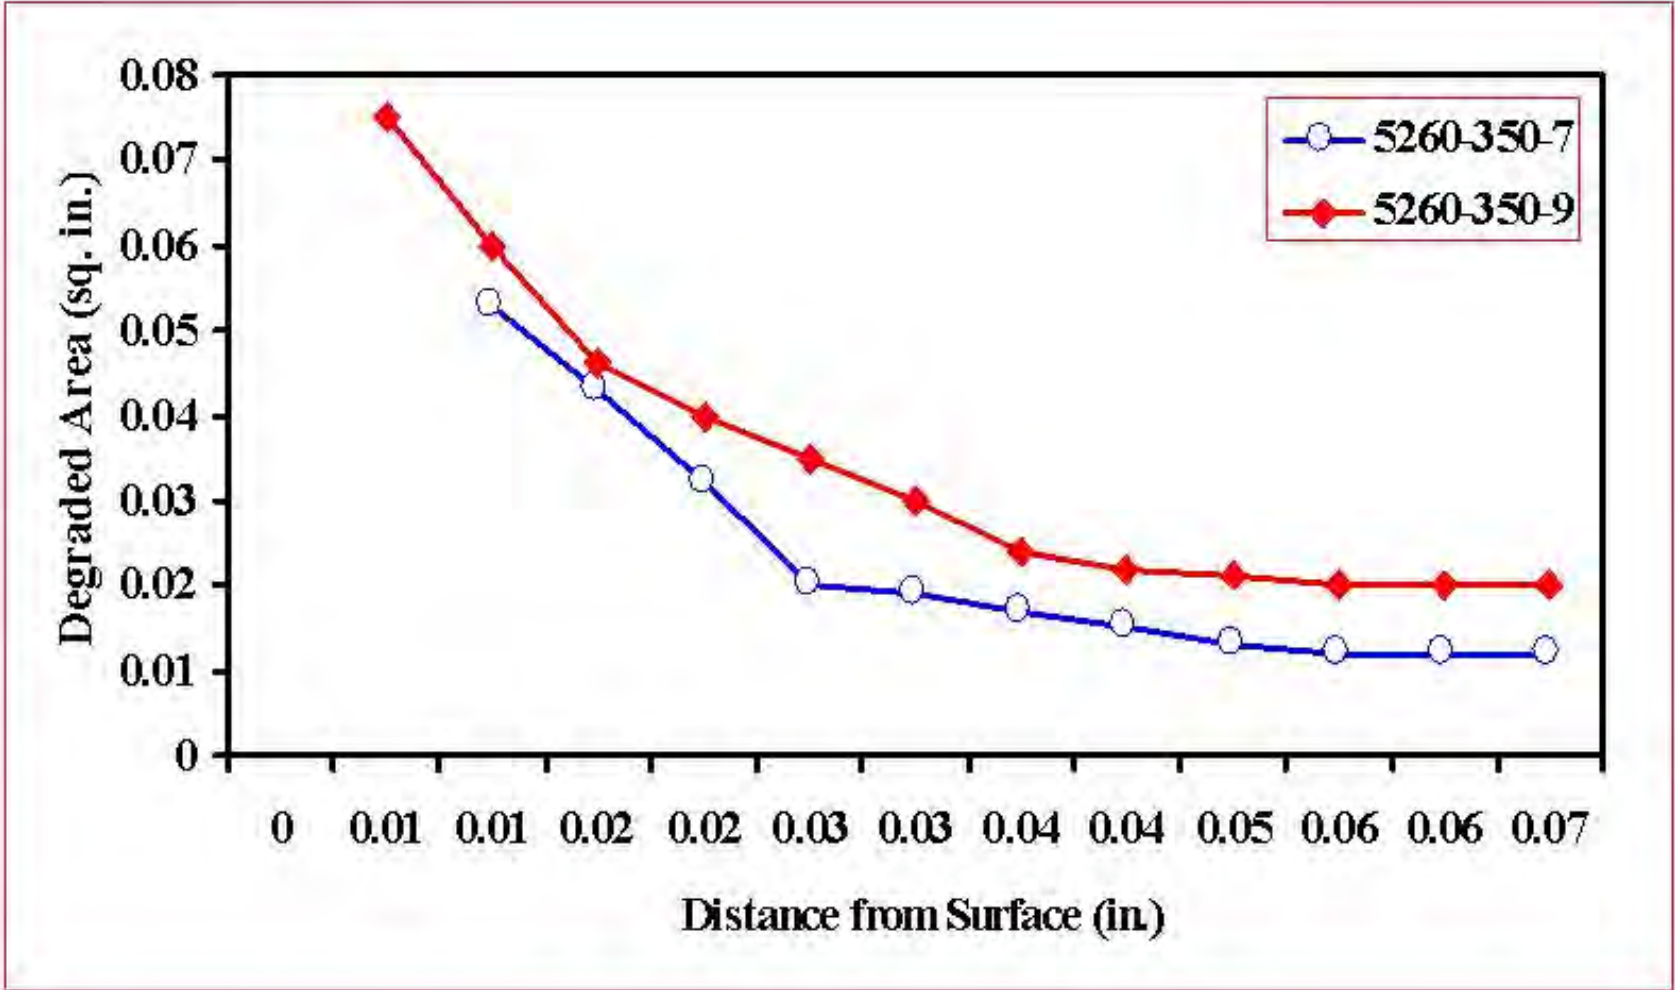
# Degraded Area in Aged IM7/5260 Quasi-Isotropic Open Hole Specimen (400°F)

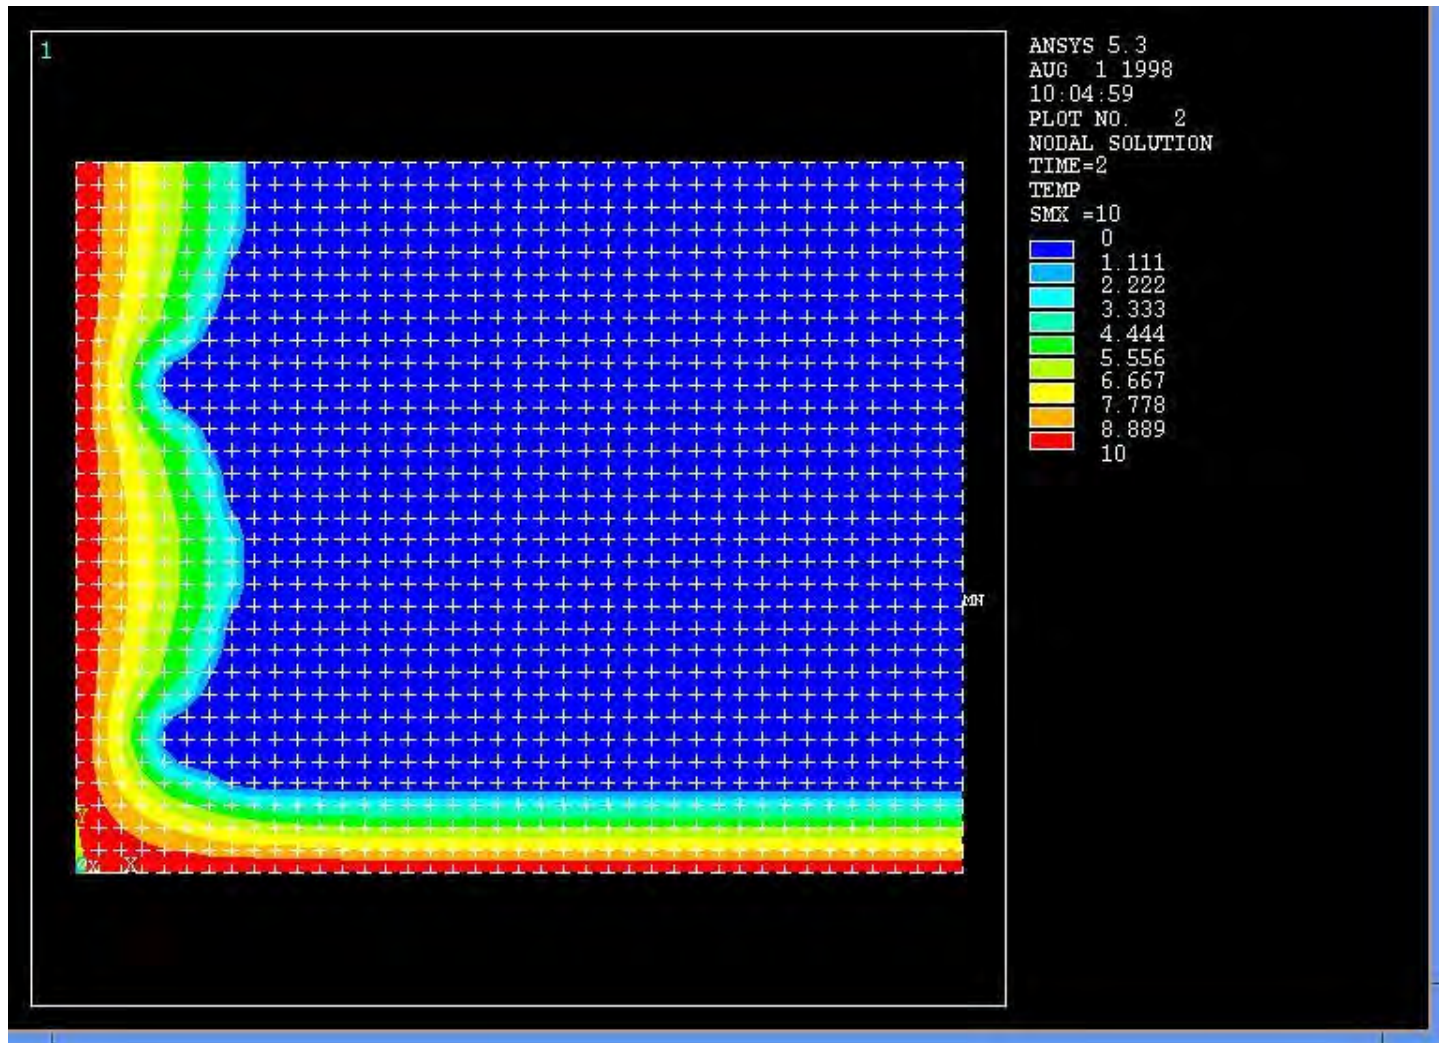
# Predicted Contours of Oxygen Concentration in IM7/5260 after 2000 hours
