## **Aging of Composite Aircraft Structures Beechcraft Starship and B-737 Horizontal Stabilizer**

**John Tomblin, PhD**  
*Executive Director, NIAR*

June 17<sup>th</sup>, 2008

**The Joint Advanced Materials and Structures Center of Excellence**

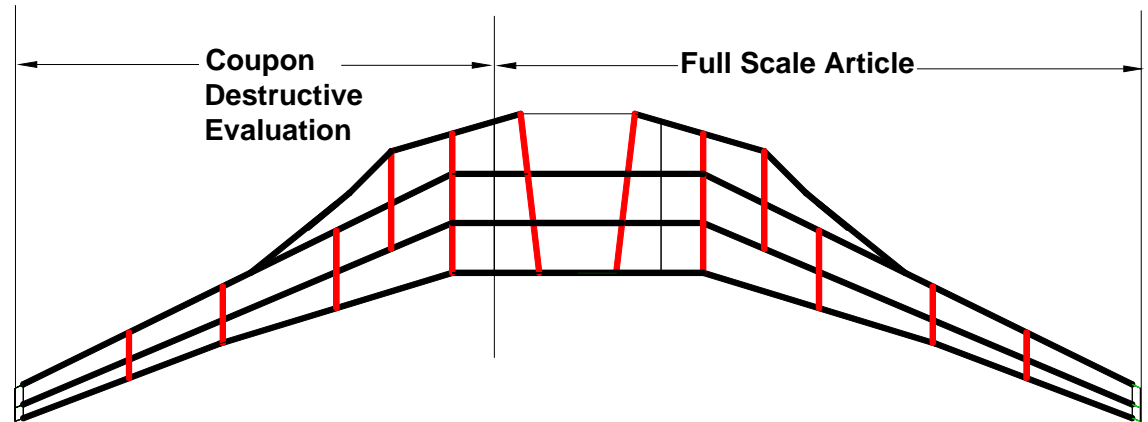
Preliminary TTU Non-Destructive inspection showed no evidence of flaws induced during manufacture or service in the skins. OEM records suggest that porosity levels in the upper skin LE flanges exceed 2.5%

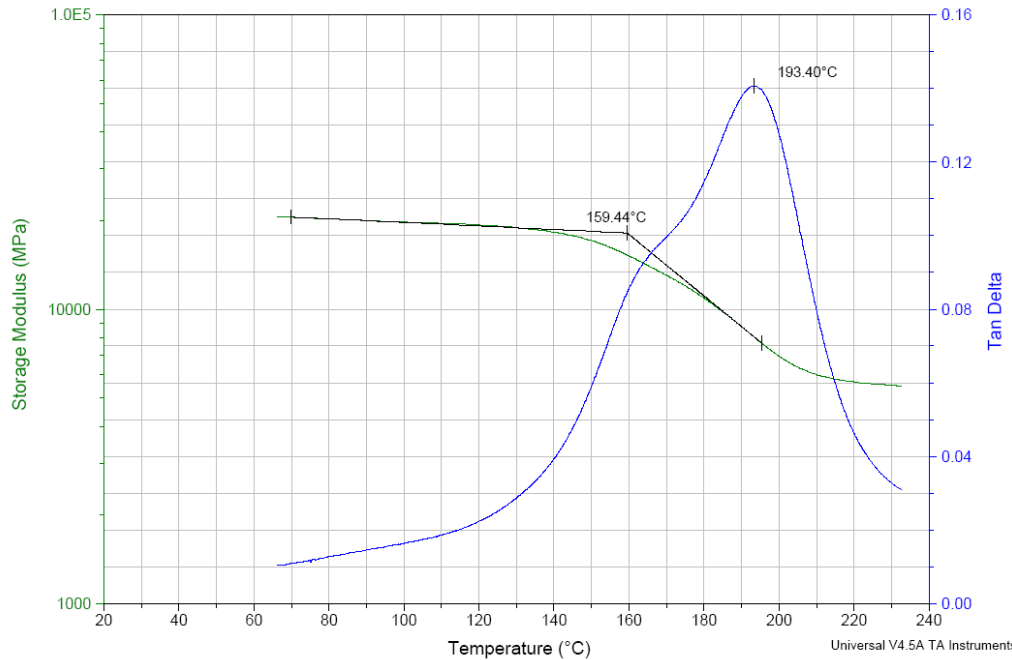
**Lower Skin LF BL 260 DMA results**  
**Storage Modulus 159°C 318°F**  
**Tan  $\delta$  193°C 379°F**

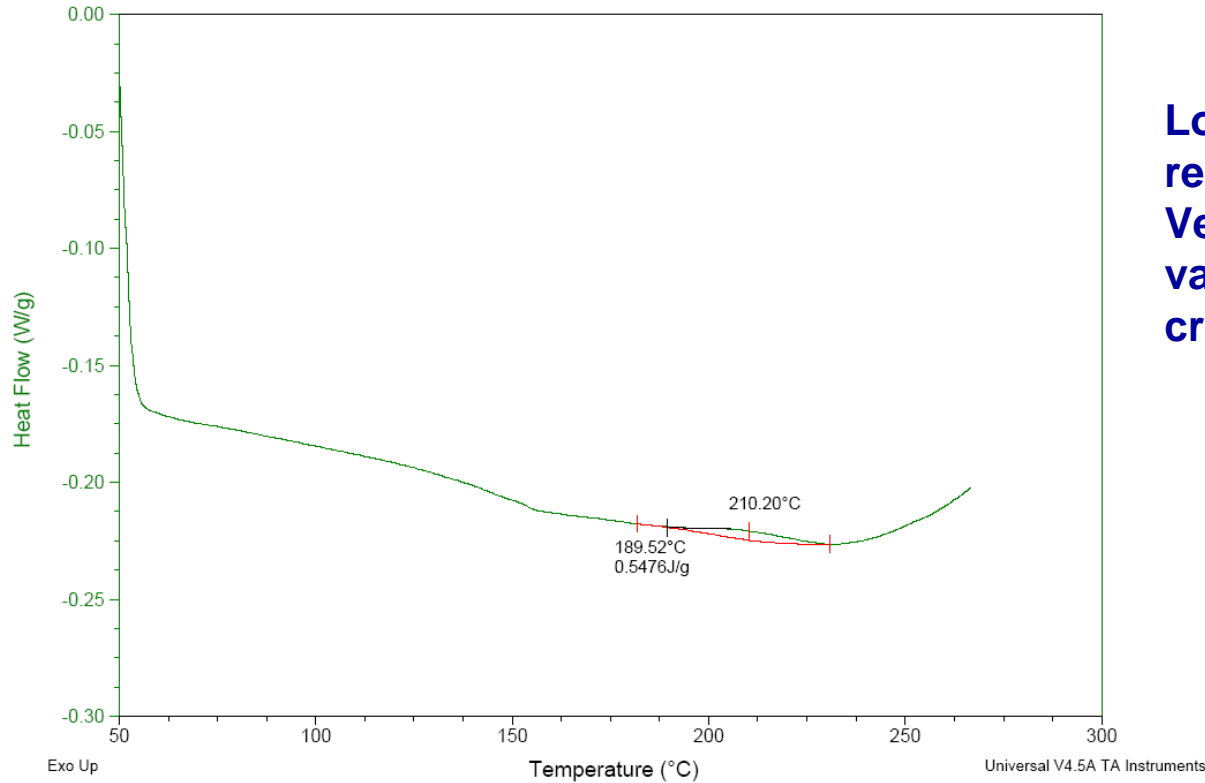
**Lower Skin UF BL 260 DSC results**  
**Very small heat of reaction values indicative of a highly cross linked material**

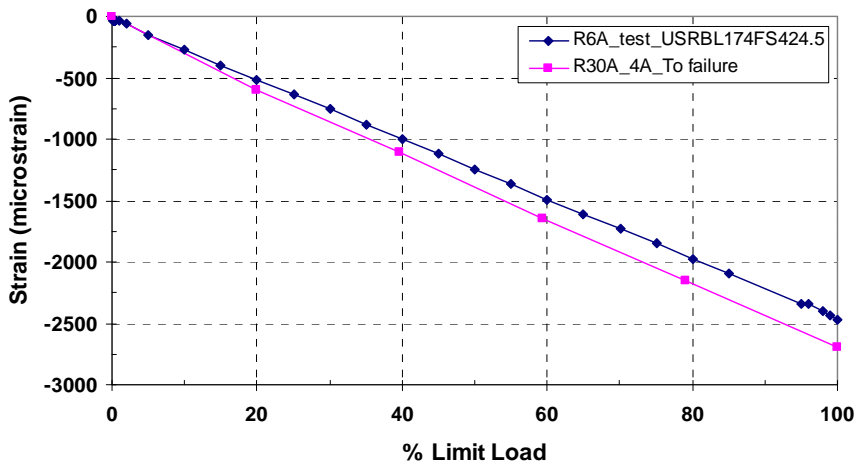
**Strain vs % LL (Current Test vs Static Max Up-Bending Test to failure)**

- Strain vs % LL comparison between current test and wing max upbending certification test (Cond 4A)
- No major change in compliance, certification data correlates very well with aged structure limit load test results

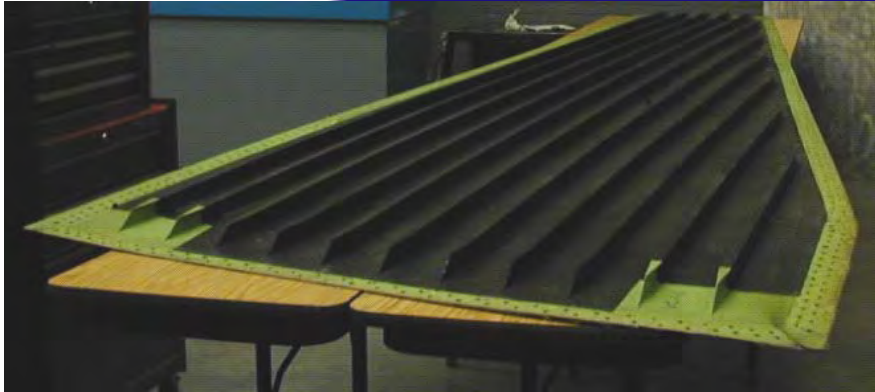
**Upper Skin (RH)**

- Structure held very well
- No evidence of pitting or corrosion as would be observed in a metal structure
- No residual strains compared to the LH

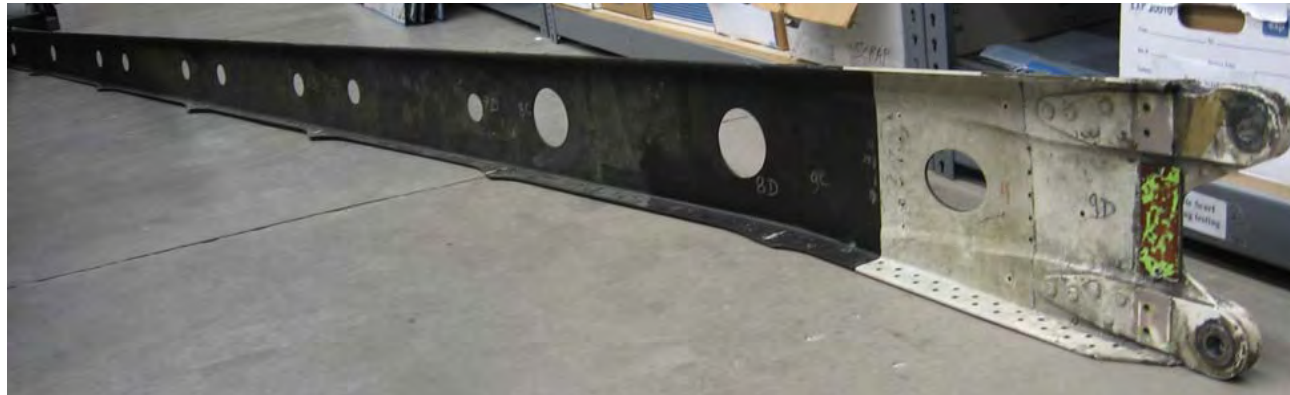
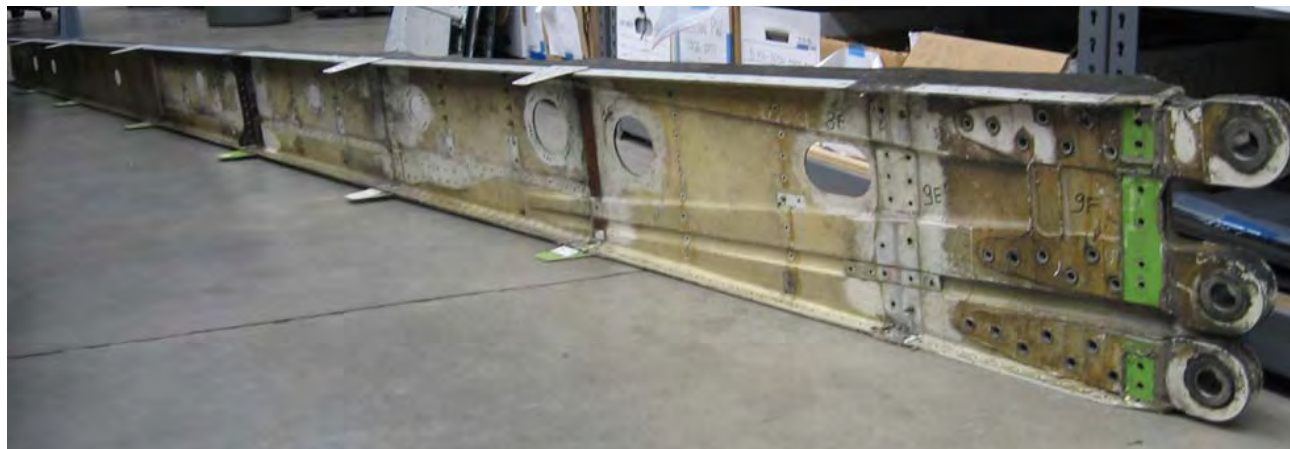
**Front (Top) and Rear (Bottom) Spars after disassembly**  
 Wichita State University

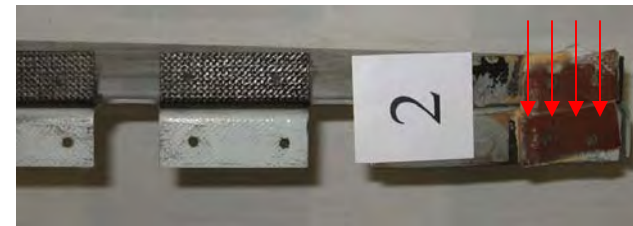
**Liquid Shims used to fill gaps between the upper skin and the stabilizer ribs**

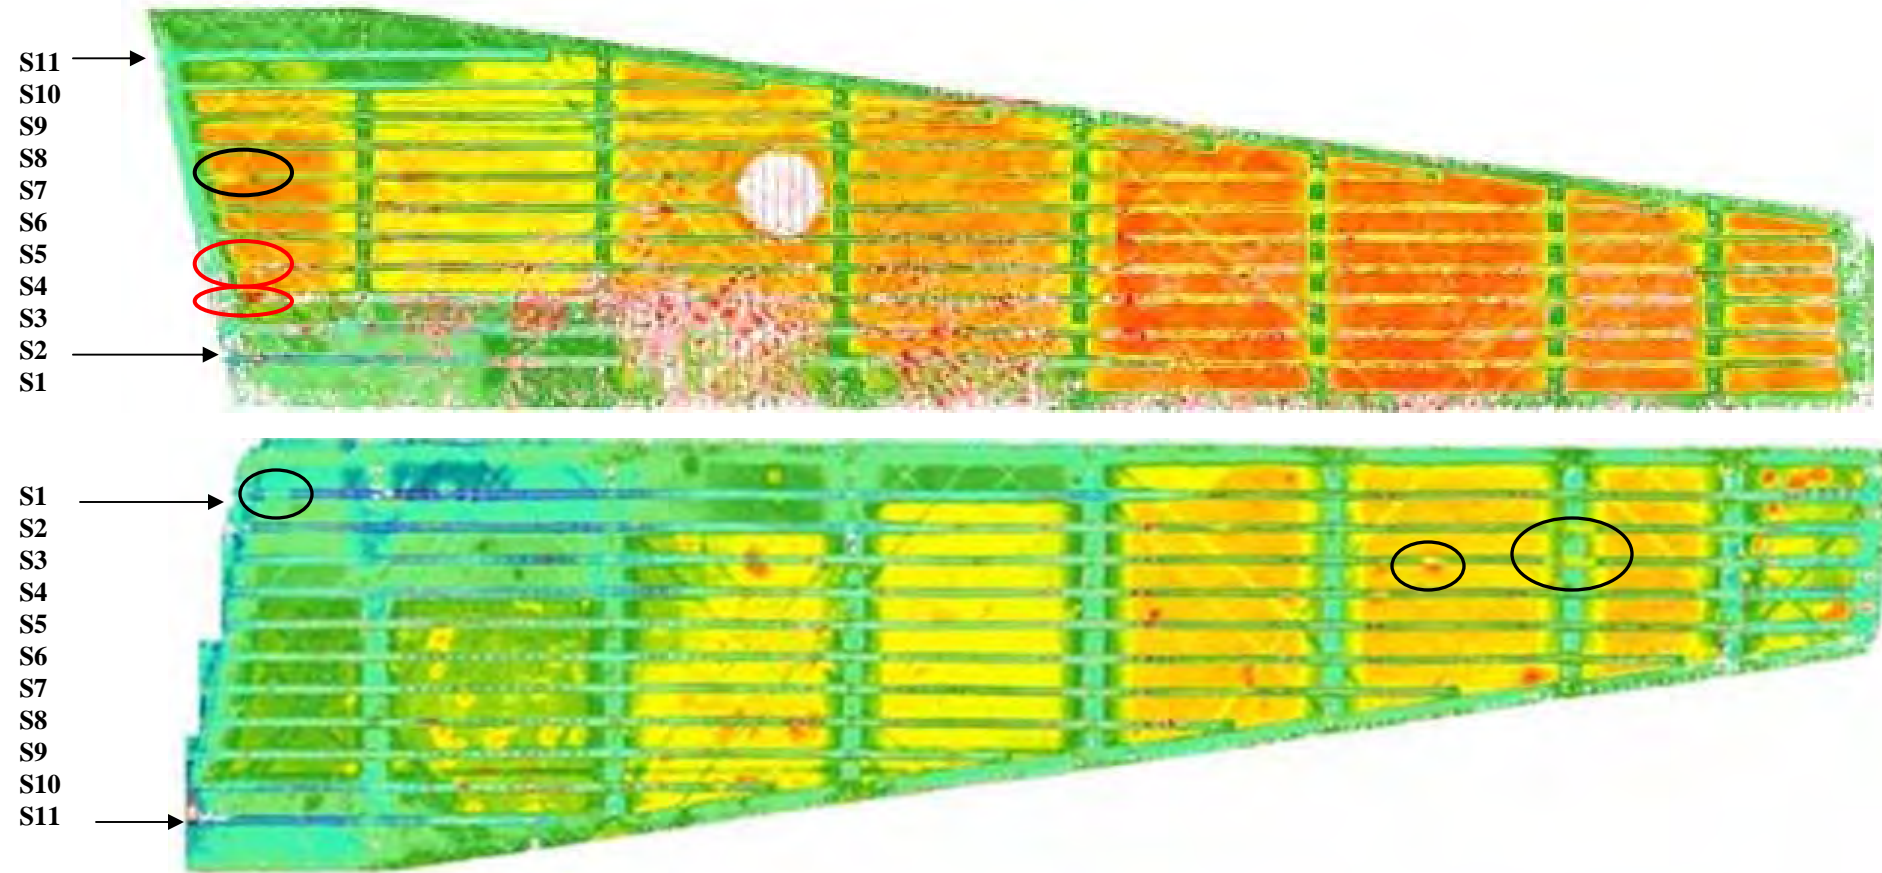
Rapidscan™ analysis (pulse echo time of flight data) of the R/H of the B737 stabilizer  
(Courtesy of Sandia National Laboratories and NDT solutions ltd. UK)  
Wichita State University

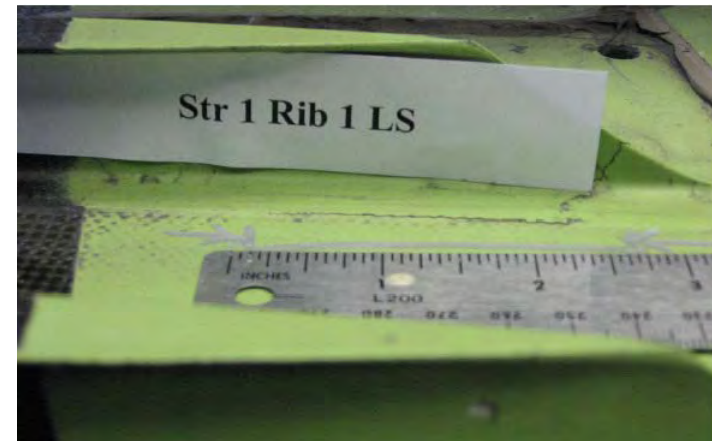
- Manual Pulse-echo was performed to inspect the skin/ stringer co-cured bonds and identify areas with delaminated stringers

Upper skin Inboard delaminations at stringer runouts

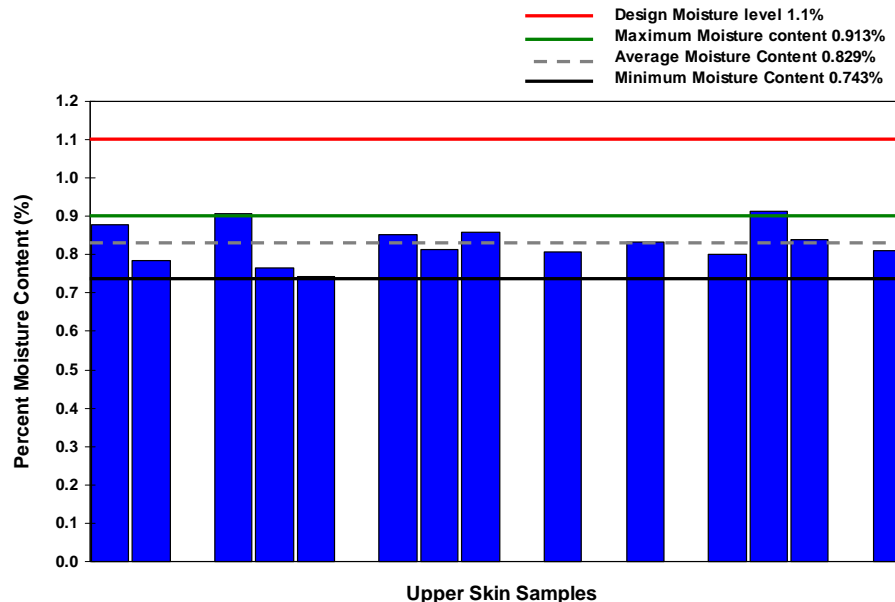
Moisture Distribution In the Upper Skin

- Moisture content in the aged structure has been quantified per ASTM D5229: specimens were extracted from different locations in the upper skin and lower skins of the stabilizer and have been dried to evaluate the moisture content of the structure.
- The results showed that the moisture content in the upper skin varied from 0.743 to 0.913% (design moisture level of 1.1%)

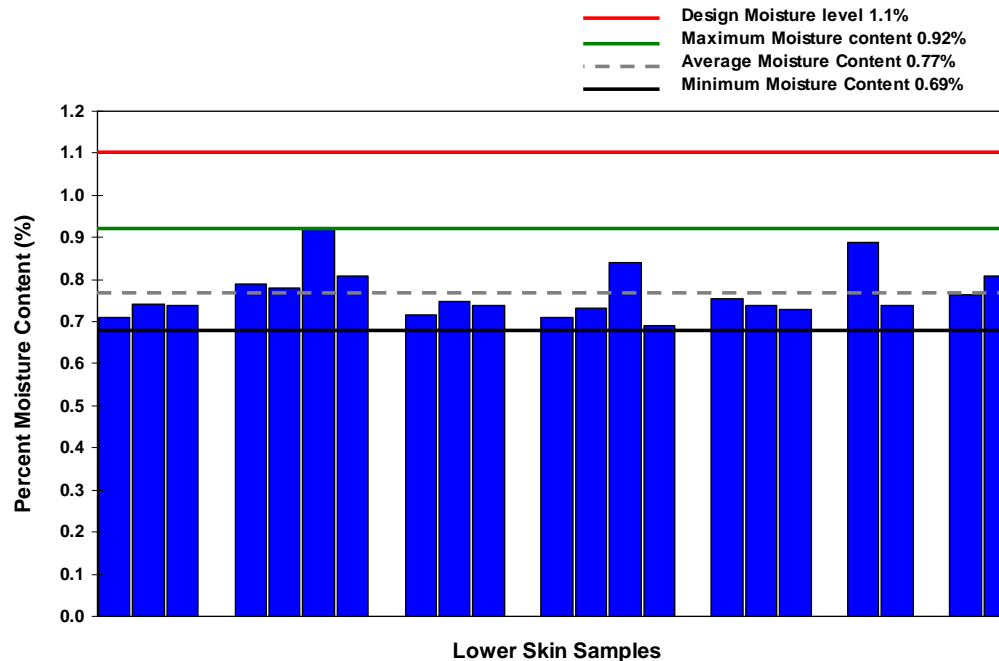
Moisture Distribution In the Lower Skin

- The moisture content in the lower skin varied from 0.69 to 0.92% (design moisture level of 1.1%)

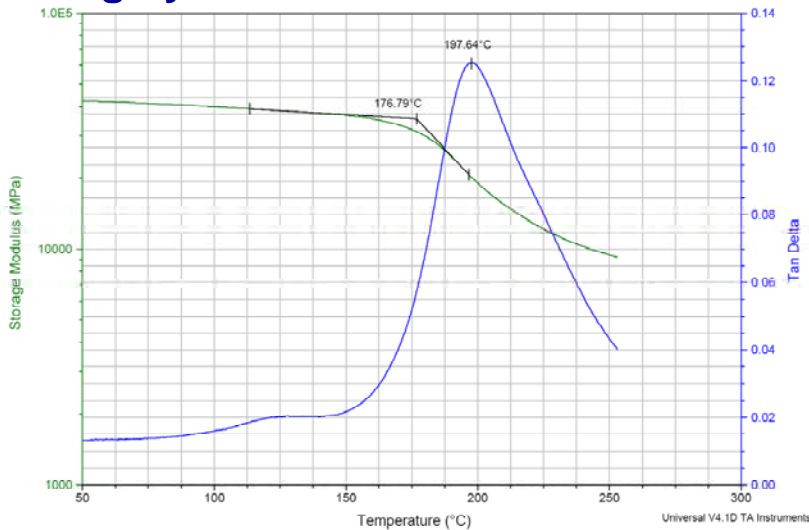
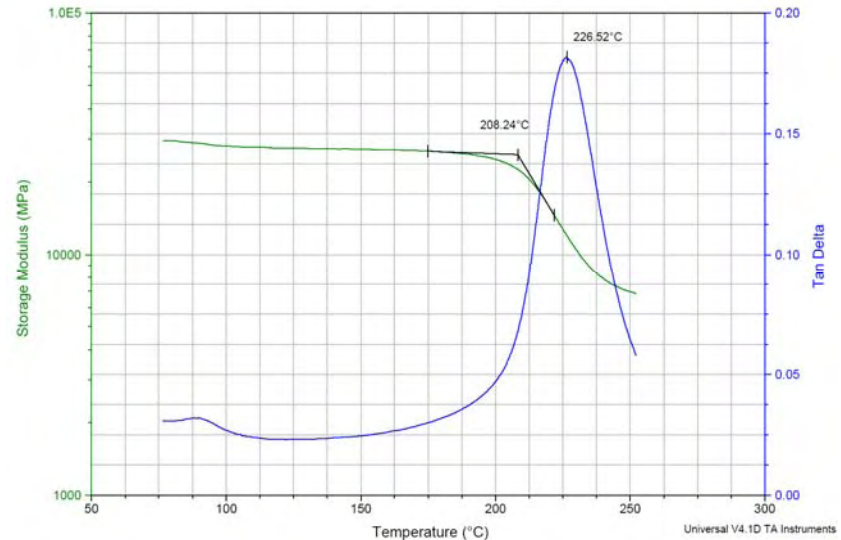
- DMA technique to determine the glass transition temperature of the aged material for coupons extracted from both the upper and lower skins
- Thermal analysis was conducted on coupons with actual in-service moisture content and dried coupons to compare the difference between the in-service T<sub>g</sub> with respect to the dry T<sub>g</sub>.
- Storage Modulus is an indication of the stiffness of the material, tanδ is a measure of the damping of the material
- DMA curves with a shallow storage modulus transition and a narrow tanδ indicate a highly cross linked material

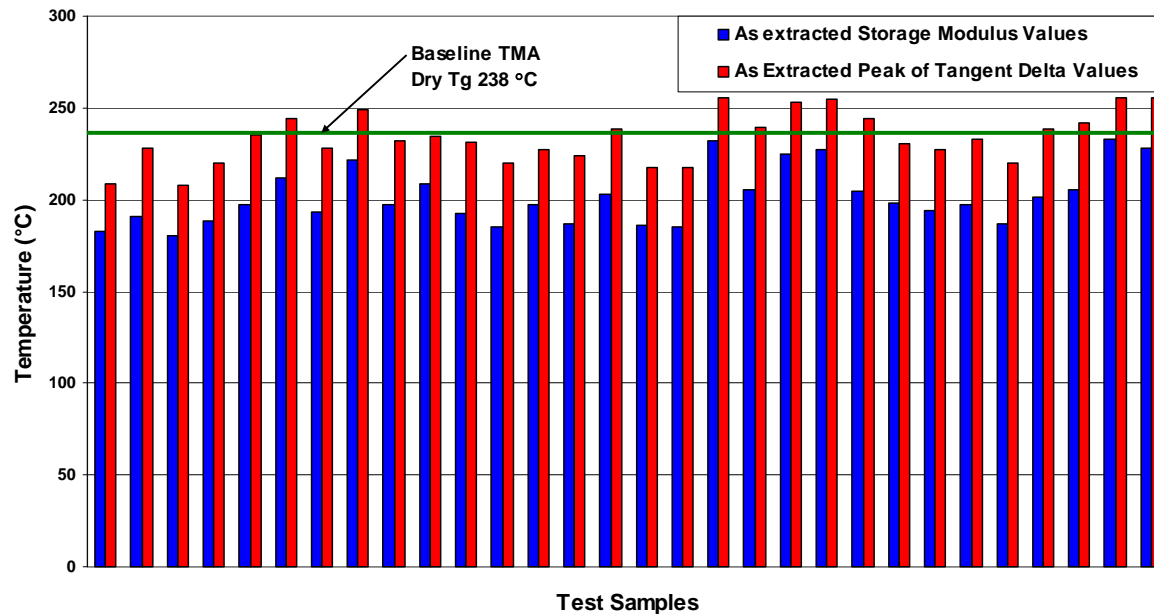
DMA Results for coupons excised from the upper skin of the B-737 Horizontal Stabilizer (Boeing Method)

- Tg values consistent and comparable to LH Results (Courtesy the Boeing Co) average values for RH (201°C/233°C)
- DMA test parameters vary/ Tg obtained is a “wet” Tg (at least 0.69% moisture content)

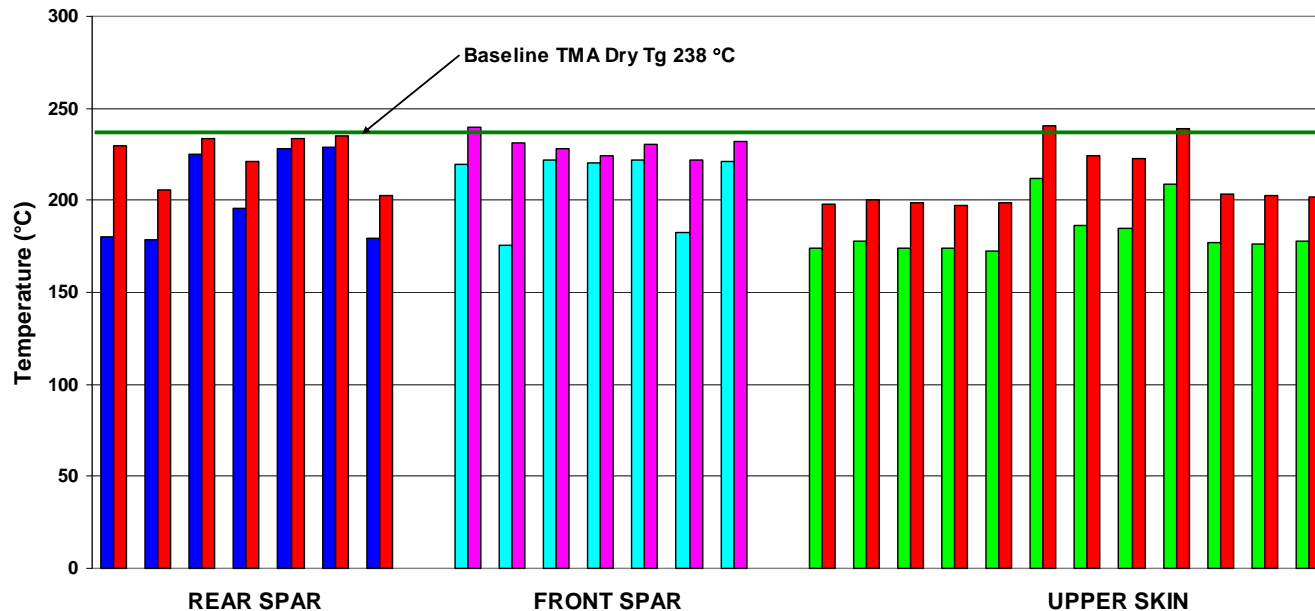
DMA Results Comparison for coupons excised from the upper skin and the front and rear spars of the B-737 Horizontal Stabilizer (ASTM Standard)

- Spar Tg is about 18°C higher than the skin Tg. (1 cure cycle for skin, 2 for spars)

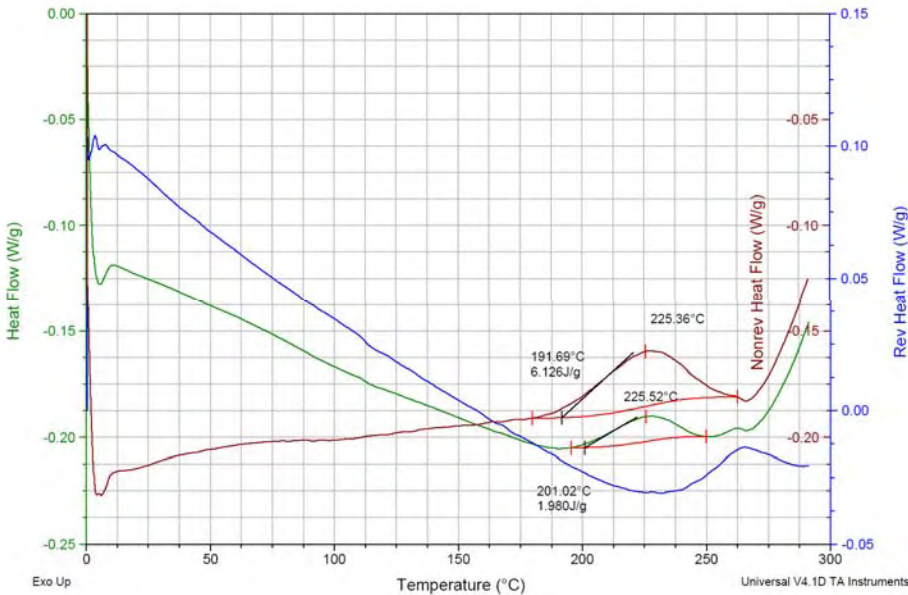
**DSC, Rib 7, as extracted**

- Non-Reversing heat flow curves reveal exotherms/ chemical reactions
- DSC heat of reaction values are extremely small (<6J/g) indicating a highly cross linked material (fully cured)
- Reversing heat flow curves reveal Tg
- Drying the specimen increased the cure onset (water acts as a plasticizer)
- Water content does not affect the degree of cure

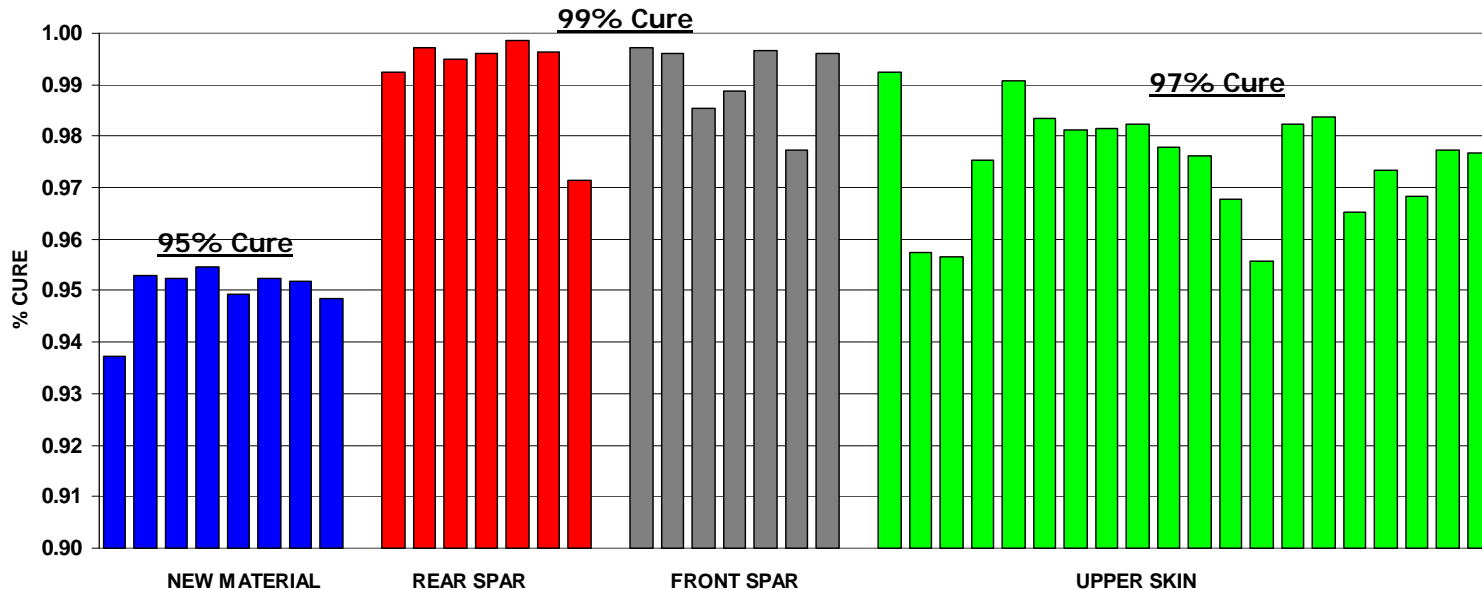
**% Cure Comparison Between New Material, Spars and Upper Skin**

- Spars have reached an almost fully cured status, postcuring occurred during the secondary bonding process (4% cure conversion increase wrt new material)
- Upper Skin has lower Heat of Reaction values than new material, additional curing has occurred during the life span of the structure (UV exposure), 2% cure conversion increase wrt new material
