Aging of Composite Aircraft Structures

John Tomblin, PhD
Executive Director, NIAR

May 19th, 2010

Beechcraft Starship Aft Wing Teardown- FAA Sponsored Project Information

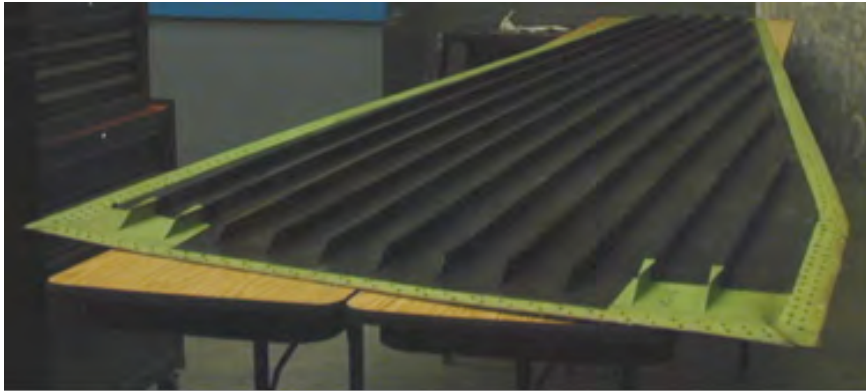
Upper Skin (RH)

- **Structure held very well**
- **No evidence of pitting or corrosion**
 as would be observed in a metal structure with similar service history

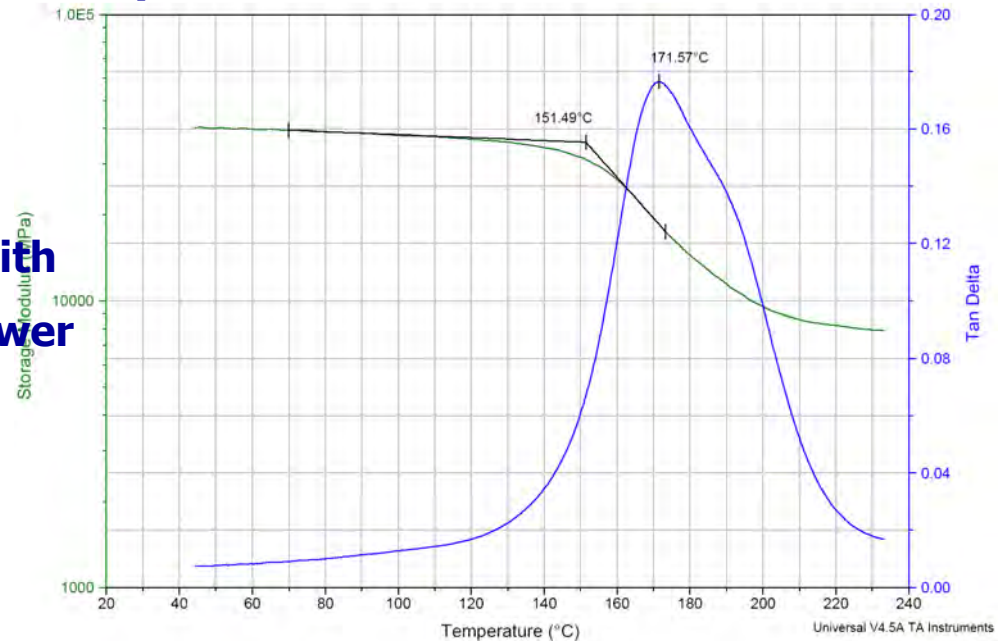
➤ Tg results from coupons extracted from upper and lower skins are very consistent (300°F cure)

➤ DSC Results on both upper and lower skins yielded small heat of reaction values -> fully cured

➤ Physical test results showed porosity levels lower than 2.3% (correlates with OEM NDI data) for both upper and lower skins

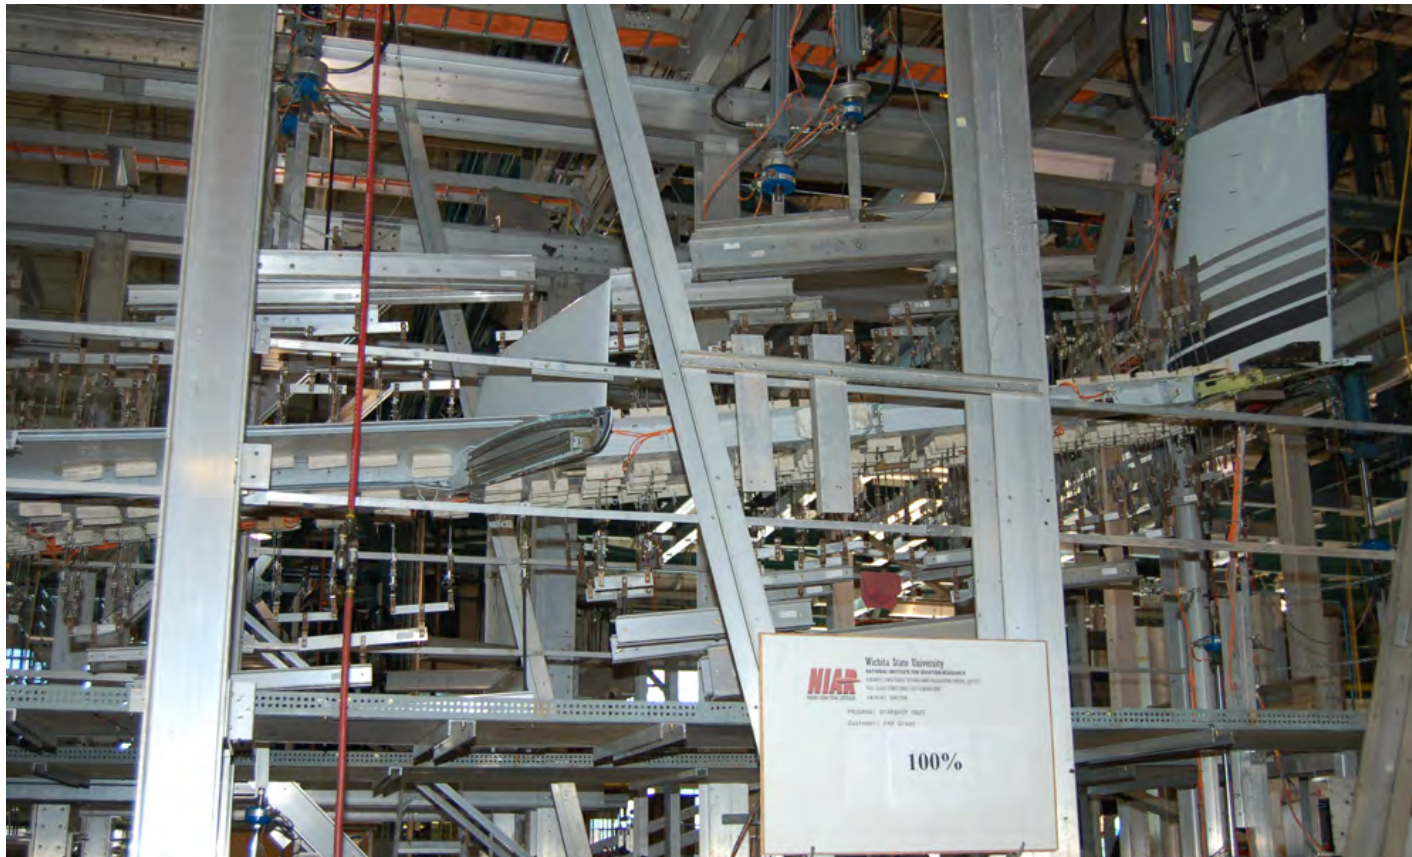
Limit Load Test (LL)-Results

- **Strain and Deflection vs % LL comparison between current test and wing max upbending certification limit test (Cond 4A)**
- **No major change in compliance, certification data correlates very well with aged structure limit load test results (data linear to limit load)**
