Impact Damage Formation on Composite Aircraft Structures

**Hyonny Kim, Associate Professor
Department of Structural Engineering
University of California San Diego**

FAA Joint Advanced Materials & Structures (JAMS) 6th Annual Technical Review Meeting
19-20 May 2010, Washington State Convention & Trade Center, Seattle, WA

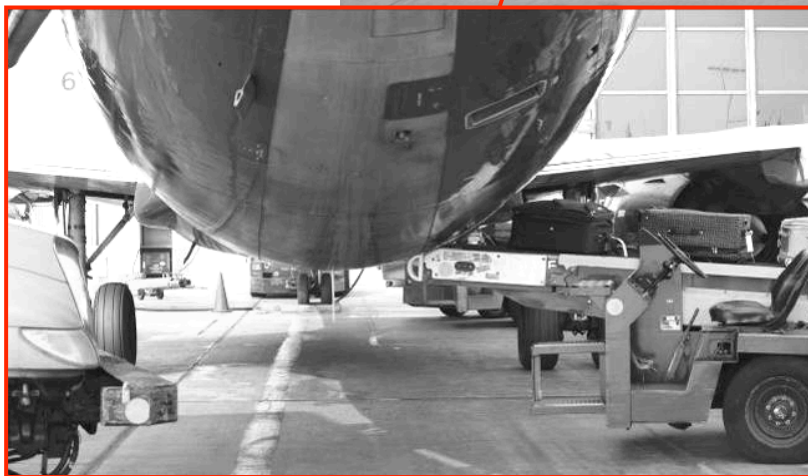
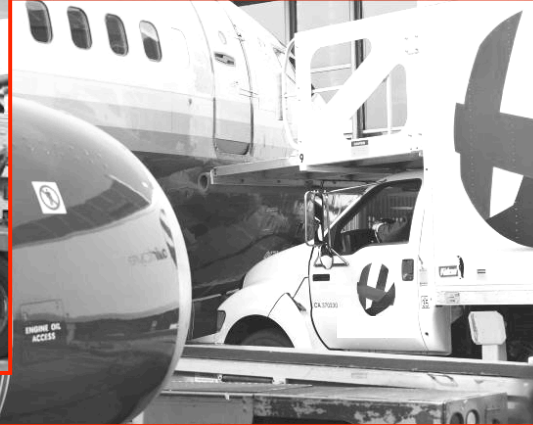
Ground Vehicles & Service Equipment

- side & lower facing surfaces
- high mass, low velocity
- wide area contact
- damage possible at locations away from impact

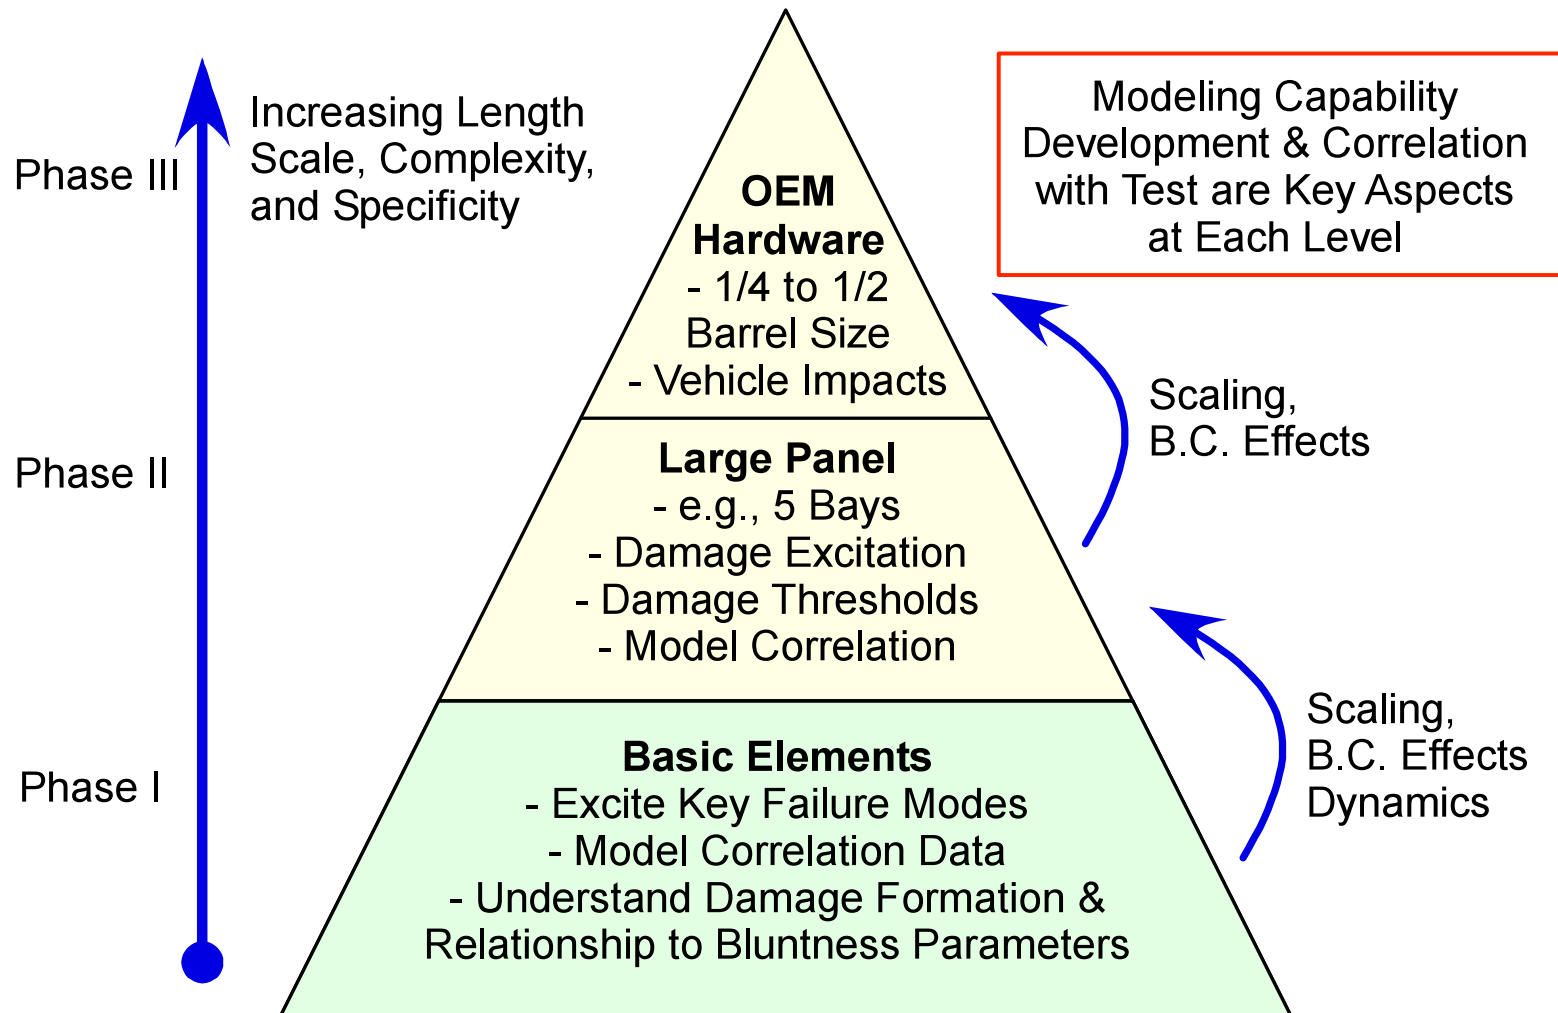
Blunt Impact Program Phases

Understanding of Blunt Impact Damage by Increasingly Complex Phases of Activity

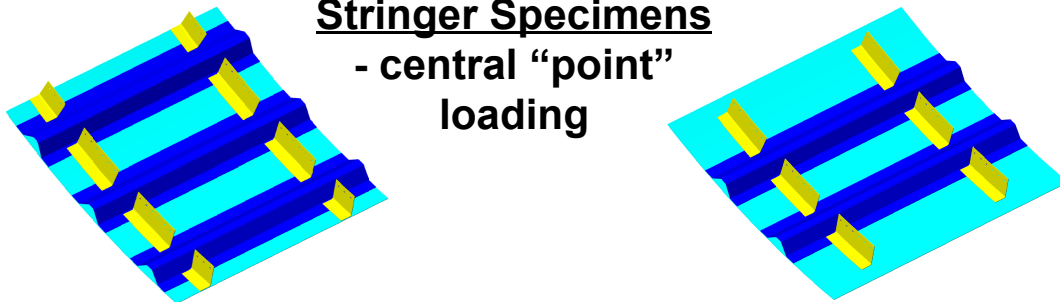
Stringer Specimens

- central "point" loading

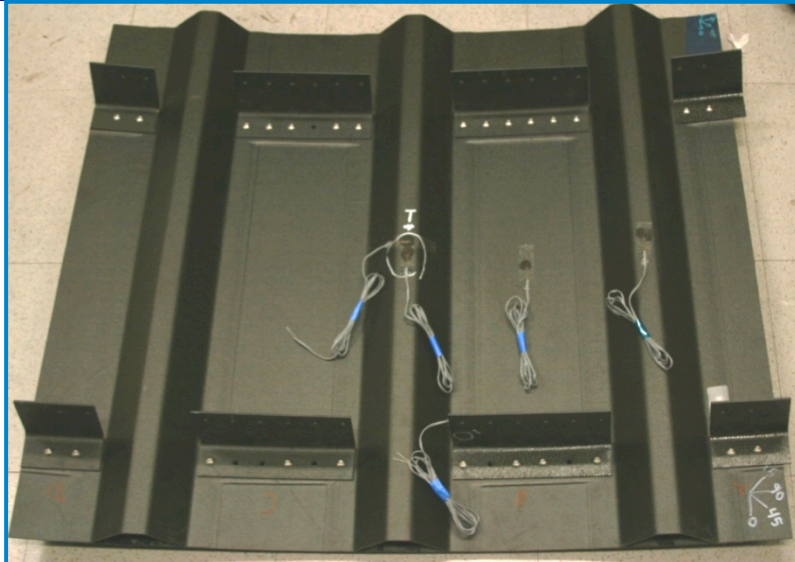
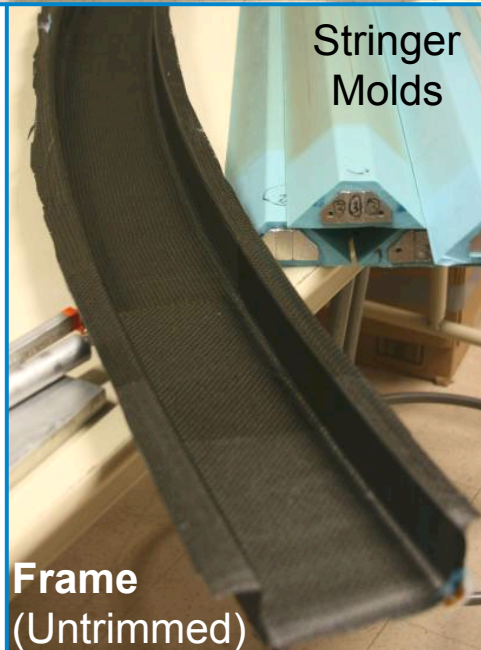
Fabricated Test Specimens

Stringer Specimen
~ 3 x 3 ft.

**Materials provided
by Cytec: Z60 / X840**

**Cure cycles courtesy
of San Diego Composites**

Frame Specimen (skin + stringers) ~ 6 x 4 ft.

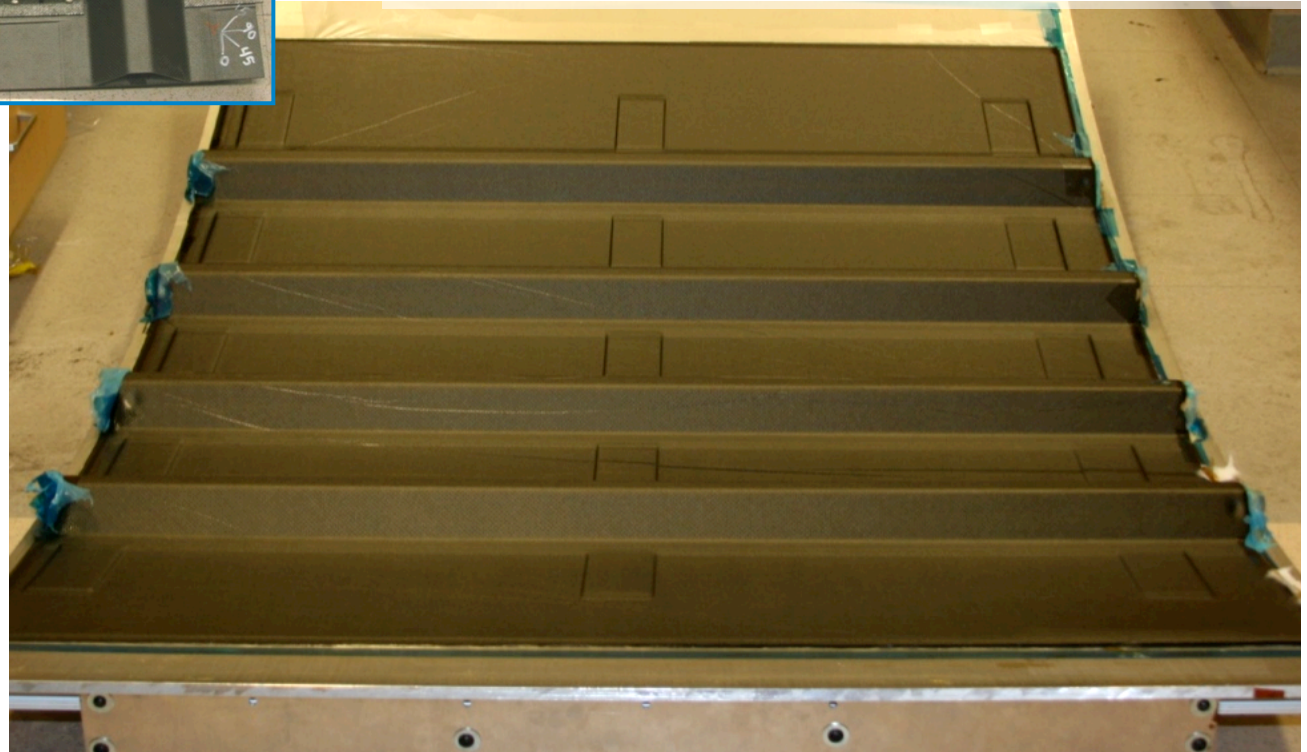
**Stringer
Molds**

**Frame
(Untrimmed)**

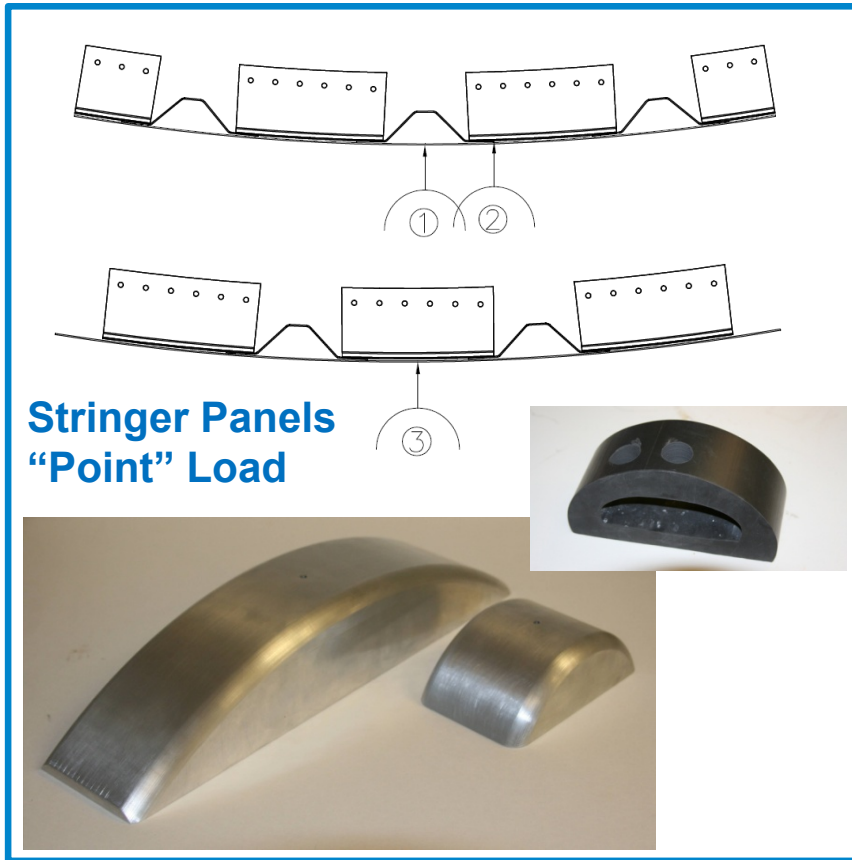
Stringer Panels
"Point" Load

The diagram shows two configurations of stringer panels. The top configuration has four panels with two indenter points labeled 1 and 2. The bottom configuration has three panels with one indenter point labeled 3. Photos show a black rubber indenter and a metal bumper.

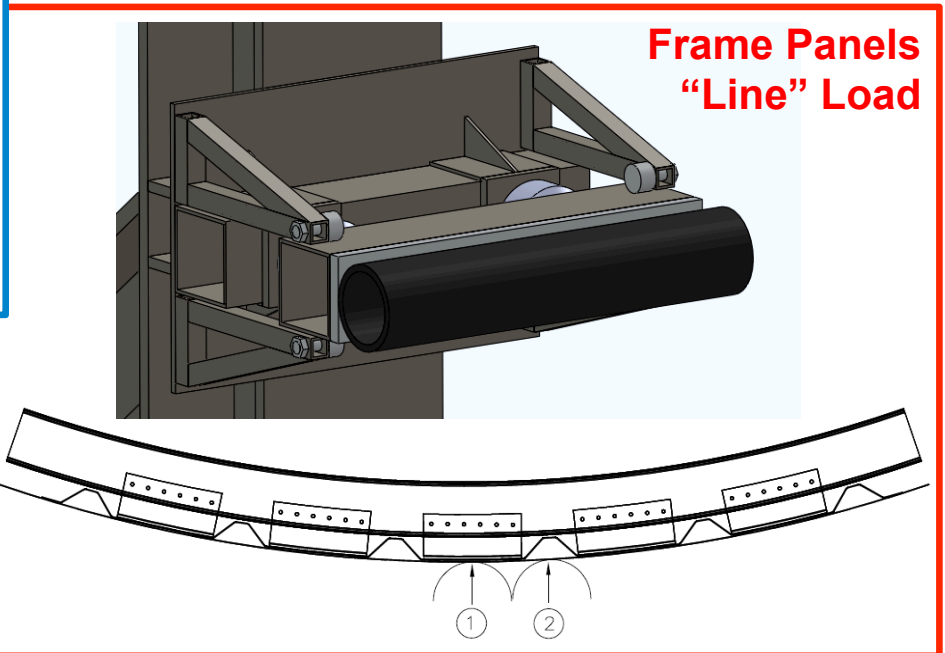
Frame Panels
"Line" Load

The diagram shows a frame panel assembly with a cylindrical indenter. Below it is a schematic of the frame panels with two indenter points labeled 1 and 2.

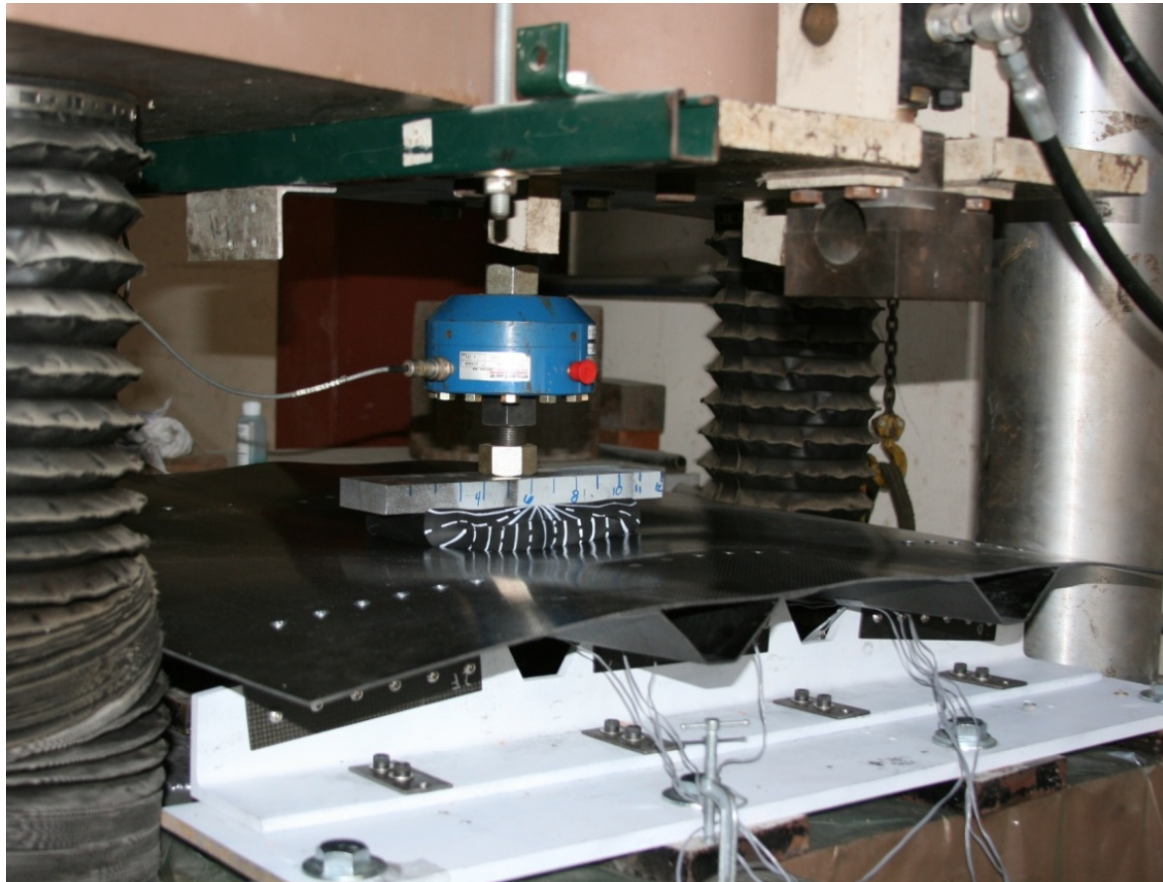
Stringer Specimen Tests

Three specimens tested to date:

- Stringer00 – rigid R3 in. directly above stringer
- **Stringer01 – rigid R3 in. on skin between stringers**
- **Stringer02 – rubber bumper on skin between stringers**

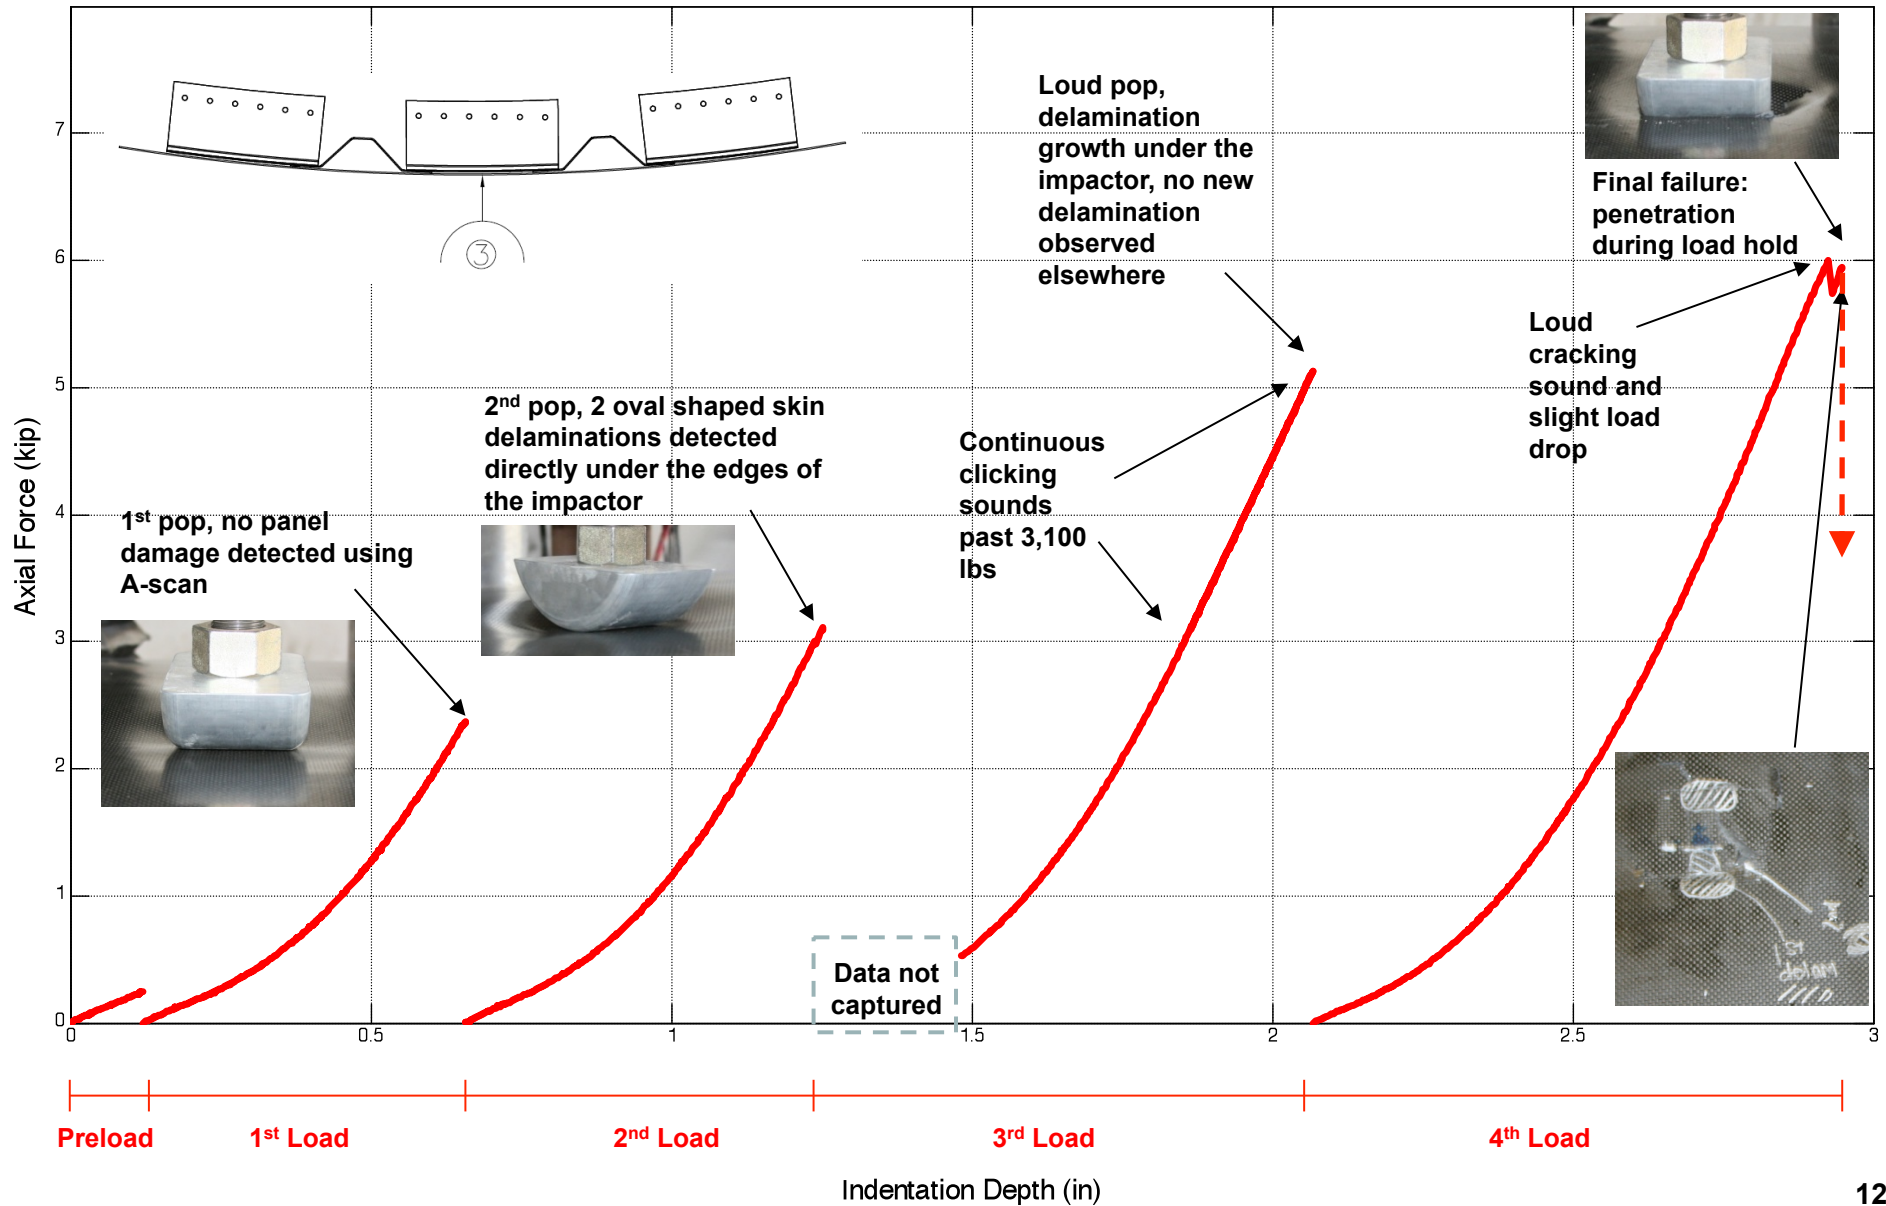
Stringer01 Results

Rigid 3 in. Rad. Indentor on Skin Between Stringers

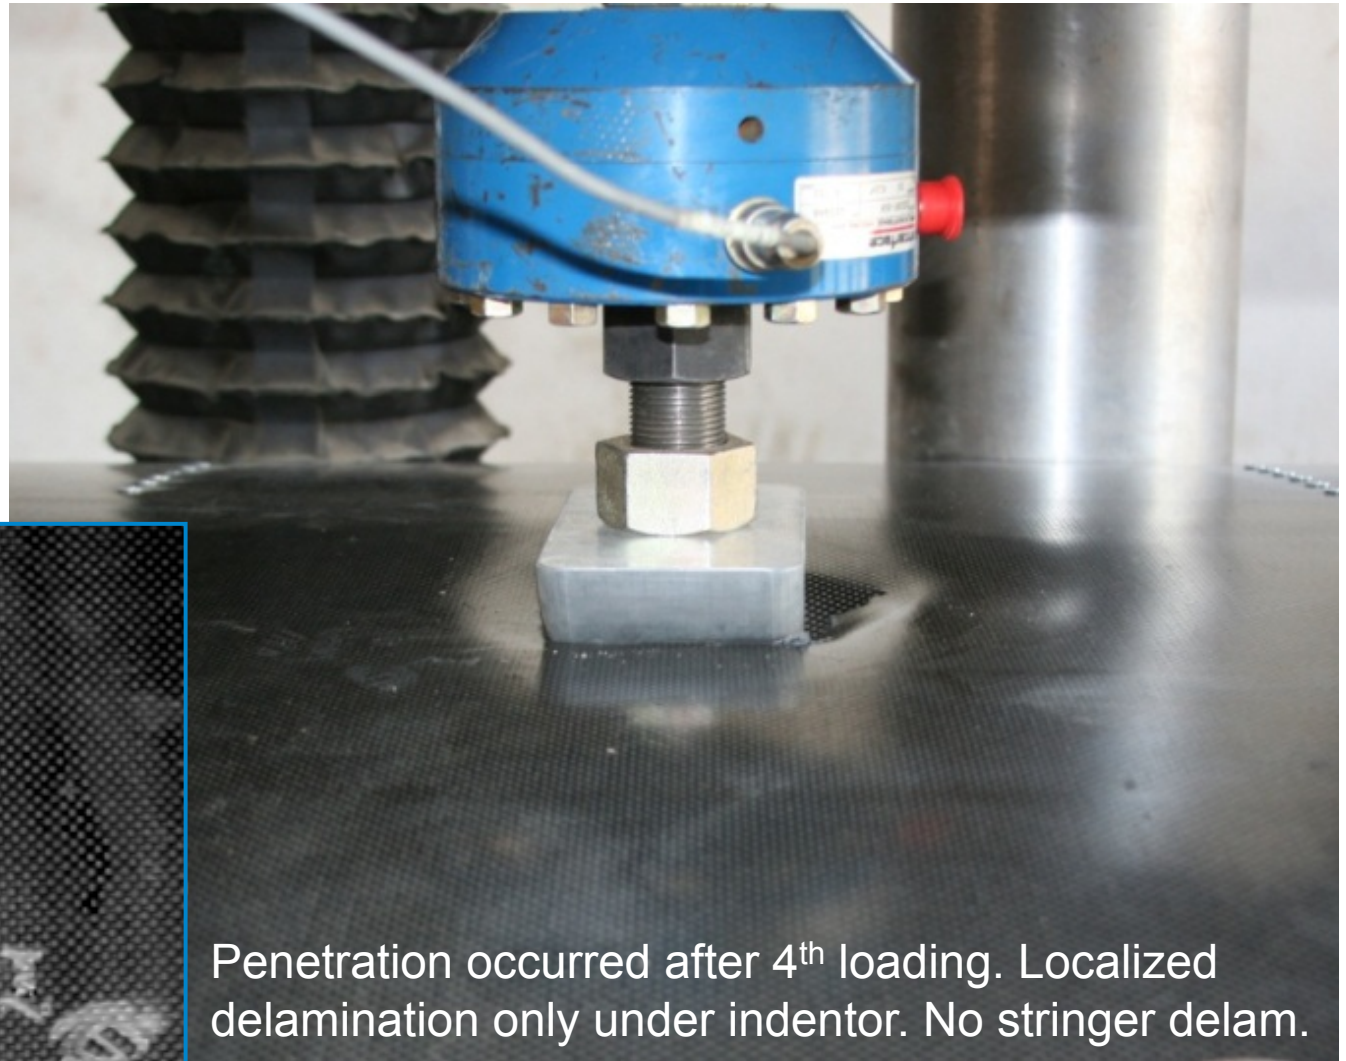
Stringer01 Exterior View After 4th Loading

Damage: Penetration & Localized Delamination

Penetration occurred after 4th loading. Localized delamination only under indenter. No stringer delam.

- » no permanent deformation or externally visible damage
 - **Rigid 3 in. radius indenter produces localized damage**
 - » penetration w/ no delamination of stringer flanges

- » initial damage is localized delamination in skin under indenter edges
 - **Models confirm high interlaminar shear develops at observed damage locations**

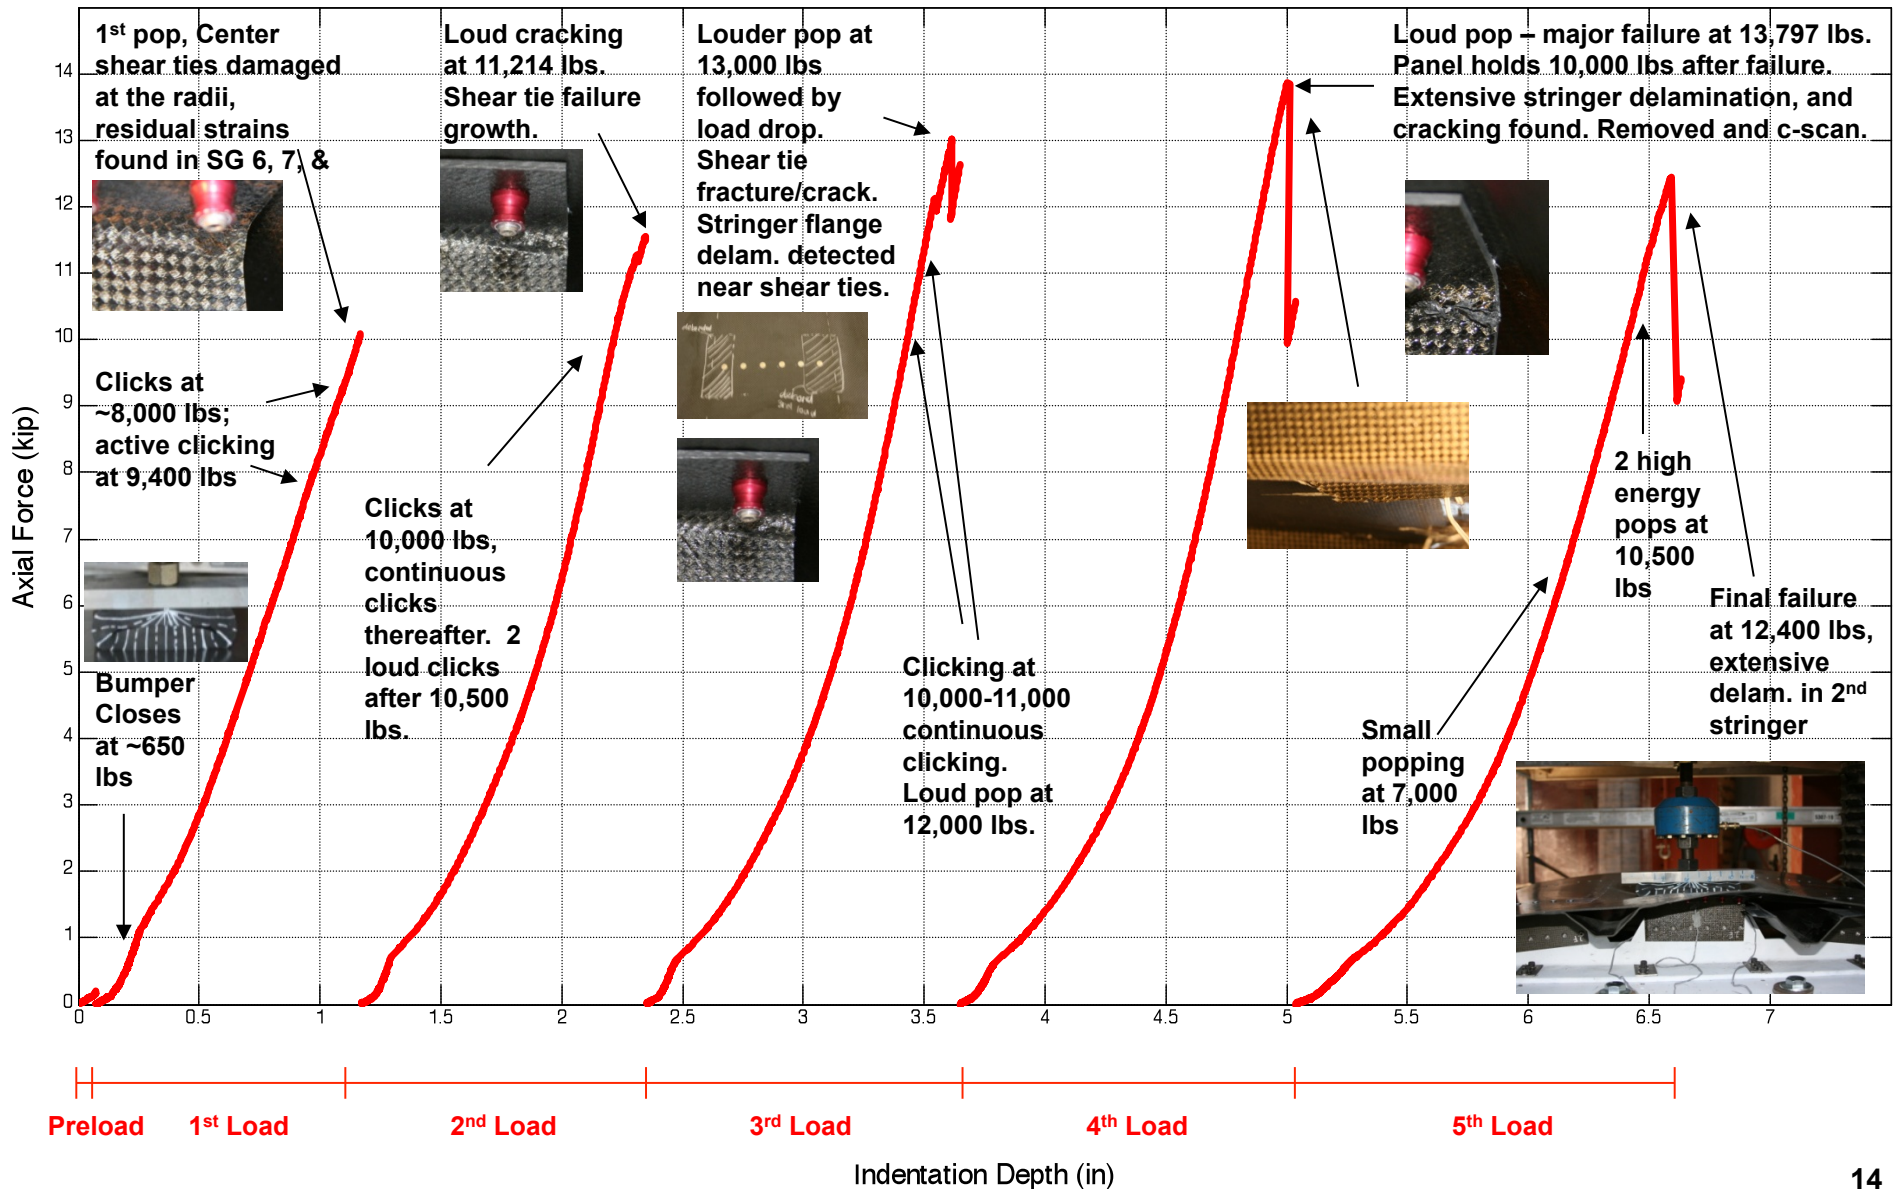
Stringer02 Results

Rubber Bumper on Skin Between Stringers

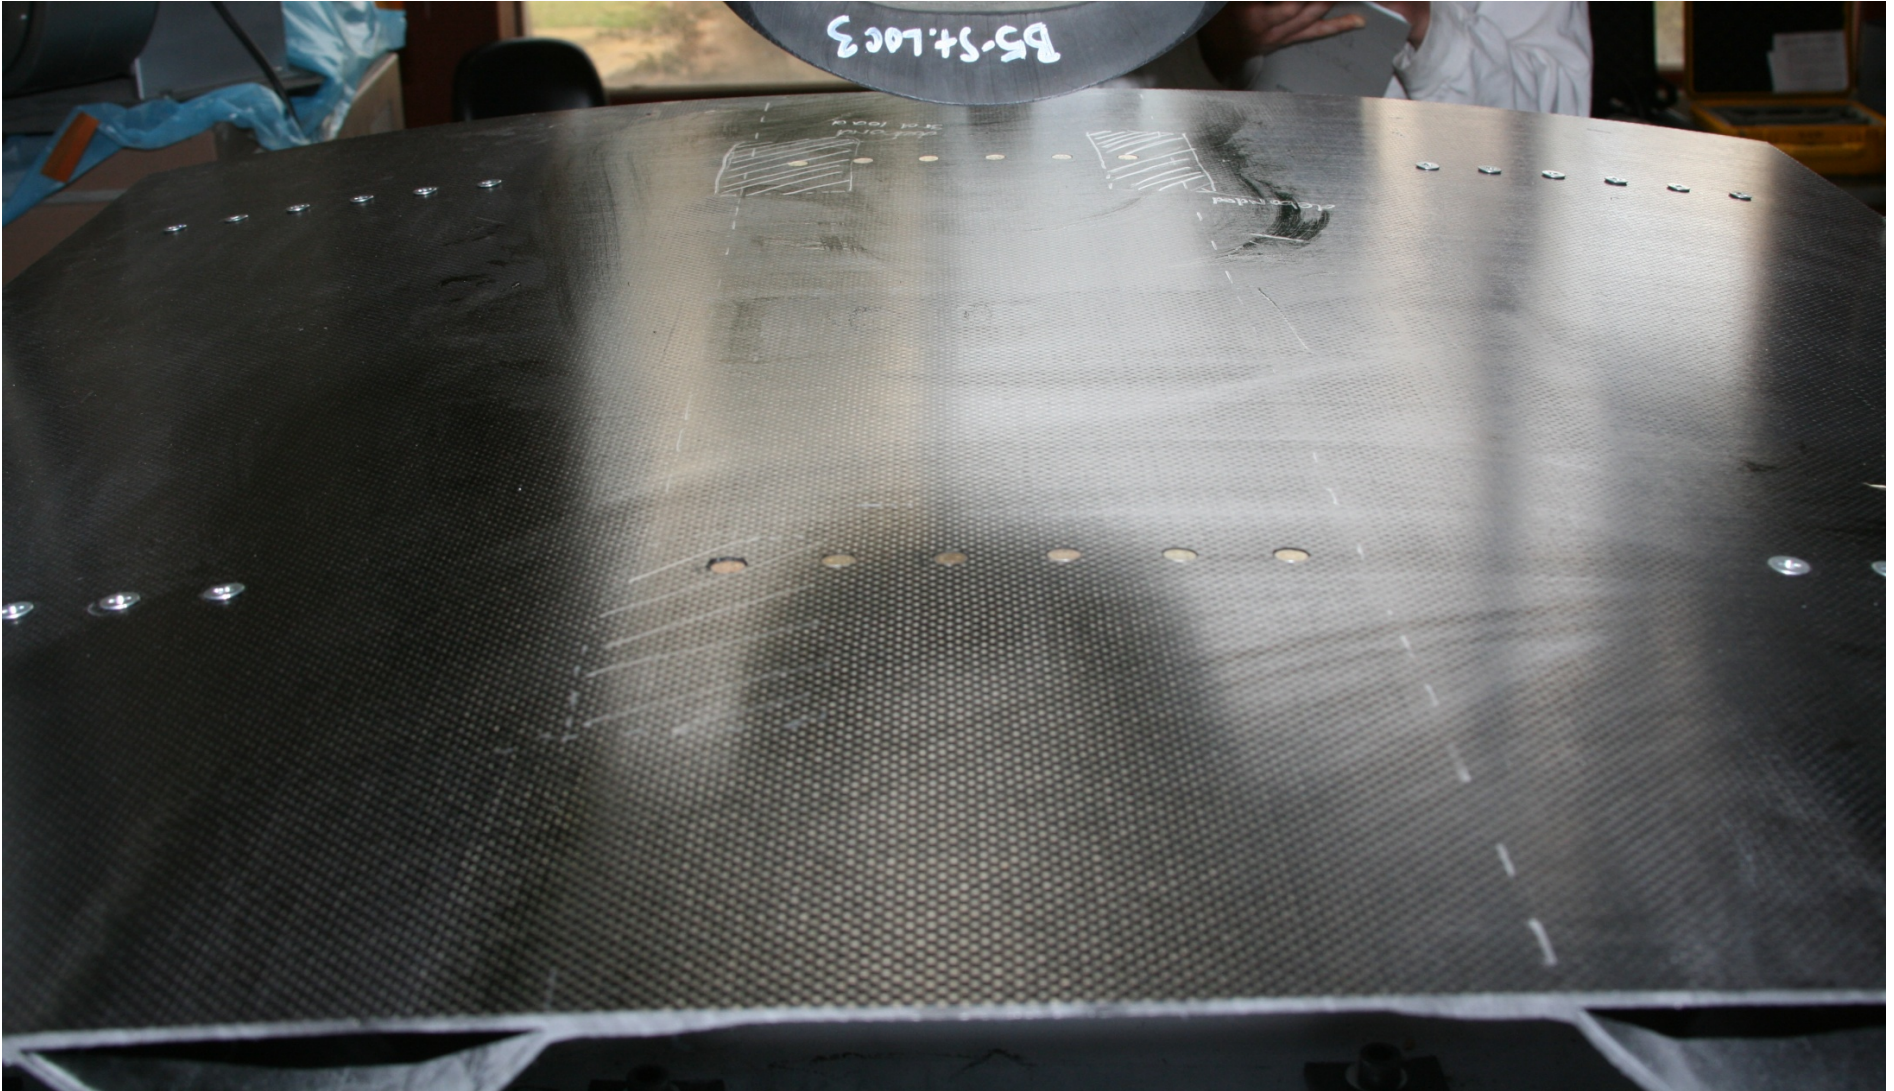
Stringer02 Exterior View After 4th Loading

Damage: Delamination in Both Stringers

Widespread stringer delamination after 4th loading.
No visually-detectable signs of damage on external surface.

- » delamination of stringers originate at internal reaction/hard points (at shear ties)
 - » damage initiation at over 3X loading than “rigid” indenter, peak force 2X higher

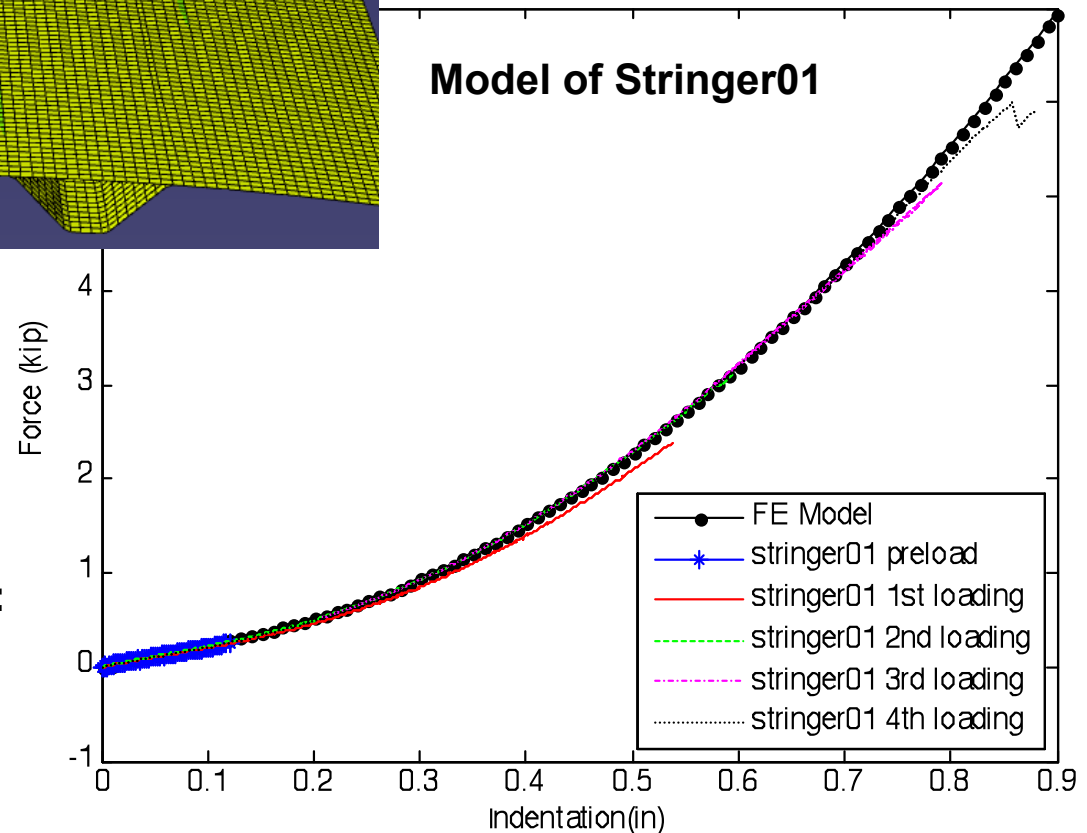
Model of Stringer01

Model results: high interlaminar shear stress (computed from ILS resultants):

-Rigid: in skin under indenter edges: 12-14 ksi at 3,000 lbs load

-Rubber Bumper: in stringer flanges at shear tie locations: ~14 ksi at 13,000 lbs load

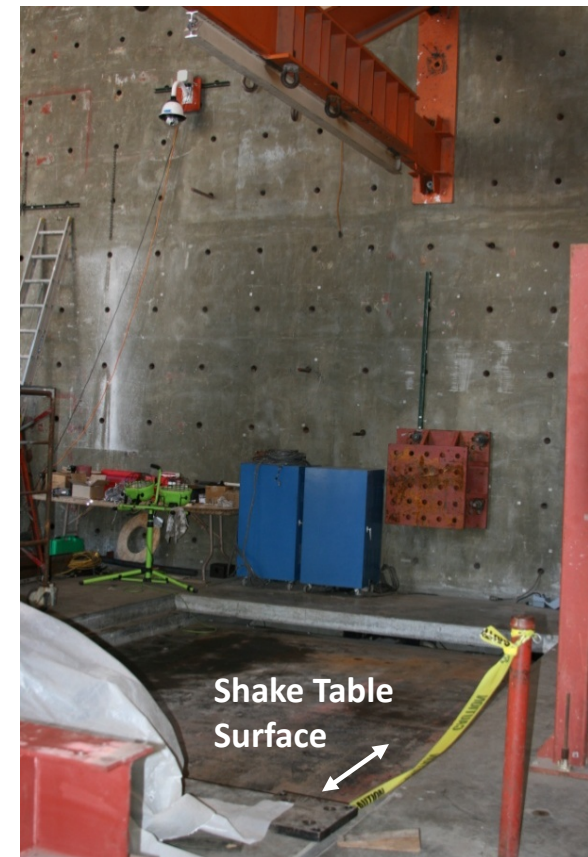
Frame Specimen Test Configuration

Setup employing 1D table (shake table) with specimens mounted to strong wall. Indentor head moves into specimen – simulating GSE contact.

Rigid Strong Wall (full wall not shown)

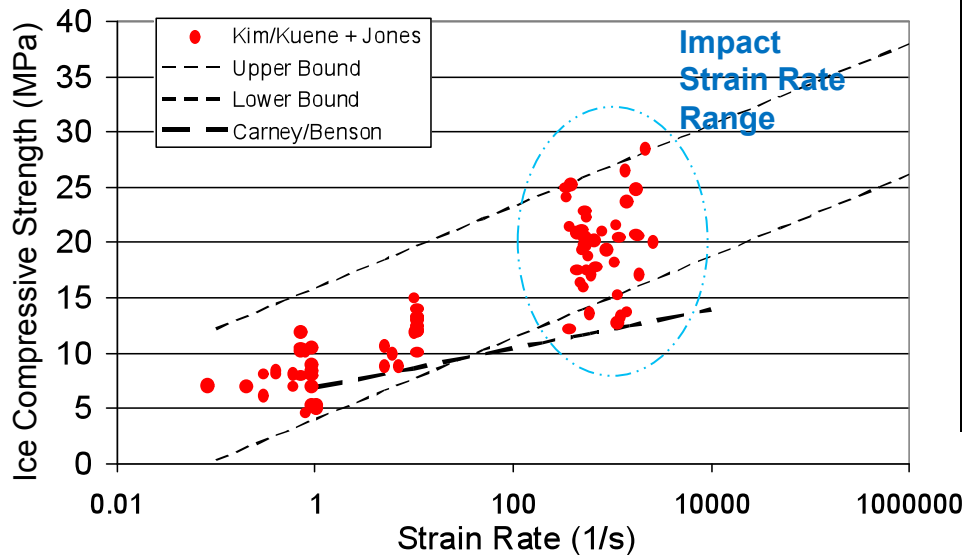
Ice Impact Models Development

- Develop accurate, strain-rate sensitive ice projectile material model – use to simulate impacts onto composite targets/structures

- » longitudinal crack formation with peak contact force corresponding to crack saturation
 - **FE models able to represent basic physics – models to be applied to composite panel specimens & made available for public domain**
